## St Michael and All Angels' Church, Thornhill East Window of the Savile Chapel

19<sup>th</sup> October 2008

David Martlew

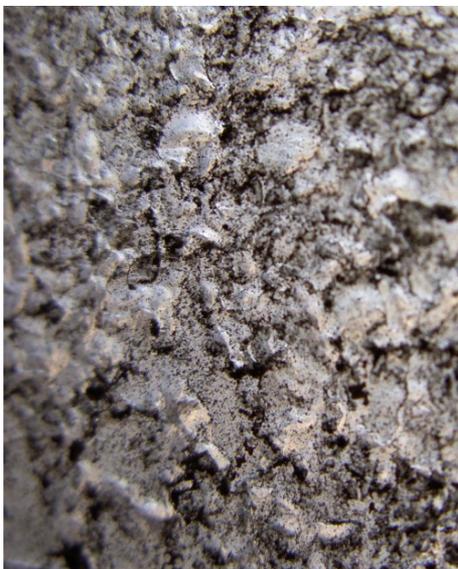
Hand lens examination of the worst affected clear glass pieces in the lower part of the window revealed a rough surface on a scale of perhaps 0.4mm or so, not 'cobbled' because there was visible angularity to the roughness, but with the sharp edges of the angularity somewhat rounded.

*severely damaged surface of a piece of clear glass*

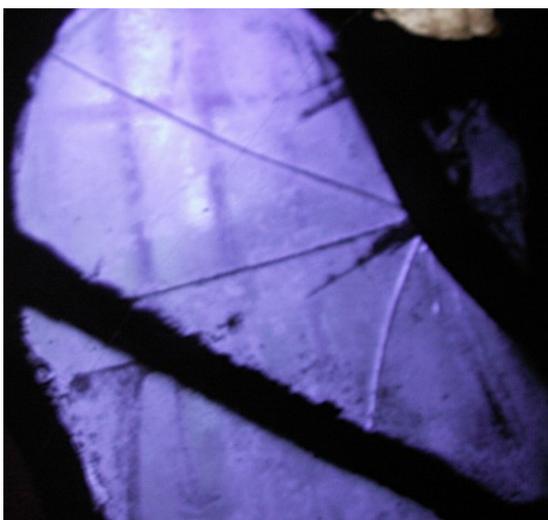
Less severely damaged pieces showed rather random cracking quite unlike the traditional stress fracture pattern generated when for example a stone strikes an annealed window. One of the blue pieces showed this effect - the cracks are predominantly linear radiating outward from the assumed impact site. The clear glass pieces exhibited more randomly orientated cracks which interestingly showed rounding of the crack edges at the glass surface.

*Radial crack pattern on a piece of blue glass indicative of impact damage.*

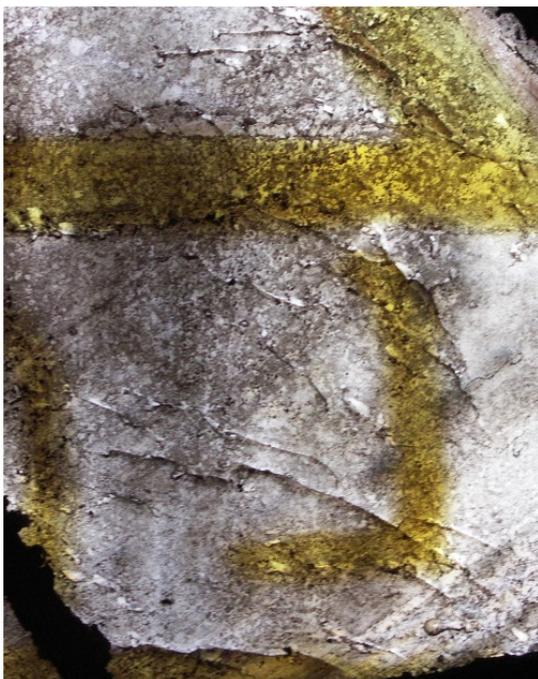
*Rather more randomly distributed cracks visible on a piece of clear glass with silver stain.*

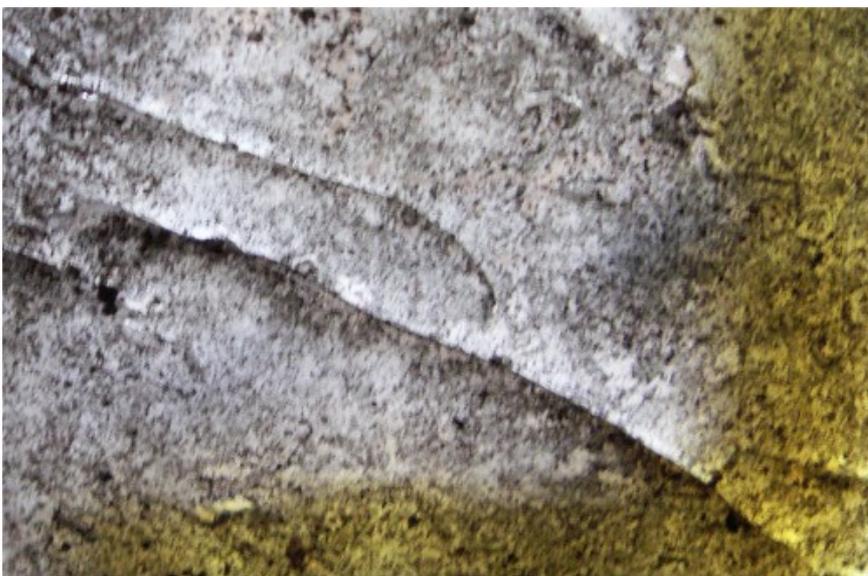
*Detail of some cracks on a piece of clear glass with silver stain – it appears that the “jaws” of the cracks are somewhat rounded.*

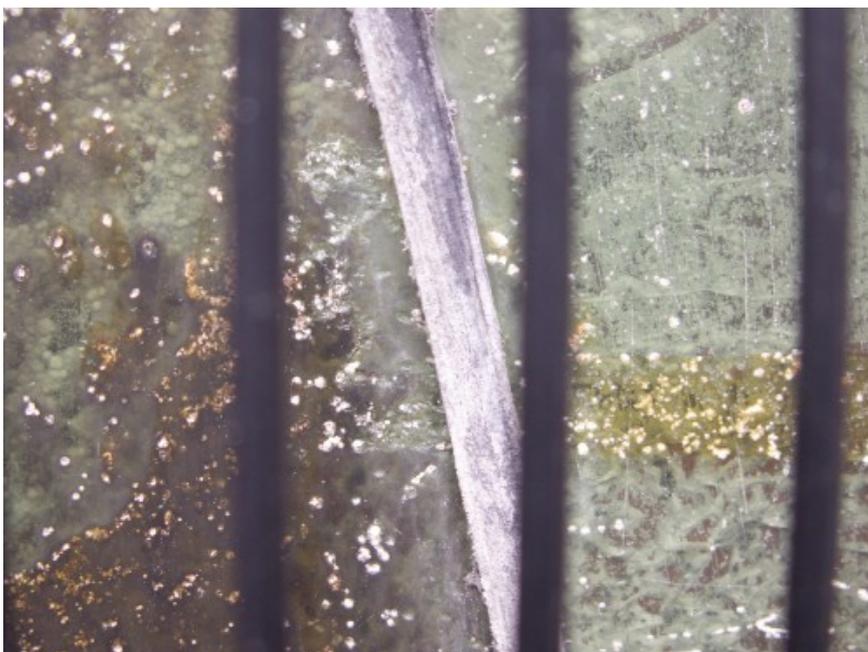
The exterior surfaces presented a very different behaviour, with much less evidence of cracking and with roughly circular corrosion pits present to a greater or lesser extent.

*Exterior surface, showing corrosion pits perhaps 0.5mm in diameter but little evidence of cracking. To the right of the lead it is clear that the cracks visible are on the interior surface and are viewed through the thickness of the glass.*

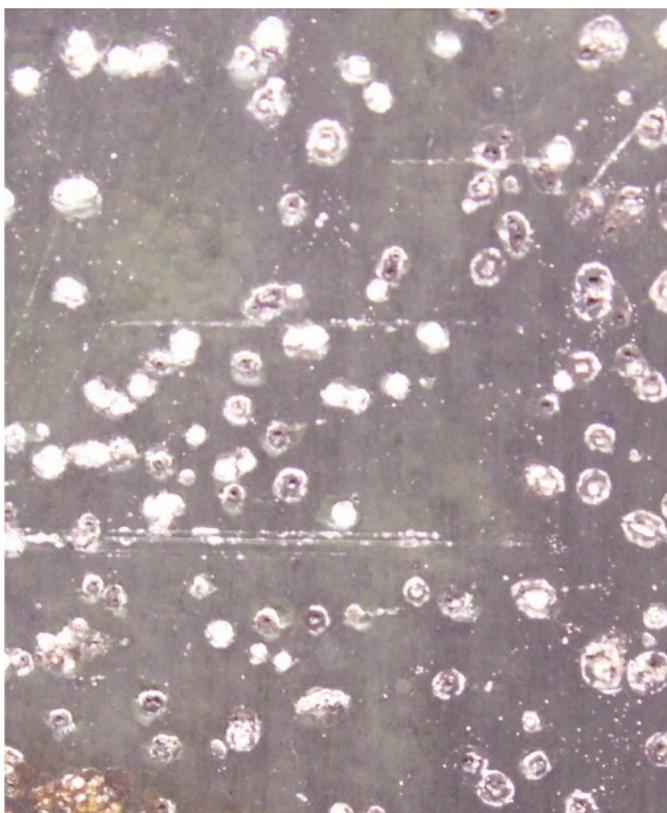
*Detail of the circular corrosion pits on the exterior surface. In some instances the pitting had become so severe that the corrosion pits began to overlap.*
