Monument # 9 The Elmsall Family Memorial

The Works

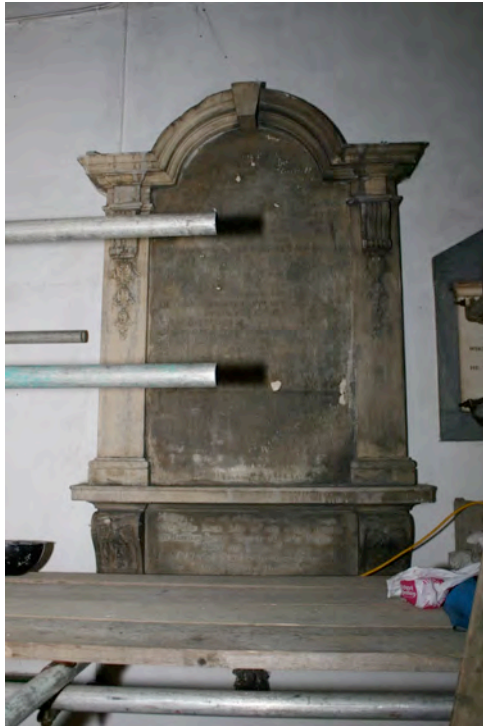
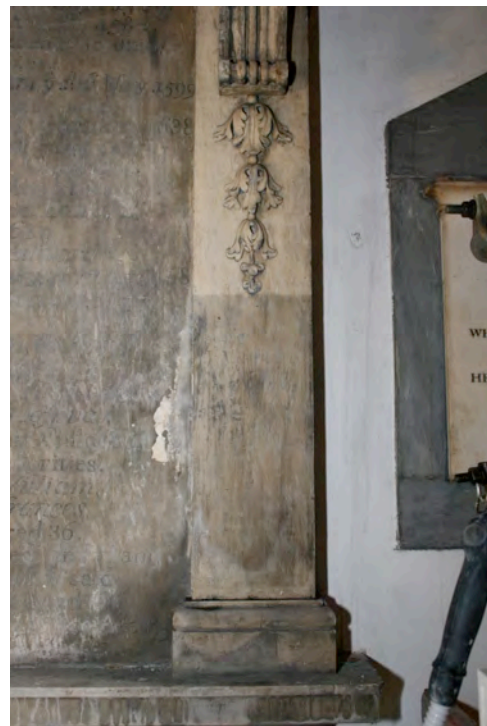
- 3.4 The whole monument is heavily soiled and did not respond well to the range of cleaning techniques and materials available to us. Vertical water marking was visible over much of the total surface area. Once cleaned the majority of flat surfaces looked like they were covered with the kind of distinctive markings usually associated with bat urine on wall-paintings, although there was no evidence of any recent bat activity.

General views of the monument during cleaning, with the viewers left side partially cleaned on the left image and the right-hand pilaster during cleaning on the right. Note on this image the small, splash marks which became apparent all over the surface during cleaning with cotton wool swabs. This type of random, soiling is sometimes seen on wall-paintings and is attributable to bat urine, close to a roost.

- 4.1 All elements underwent a preliminary dry clean with a vacuum cleaner to remove the heavy layers of dust particularly from the top bed of the cornice.
- 4.2 A series of cleaning and solubility trials were conducted on the limestone and painted remains within the inscription, which did not respond all that well to the techniques available.
- 4.3 All architectural elements were sound with no de-scaling and were cleaned with low-pressure steam, with dirty residues collected with paper towelling to prevent re-distribution. The upper and lower inscription panels were cleaned with great care due to their fragile nature. This was carried out using cotton wool swabs dampened with a 1% v/v solution of de-ionised water and Synperonic A7 (a non-ionic surfactant).

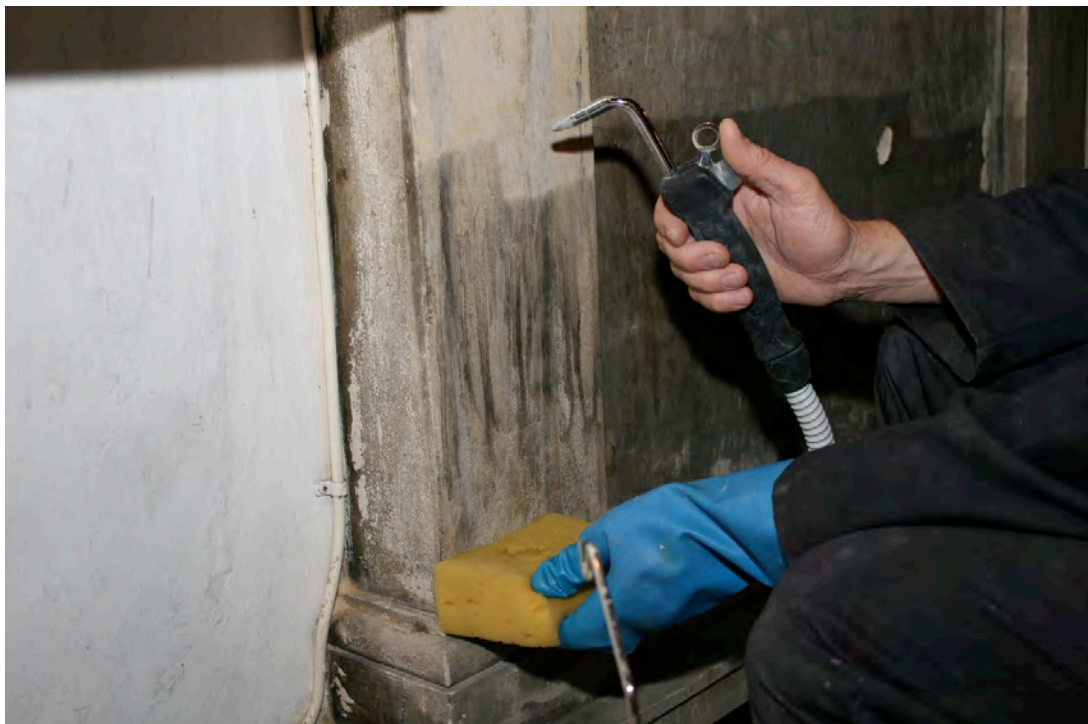
Steam cleaning of the left pilaster in progress, with dirty residues collected in sponges to prevent re-distribution.

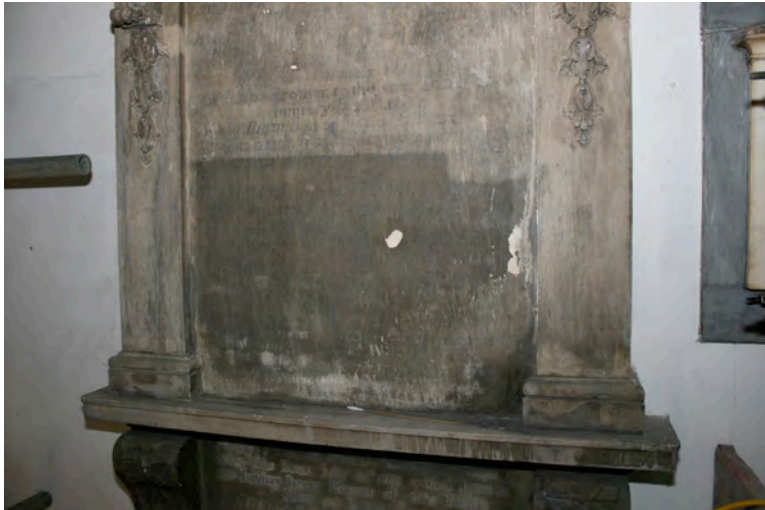
A clear cleaning contrast on the upper inscription panel. Neither panel were up to anything other than cleaning with cotton wool swabs, as great care had to be taken around de-laminating and blistering areas as well as the need for applied water to be kept to a minimum.

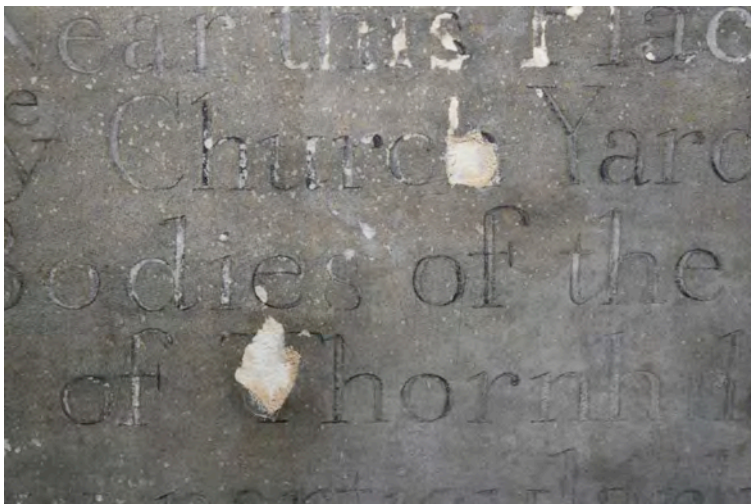
- 3.5 The case-hardened upper surface of the main inscription panel, displayed a number of aged blisters (where the substrate was exposed) with adjacent stone sounding hollow when gently tapped, where it had de-bonded from the substrate. The pilasters were in a much more sound condition, thus allowing the use of low-pressure steam.
- 3.6 It was noted there was very little paint remains in the shallow inscription to both panels, which made it difficult to read from floor level.

Detail of some of the blisters which were concentrated on the upper section of the larger inscription panel. Support fillings were inserted where practicable. Note how lightly incised the inscription is, coupled with the level of cleaning achievable making the lengthy inscription difficult to read, even when up close.

- 5.1 The areas of blistering and adversely affected adjacent areas were consolidated by two syringe applications of a 2.5% w/v solution of Paraloid B72 dissolved in Acetone : IMS 50 : 50 and a single application of a 5% solution of the same material. This was successful in restoring physical cohesion to these depleted areas and restoring a bond between de-scaling areas.
- 5.2 Once the solvent carrier of the consolidant had dried, support fillings were introduced beneath and around the perimeter of the blisters to prevent further loss of surface material. A repair medium of sieved, Portland and Guiting stone dusts was mixed with a 10% w/v solution of Paraloid B72, which was then inserted behind blisters with dental tools. The dusts were selected to assimilate the colour of the exposed substrate and are easily reversible in the future due to the use of the acrylic resin Paraloid B72.

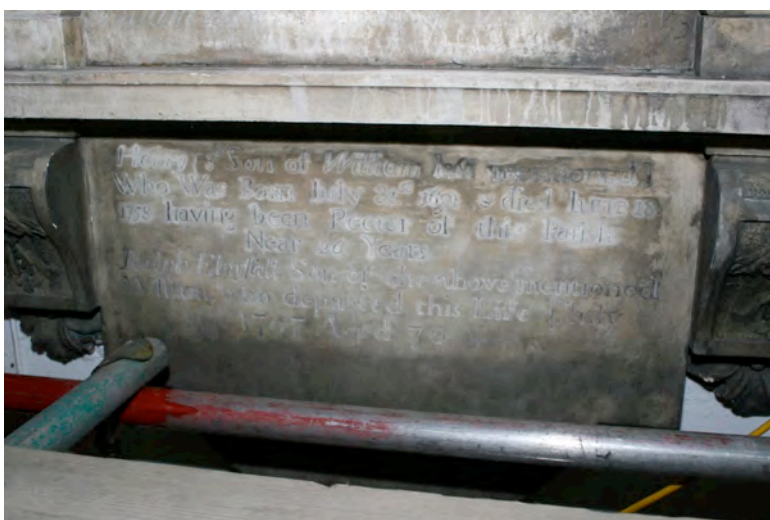
Cleaning in progress to the lower inscription panel. Note the random splashing is not so evident over the surface of this panel.
