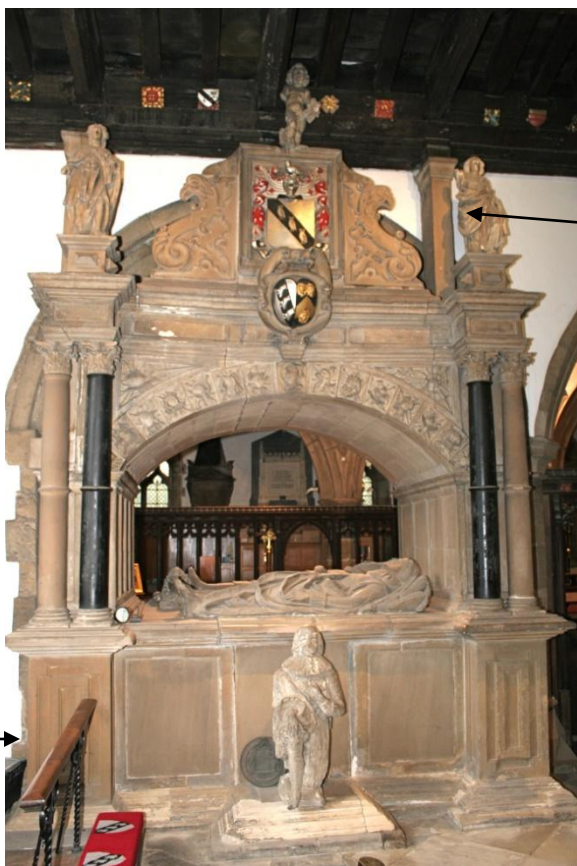
General view of the north elevation from the Savile chapel, note the two sandstone posts, one partially obscured by the upper left-hand figure, these are thought likely to be providing structural support to elements above. Note the light coloured surfaces to the plinth (beneath the kneeling figure in particular) are exposed limestone substrate, with the brown paint layer now missing from these areas. The left hand pilaster also displays significant loss of paint to reveal the brown sandstone beneath. The arrow on the left-hand side denotes where stone drillings were removed from and tested for absolute moisture content, soluble salt levels and where the oak dowels were inserted and sealed in to allow re-testing.

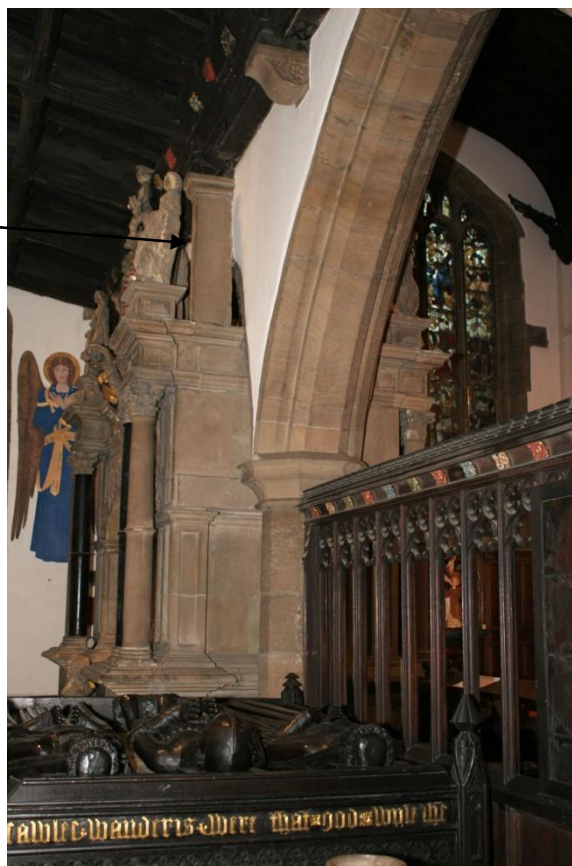
General view of the scale of the monument situated beneath the overflying arch, spanning the Savile chapel and choir. Note the large tracery window to the south bathes the stonework on the south elevation in sunlight on sunny mornings.

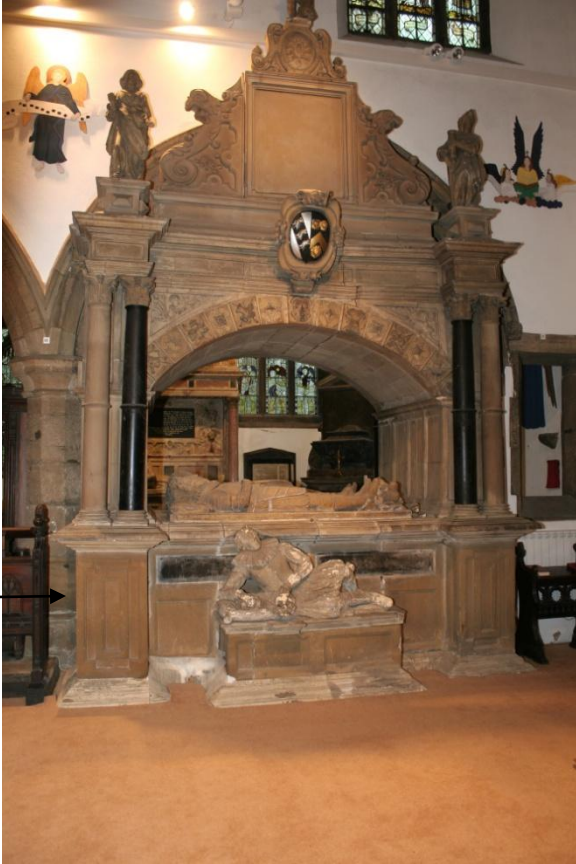
General view of the south elevation from the choir, note the monument appears much more uniform in colour on this elevation. The arrow on the left-hand side denotes where stone drillings were removed from and tested for moisture content, soluble salt levels and where the oak dowels were inserted and sealed in to allow re-testing. The lower elements of the tombchest have fared worse than the opposite elevation with regard to efflorescence. Efforts should be made to remove this on a regular basis using soft bristle brushes and a vacuum cleaner, before the salts move back into solution.

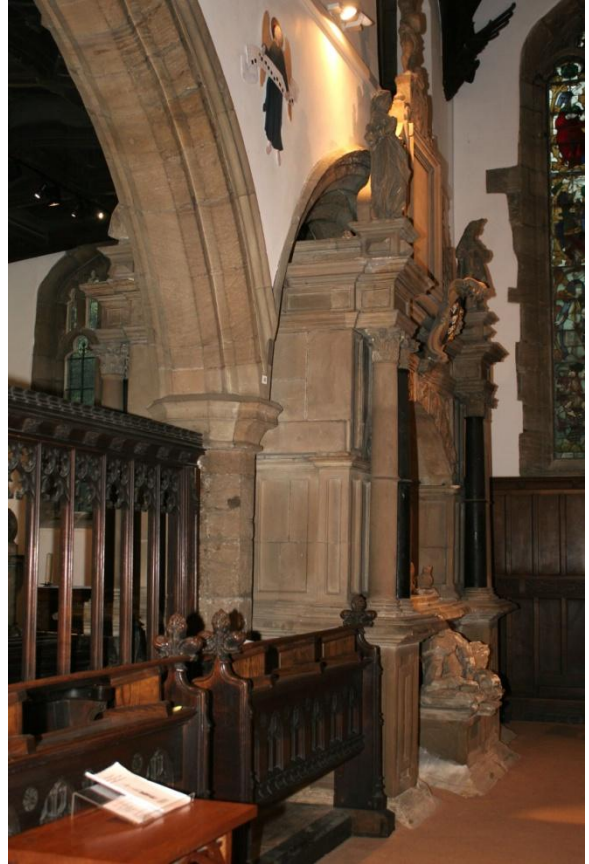
Note again the scale of the monument from north to south. The fine joints on the return elevation can just be seen and display no obvious signs of movement or deformation, on either of the return elevations.

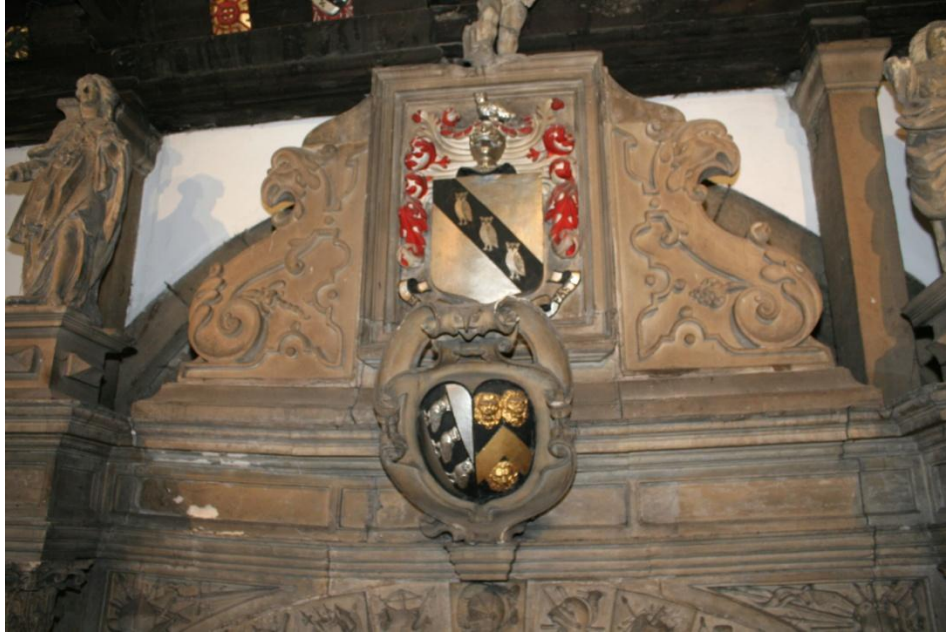
The main horizontal axes of the canopy on the north elevation, note the overall extent of deformation/sagging, note also the extent of surviving decoration and its relatively sound condition.

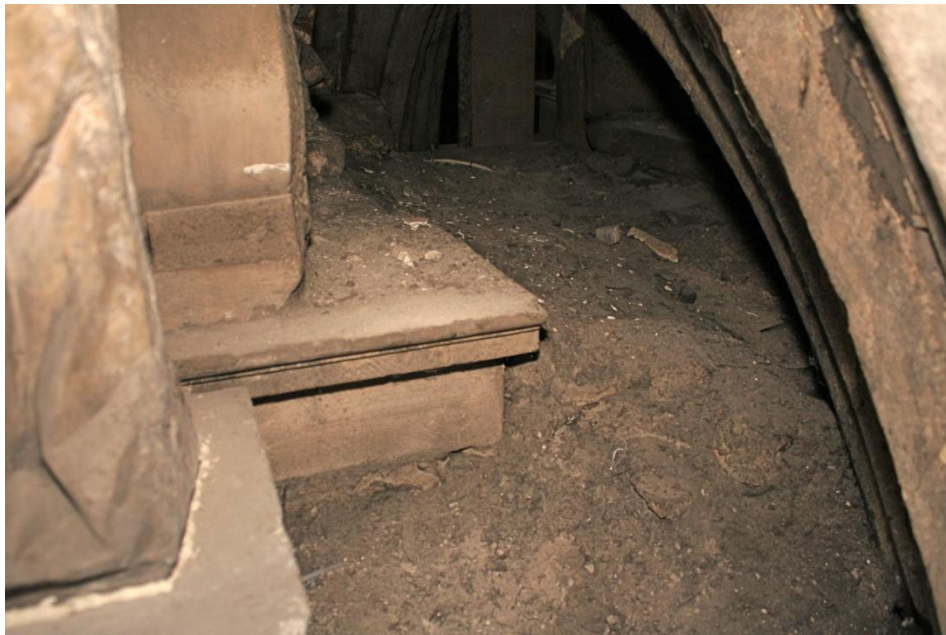
General view from the south-east corner , inside the top of the canopy highlighting the extent of rubble stonework and mortar spanning between the two elevations, adding unnecessary weight to the crown of the arch/vaulting.

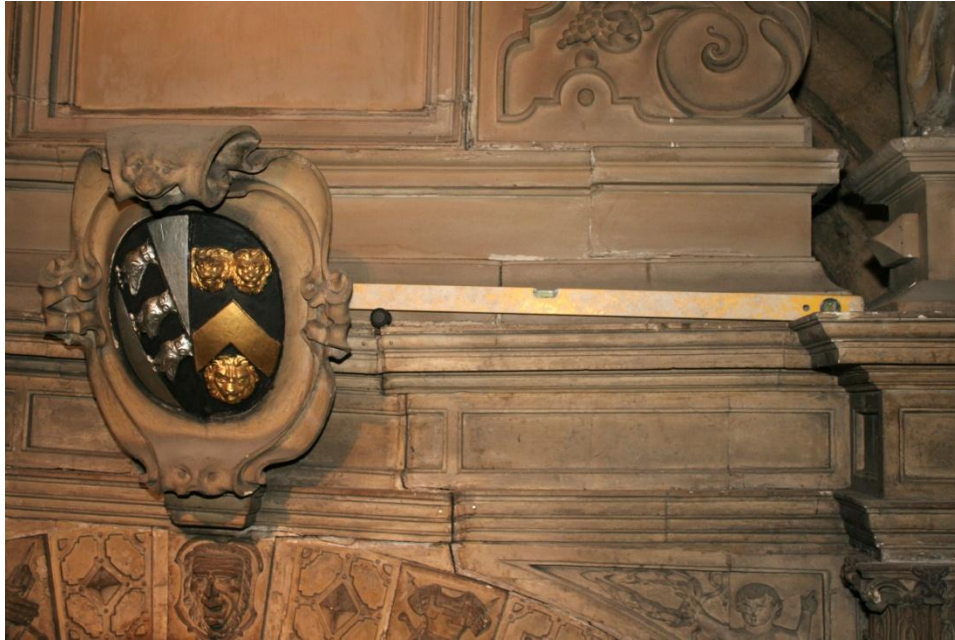
General view of the south elevation, highlighting the deformation present in the canopy, note the vertical joint has opened up from the extrados of the arch to the top bed of the cornice and has been filled with plaster to make up the moulding. The spirit level is perfectly horizontal, highlighting the discrepancy of 30mm, with a maximum of 44mm in the same place on the north elevation. This would need to be taken into consideration when re-building the canopy plumb/horizontal.

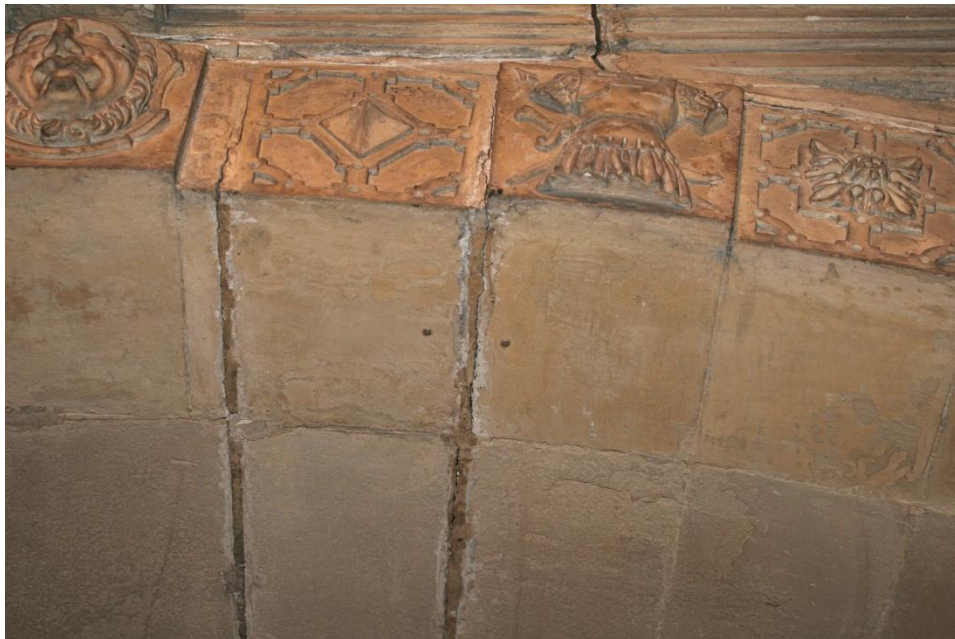
General view of voussoirs one and two to the east of the keystone, the Demec studs had closed up by 15.49mm over the course of five months from the date they were applied, with the joint now appearing tight.

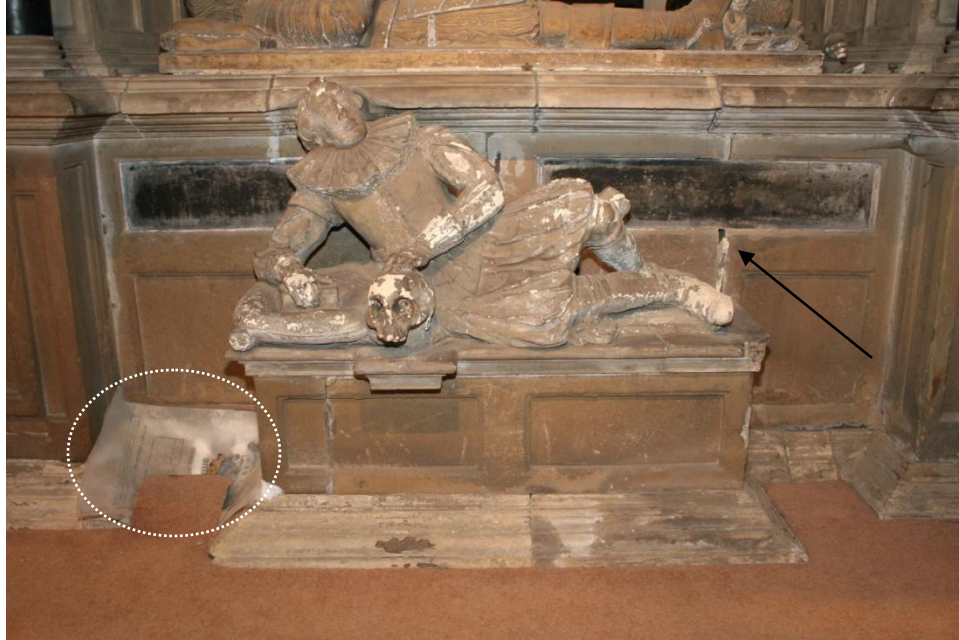
General view of the south elevation, the arrow indicates where visual access to the core of the tombchest was possible. The area circled shows where trials were undertaken to remove and replace defective mortar, being covered with damp cotton-wool and plastic to prevent premature drying, this will be monitored closely to chart the anticipated movement of soluble salts through the new mortar.

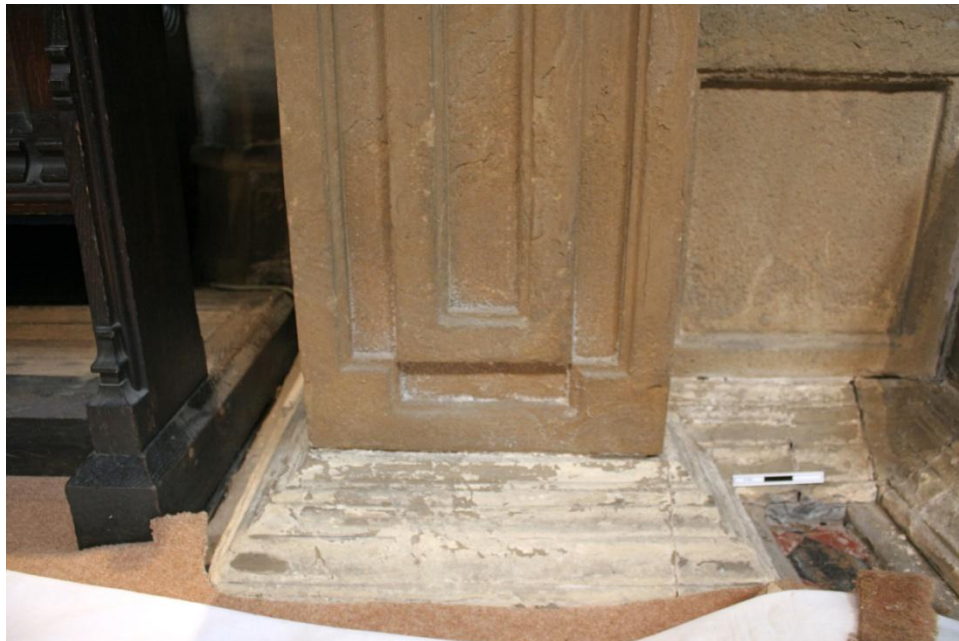
Context view of the left-hand plinth and pilaster, highlighting the loss of painted material from the plinth. Note the light-grey areas are fluffy efflorescence which should be vacuumed on a regular basis to prevent them moving in and out of solution.

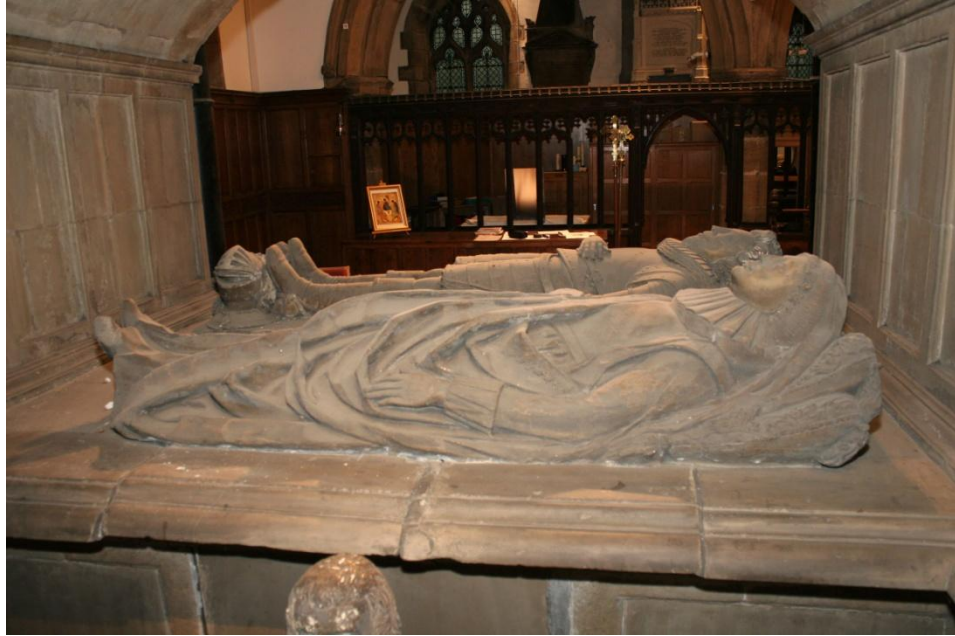
General view of the female effigy from the north elevation, note the accumulation of atmospheric dirt obscuring carved detail, note also the springing/uprights of the arch are free of decoration, with vertical, ferruginous veining clearly visible.

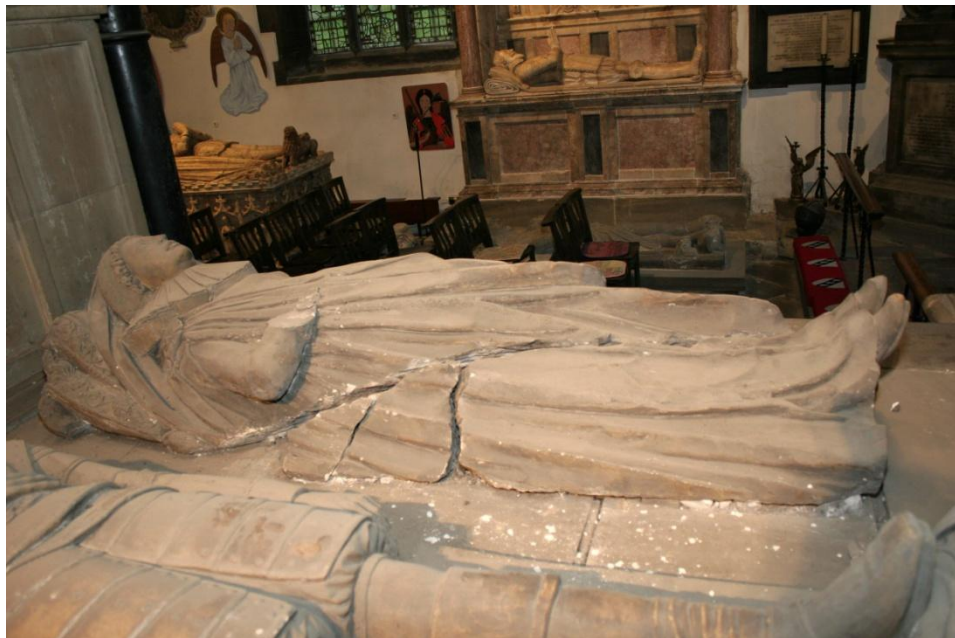
General view of the female effigy highlighting the extent of damage from the proper right torso down to her feet, which have completely separated and display significant loss of material from break edges.
