**St Michael & All Angels Church, Thornhill.  
Conservation report on the internal monuments**

**General description and Detailed condition survey of the  
monument to Sir George and Lady Anne Savile – south  
elevation**

**Prepared for:  
Thornhill Parish Church Council  
June 2010**

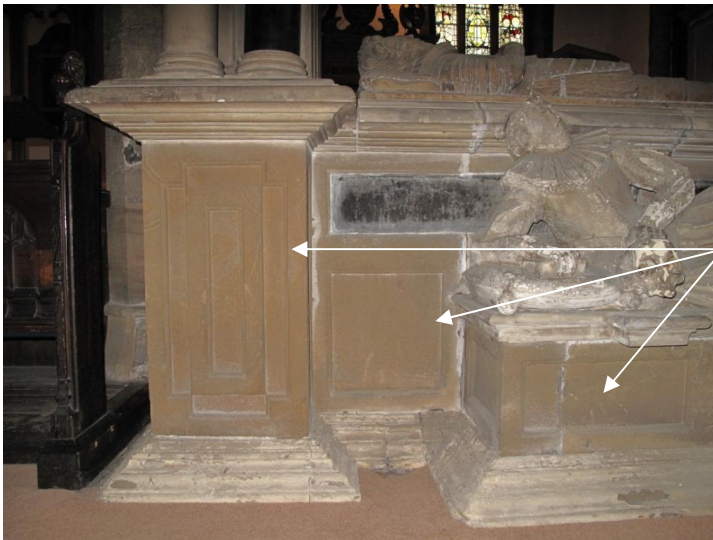
08/006

In this area the moulded and carved sections of stone would appear to be limestone while the larger panels are carved from sandstone.

The base mouldings are badly eroded and appeared quite damp at the time of the survey.

There is considerable efflorescence of soluble salts on the stones in this area.

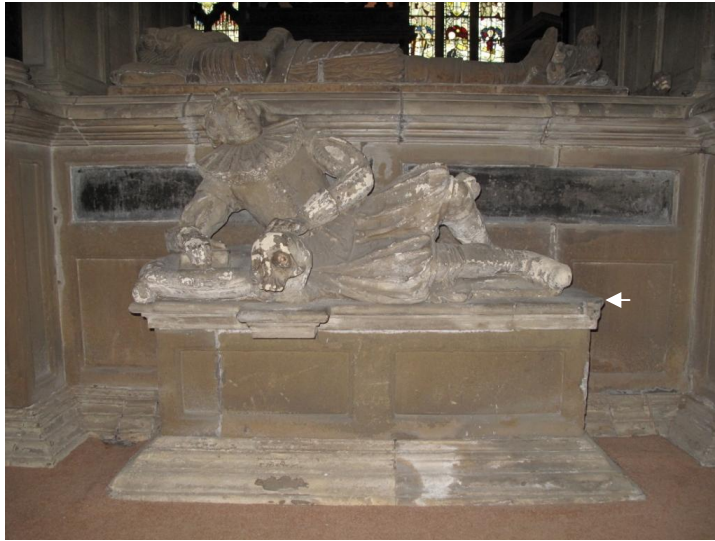
08/007

As previously discussed the areas adjacent to the monument at floor level are subject to considerable dampness and the monument itself is suffering badly from the ingress of moisture and soluble salts.

In addition there are some impact damages generally across the surface – most notably here in the east corner on the chest of the son's effigy

as indicated by the white arrow.

The surface of the Belgian black panels is badly eroded and some of the polish has been lost. This is typical of this material in damp environments and this instance is considered consistent with its age and location. It is indicative of condensation forming on the monument over a prolonged period.

It appears that the monument may have been given a coating at some time as the surface of the limestone in particular has a darkened skin. It is apparent here on the effigy showing in contrast as a retained dark area in contrast to the white surfaces where it has eroded (on the arm and the foot for example). It is also at other locations including at high level as will be pointed out later. It will be suggested that this be examined further to ascertain what it is.

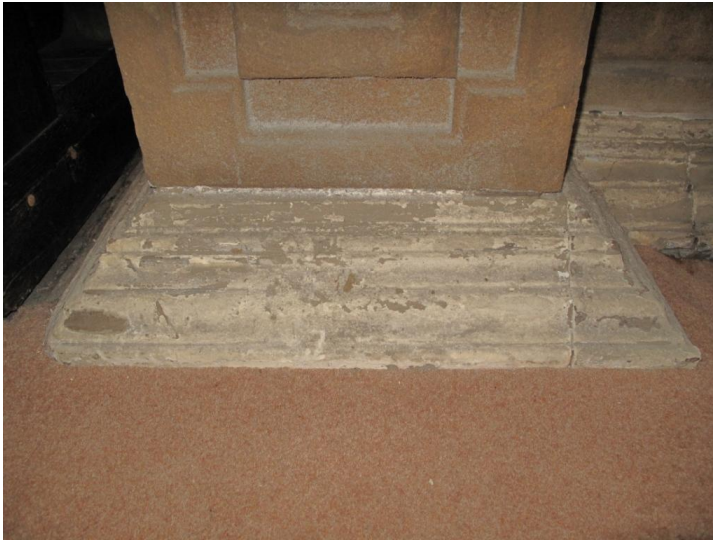
08/009

Detail of the west end base stone, south elevation.

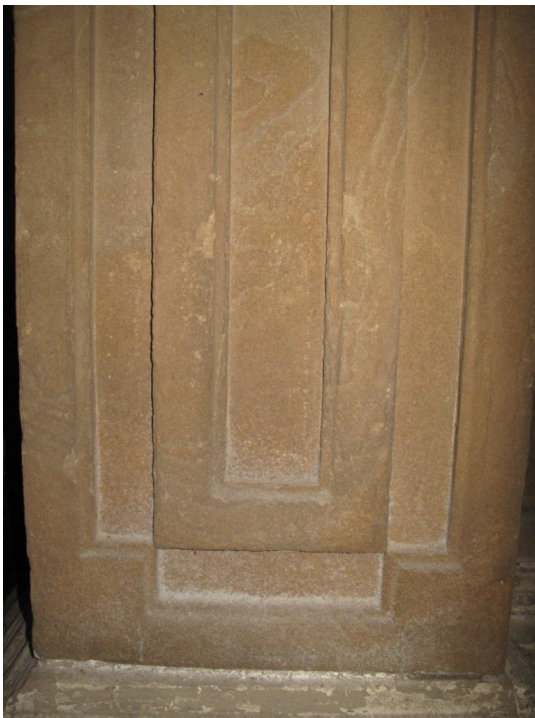
08/010

Left: Detail of the front panel west end pilaster block, south elevation.

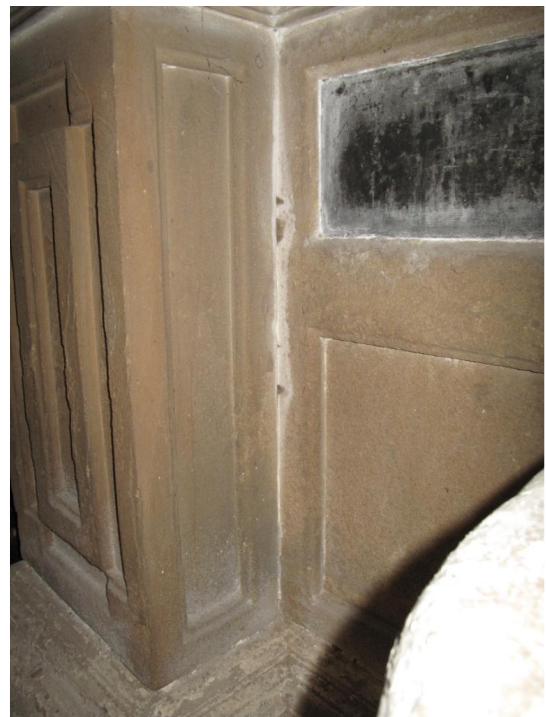
08/011

Below: Detail of the east elevation panel of the same pilaster block. The lack of definition in the moulding for example is indicative of long gradual erosion of the surface which considering the internal location must be the consequence of moisture and salt damage over a very long time.

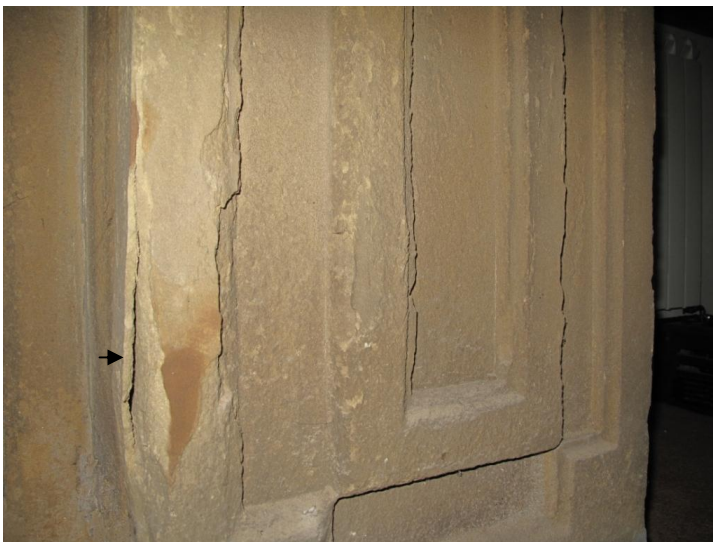
08/024

*Above:* Detail of the 'recess' between the son's effigy and the eastern plinth block.

In this photograph the salt efflorescence is shown to be substantial and easily visible to the eye (white arrow).

It is worth noting the, possibly four, different types of pointing in this area are indicative of several different restorations (orange

arrows).

*Above left:* There is exfoliation on the surface of the stone which is similar to weathering seen on external sandstone where the surface hardens, expands and exfoliates; (black arrows). The strong mineral discolouration, apparent as a dark rust coloured spot, is indicative of severe moisture ingress. See also the following photograph.

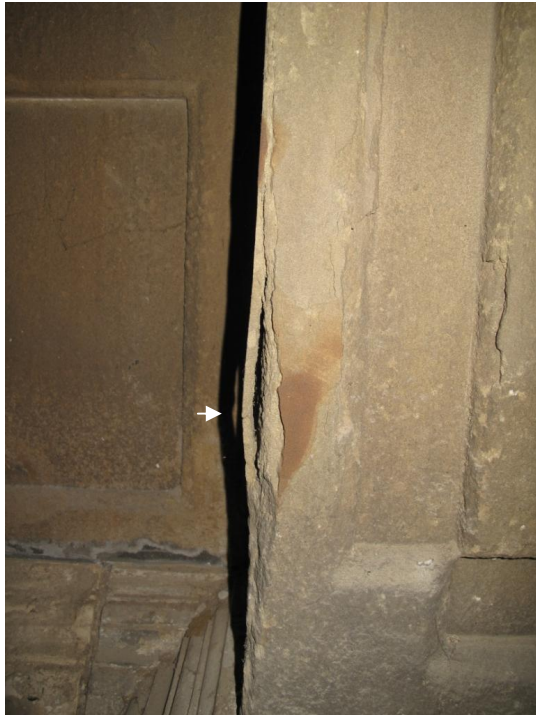
08/023

Detail of the above area of exfoliation taken from the front.

The shadow shows that light passes through the exfoliated piece of stone demonstrating that the surface of the stone is completely detached and in imminent danger of falling from the surface.

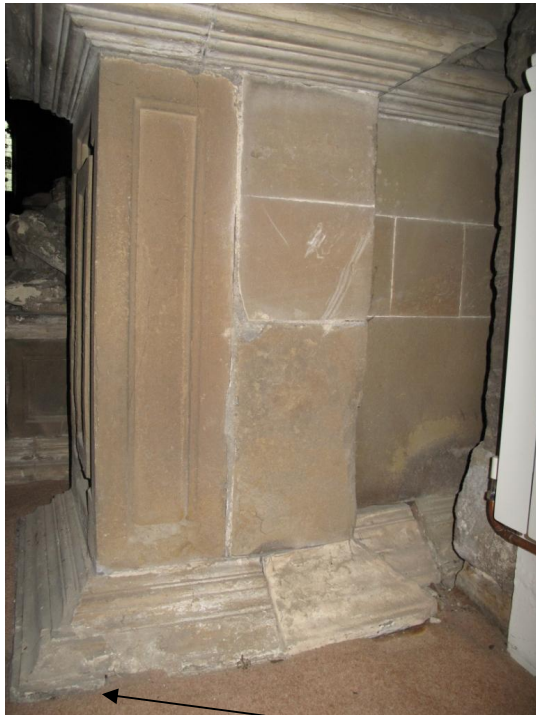
08/025

Left: A detailed view showing the eastern elevation of the chest tomb and including the abutment with the base of the arcade arch. Compare the design of this end with the opposite one shown later. It can be seen that the stones on the return elevation here have most likely been replaced with plain ashlar blocks

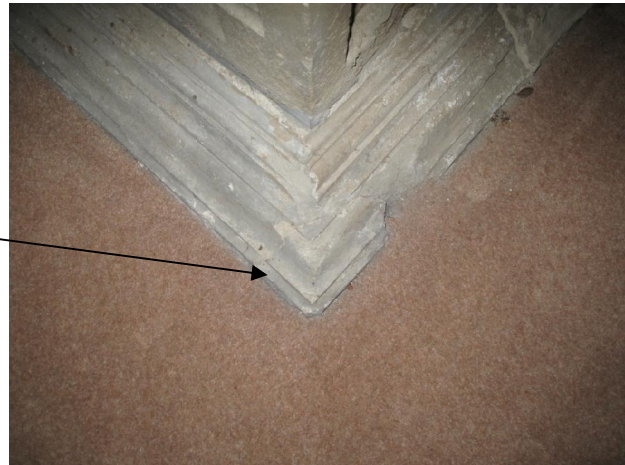
08/026

Below: The corner of the plinth at this point has been broken.

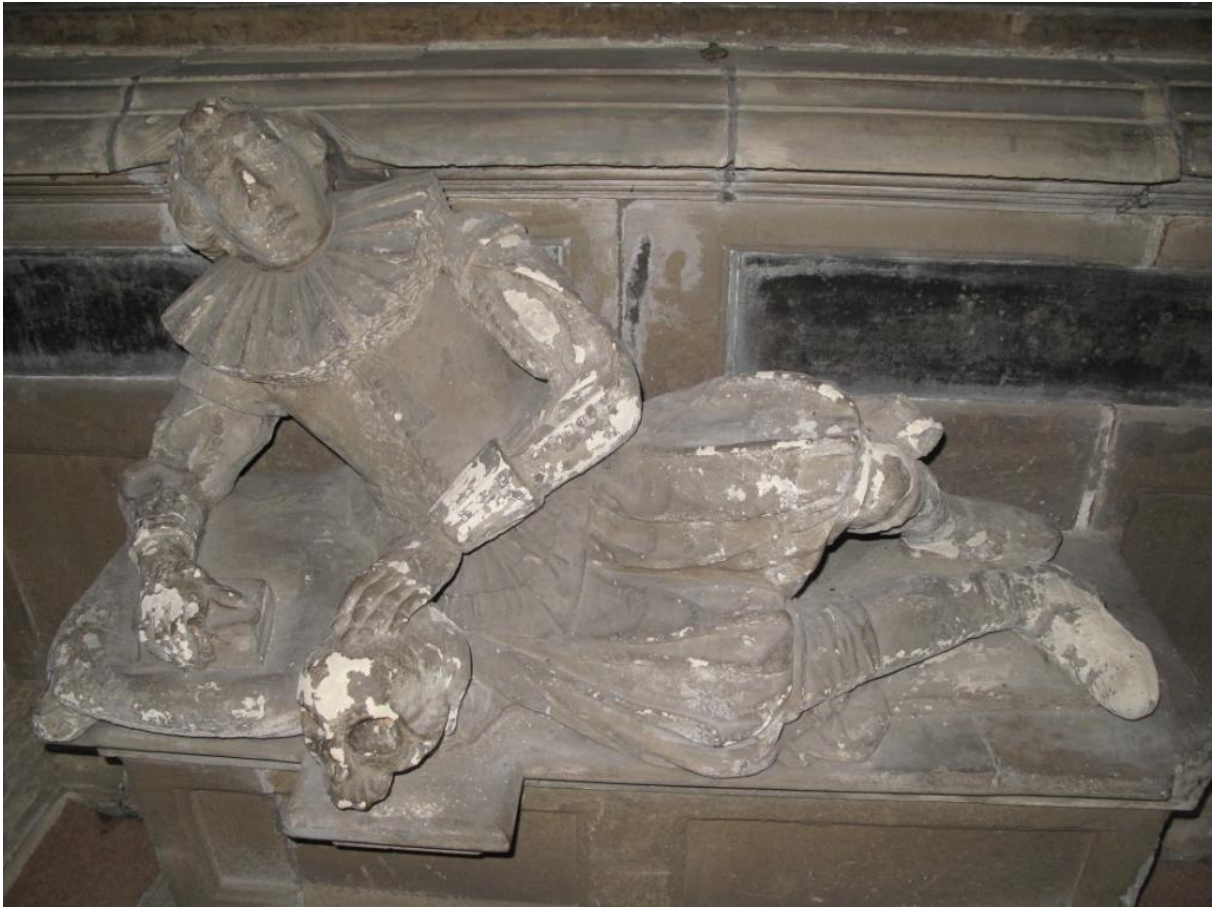
08/028

An overall view of the effigy to the elder son of Sir George Savile: The stone is a fine white soft limestone and it can clearly be seen in this photograph that the surface has dark finish which is flaking to reveal the stone beneath. In these areas the stone is friable and needs to be more closely examined to ascertain if consolidation should be carried out.

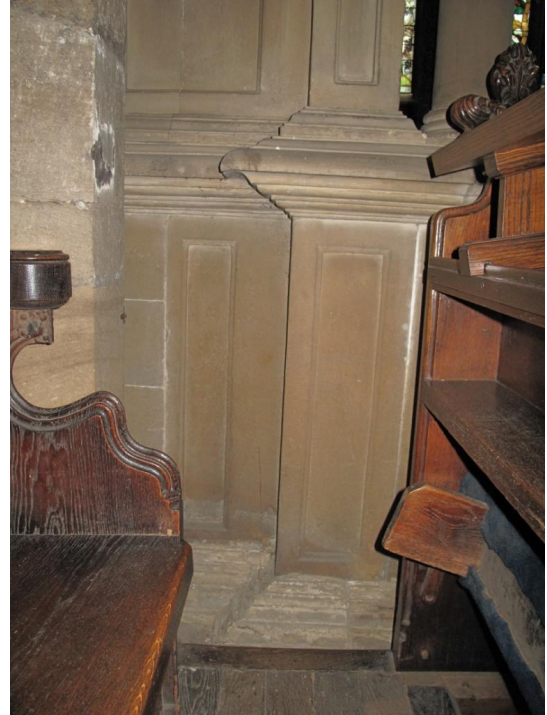
Above left: Oblique view of the western end of the chest.

Above right: Detail of the western elevation of the chest.

Compare the configuration and carving of the fielded panels to the opposite end which indicates that changes have been made as it would be expected for the design to be symmetrical. Currently the eastern elevation has only one moulded panel and the rest is constructed in plain blocks while on the western elevation are three moulded panels.

Note also that the panel above has moved out of vertical alignment with the adjacent section (see the black arrow above left).

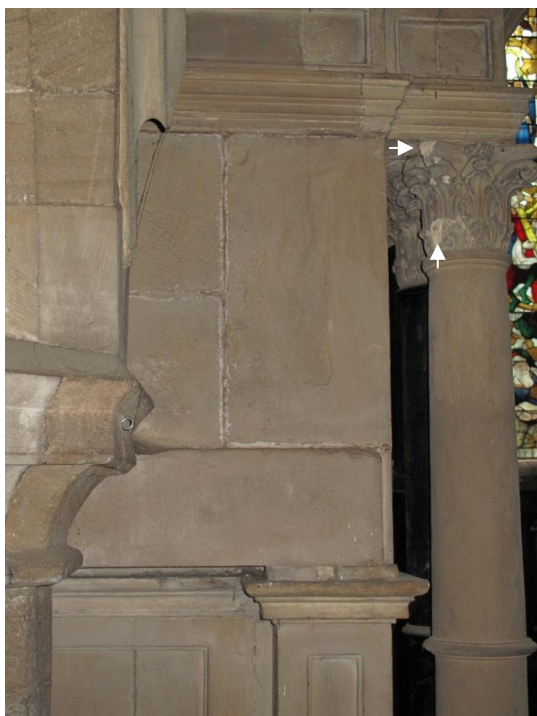
08/034

Western elevation at the level of the spandrel panels.

Note the exfoliation occurring on the details of the capital in this photograph (white arrows).

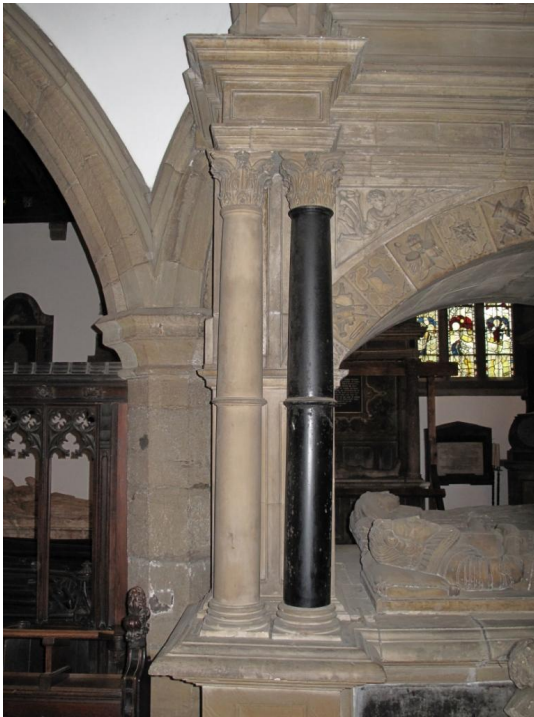
08/037

Front elevation of the western columns.

The Belgian Black marble column retains a surprising degree of polish.

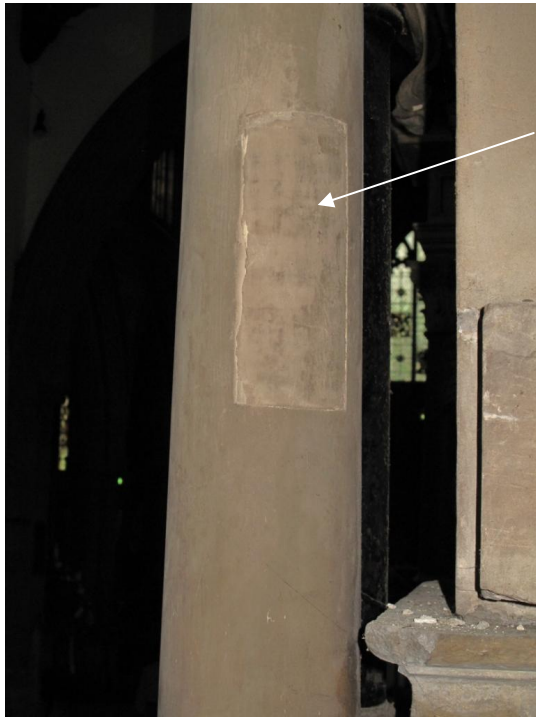
08/043

The east elevation of the east sandstone column has a large indent repair.

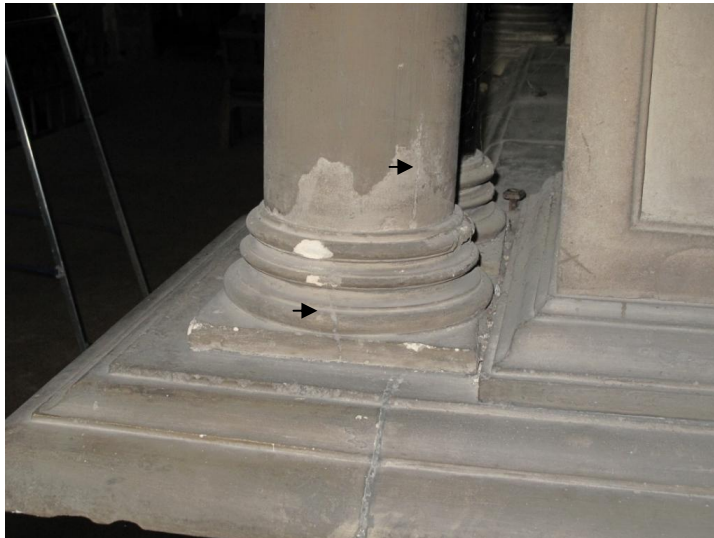
08/044

The base of the column appears to have an old stress fracture and the bottom of the column also has one (black arrows). These are not of major concern.

The impact damage on the roll mouldings appears relatively recent.

The discoloured area at the base of the column appears at first to be a fill but this is not certain and further examination might be required to confirm the nature of this discrepancy.

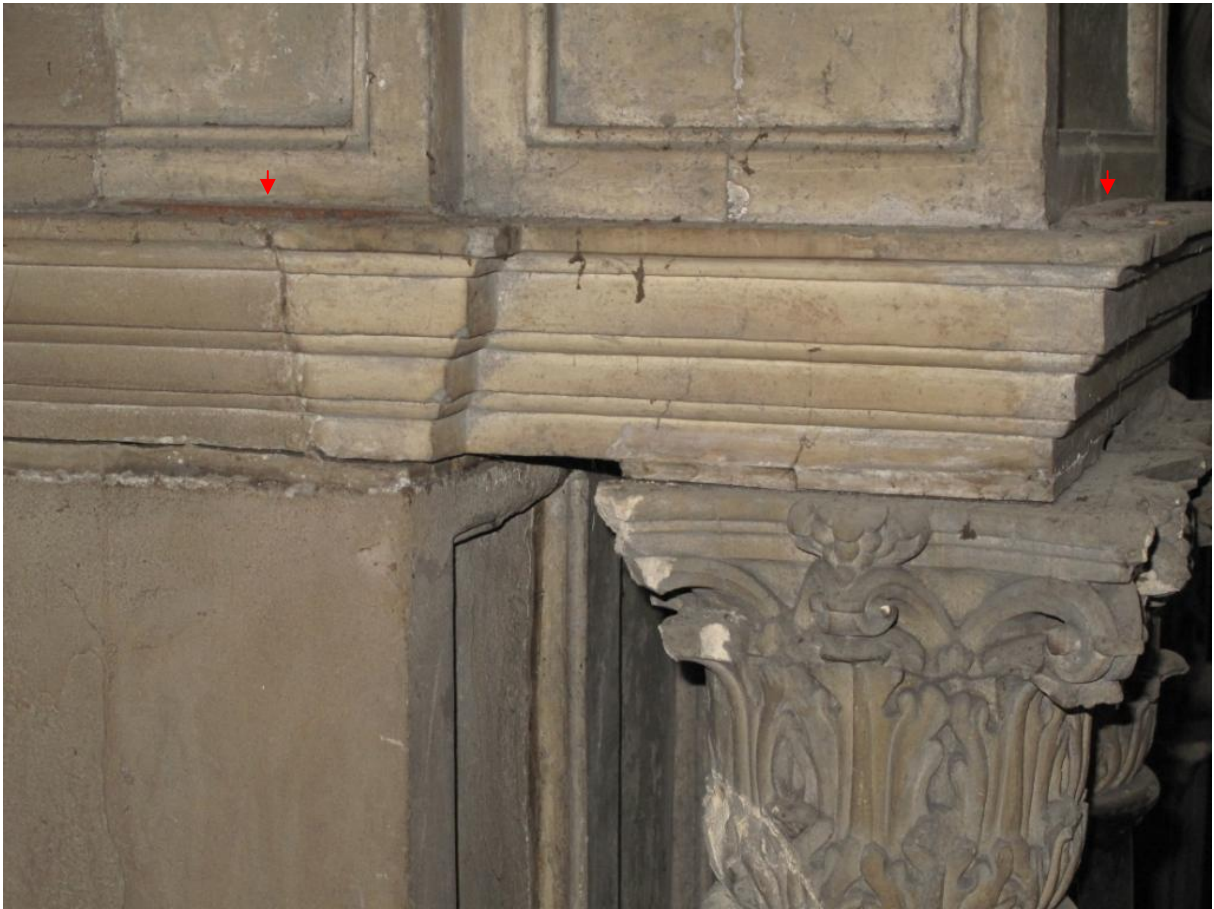
08/047

Detail of the architrave at the western end.

There are exposed ferrous cramps visible as shown by the arrows and shown in greater detail below.

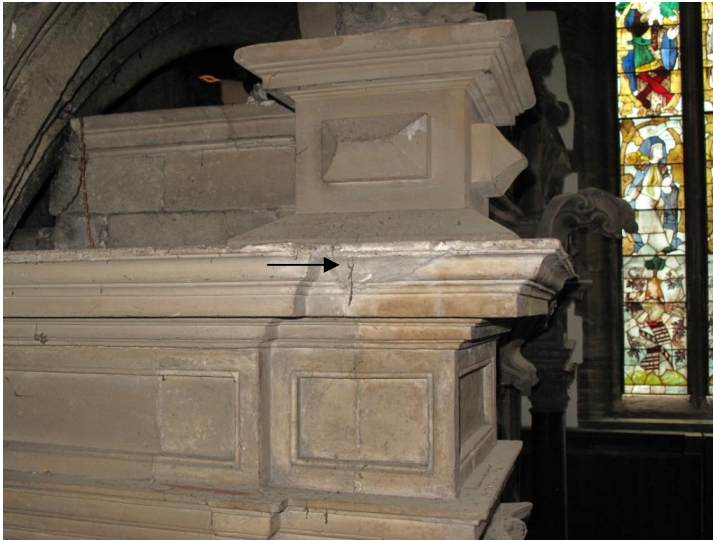
08/050

The area indicated appears to be made up from a mortar repair.

There is also a high level of rust coloured staining in the stone in this area. Was there previously a ferrous cramp perhaps that had failed?

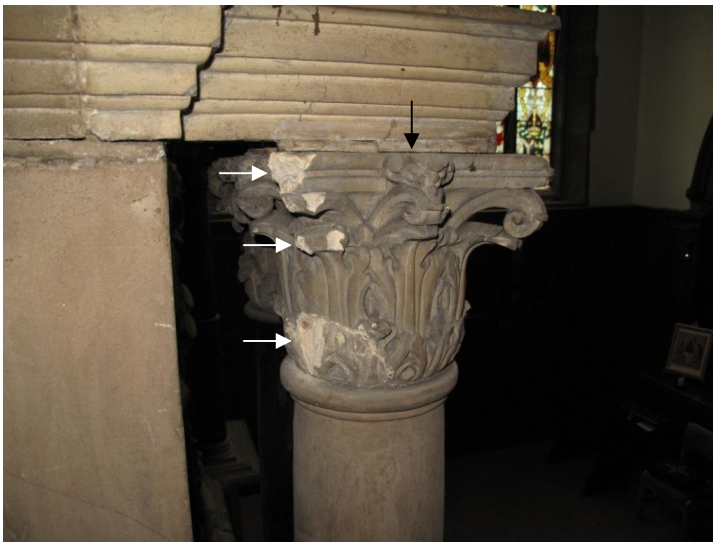
08/051

Detail of the top of the western column.

The extent of the damage would be considered unusual at this level and perhaps is the result of an impact (white arrows).

be jacked slightly open indicating the presence of a ferrous cramp actively corroding. This needs to be checked (black arrow).

Of note here is the thick joint between the column and the architrave stone and that the bedding has subsequently cracked and the joint appears to

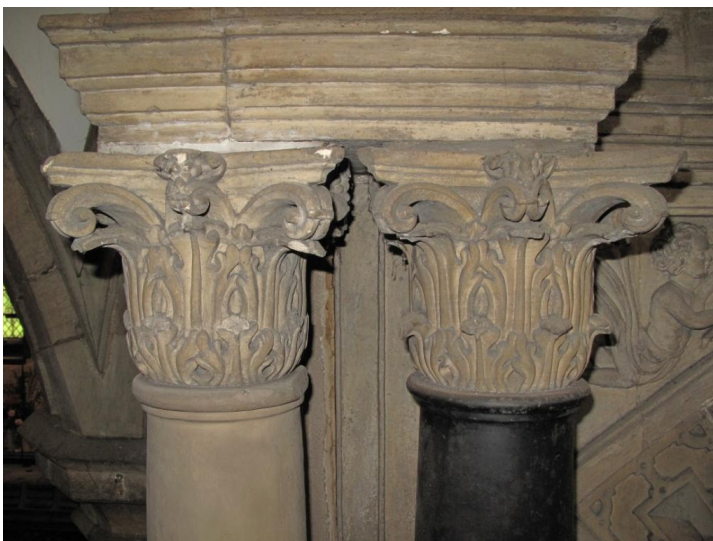
08/054

Detailed view of the south elevation of the western capitals showing further impact damage.

The different pointing mortars used on the two capitals indicate different periods of intervention and therefore suggests the possibility of a progressive deterioration that has required repair.

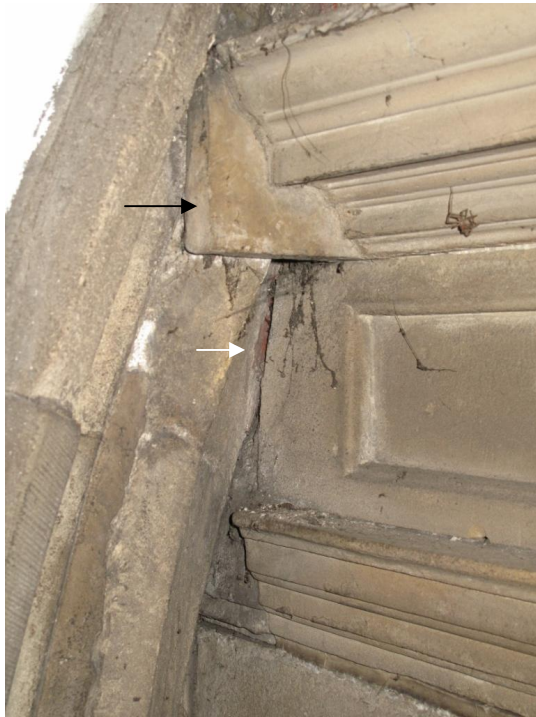
08/052

Detail of the junction of the western return of the entablature and the reveal of the arcade arch.

The construction detailing at this point (black arrow) would indicate that the intention was for the moulding to abut a flat ashlar wall.

Of great interest here is the presence of red pigment remaining on the arch stone as indicated by the white arrow. There is further evidence of painted stone at the eastern end as shown in the photographs below.

Samples should be examined by a specialist to try and ascertain a date for this paint.

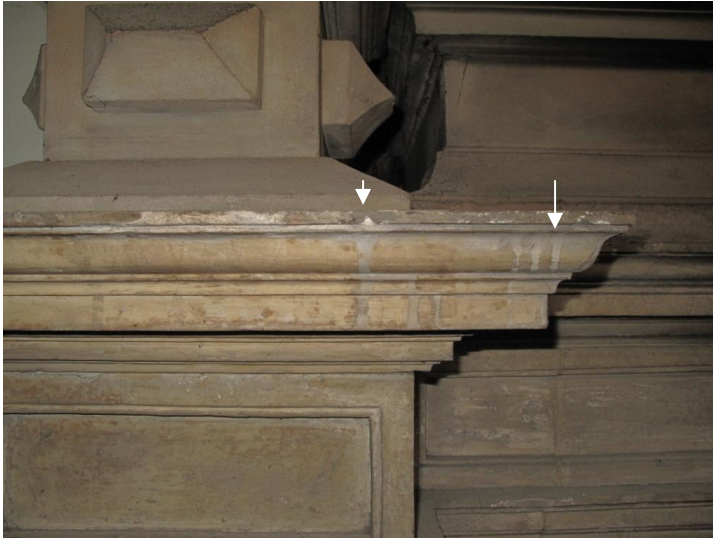
08/054

Detail of the entablature cornice below the western allegorical figure.

The marks across the surface here would indicate damage from water. This is probably more likely to have been from a leak in the roof rather than from any prolonged condensation issues because it is localised.

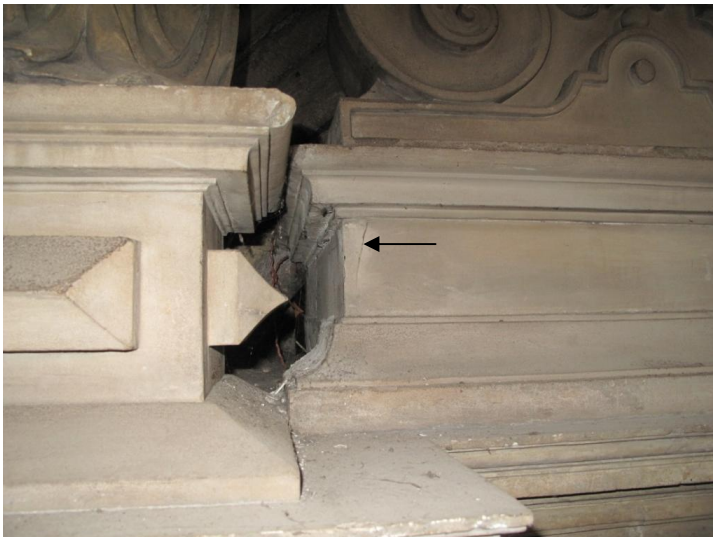
08/056

Detailed view of the base of the pediment adjacent to the western allegorical figure's base.

There is a stress fracture apparent in the stone as indicated. This is most likely but not definitely the consequence of an internal cramp corroding.

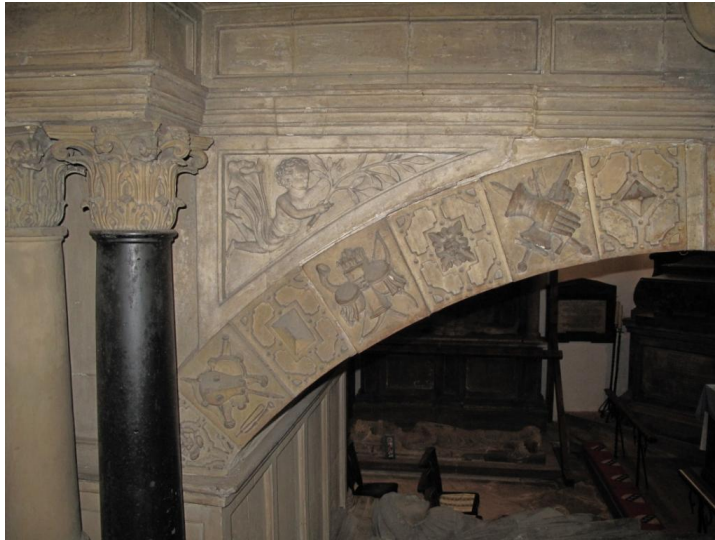
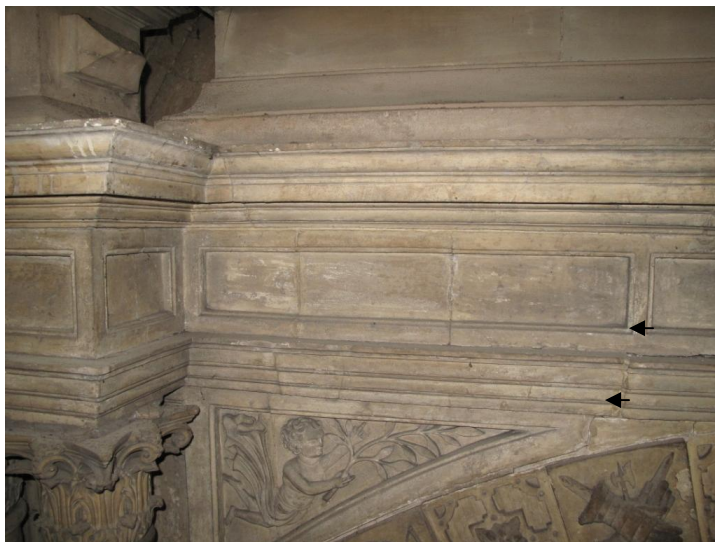
General view of the western spandrel panel.

Oblique view of the entablature above the western spandrel.

In both of these photographs there is evidence of the arch spreading which has been causing cracks to form.

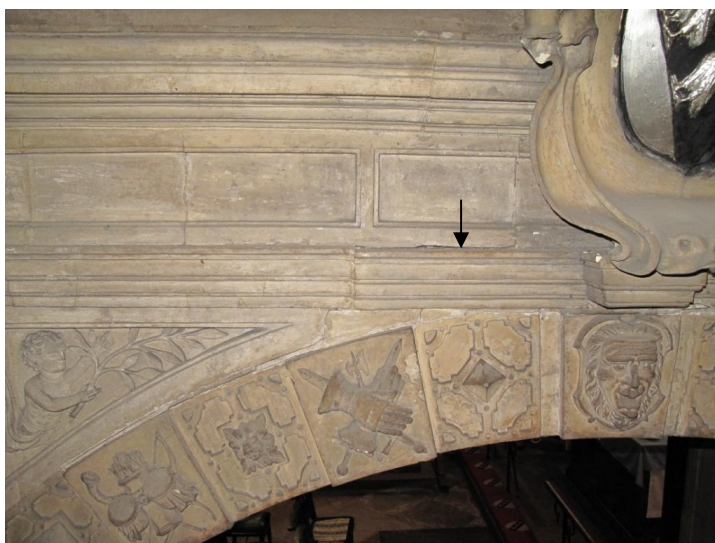
08/060

It appears that the cracks have been developing over a period of time and that they have been pointed on previous occasions. It is difficult to ascertain exactly how often works may have been undertaken but further on site examination might reveal more about the history of the repairs. In the lower area the joint is currently cracked indicating that it has progressed since the last intervention (black arrow).

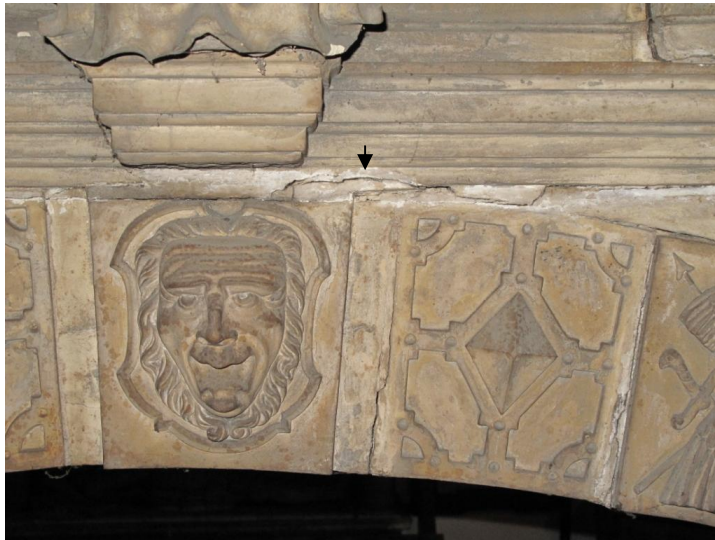
08/071

Detail of the central section of the arch reveal.

The keystone along with the adjacent blocks has dropped due to the spreading of the arch. There is also an area of old damage and repair (black arrow) – the cause of this is unclear.

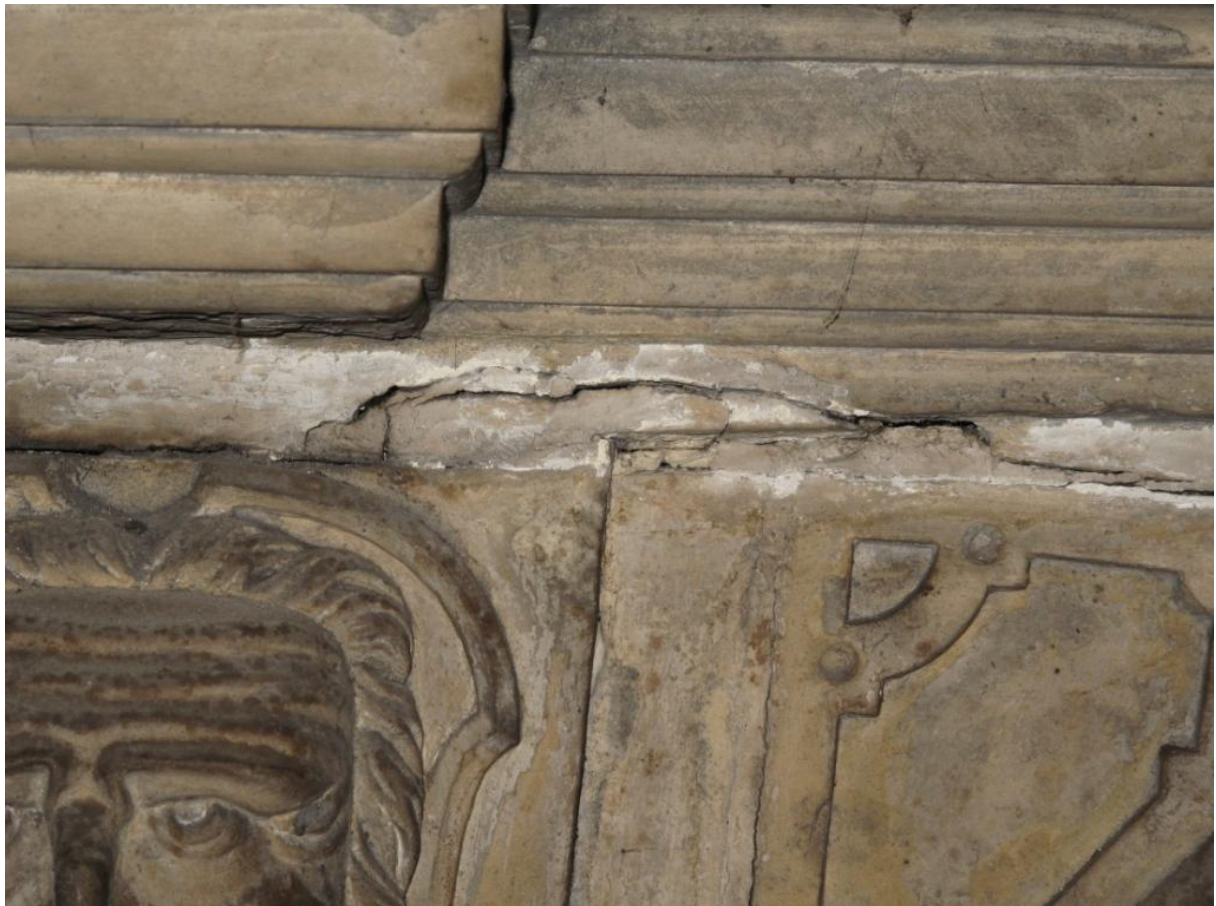
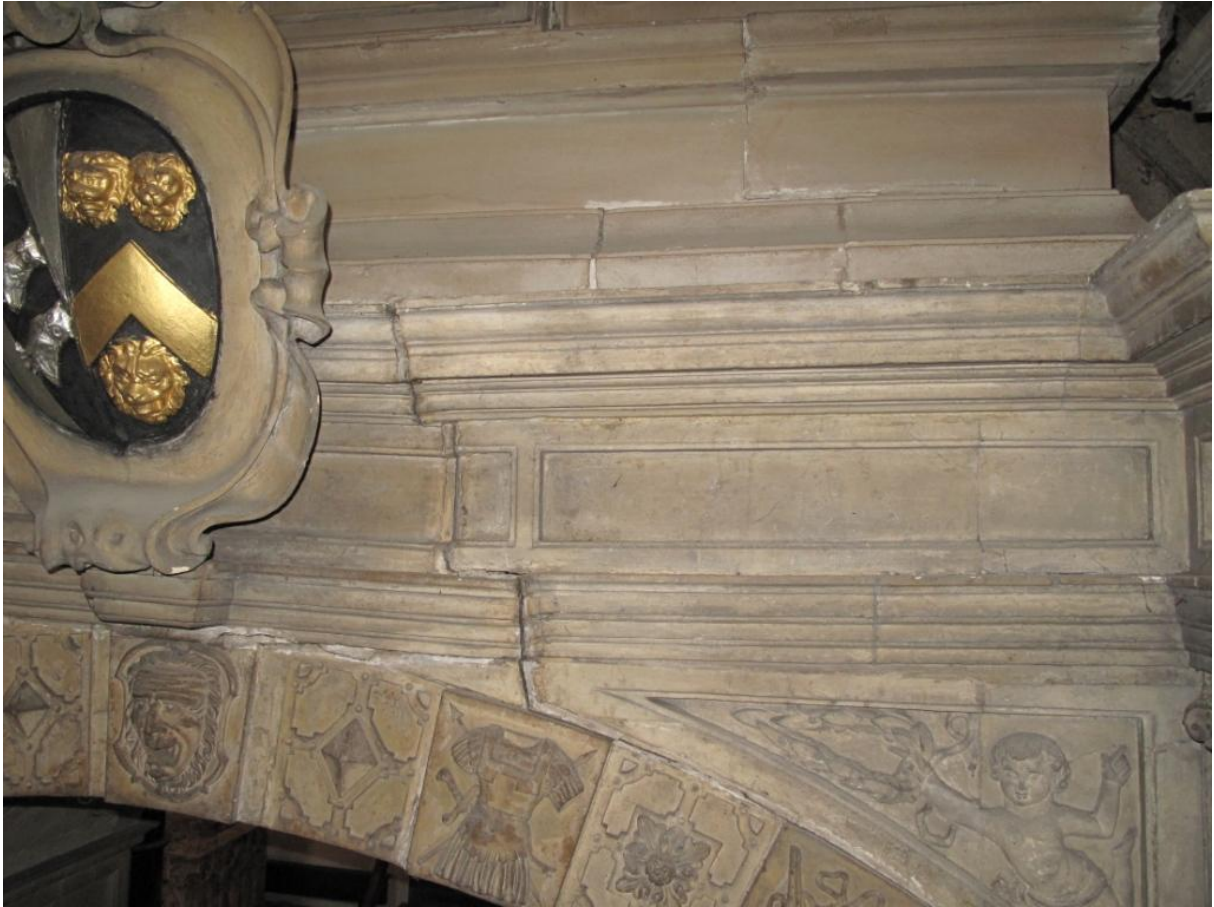
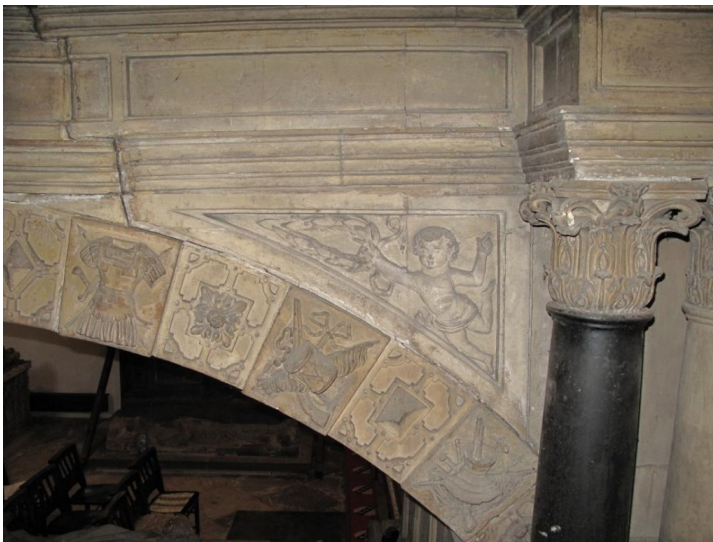
Above and left: the eastern spandrel exhibits movement comparable to the western side but here it is perhaps more pronounced.

As discussed previously there is evidence of old repair and subsequent movement.

It is extremely difficult to ascertain if the movement is still progressing and a decision will need to be made regarding instigating a period of monitoring to establish this or to undertake precautionary remedial works to tie the arch preventing future movement.

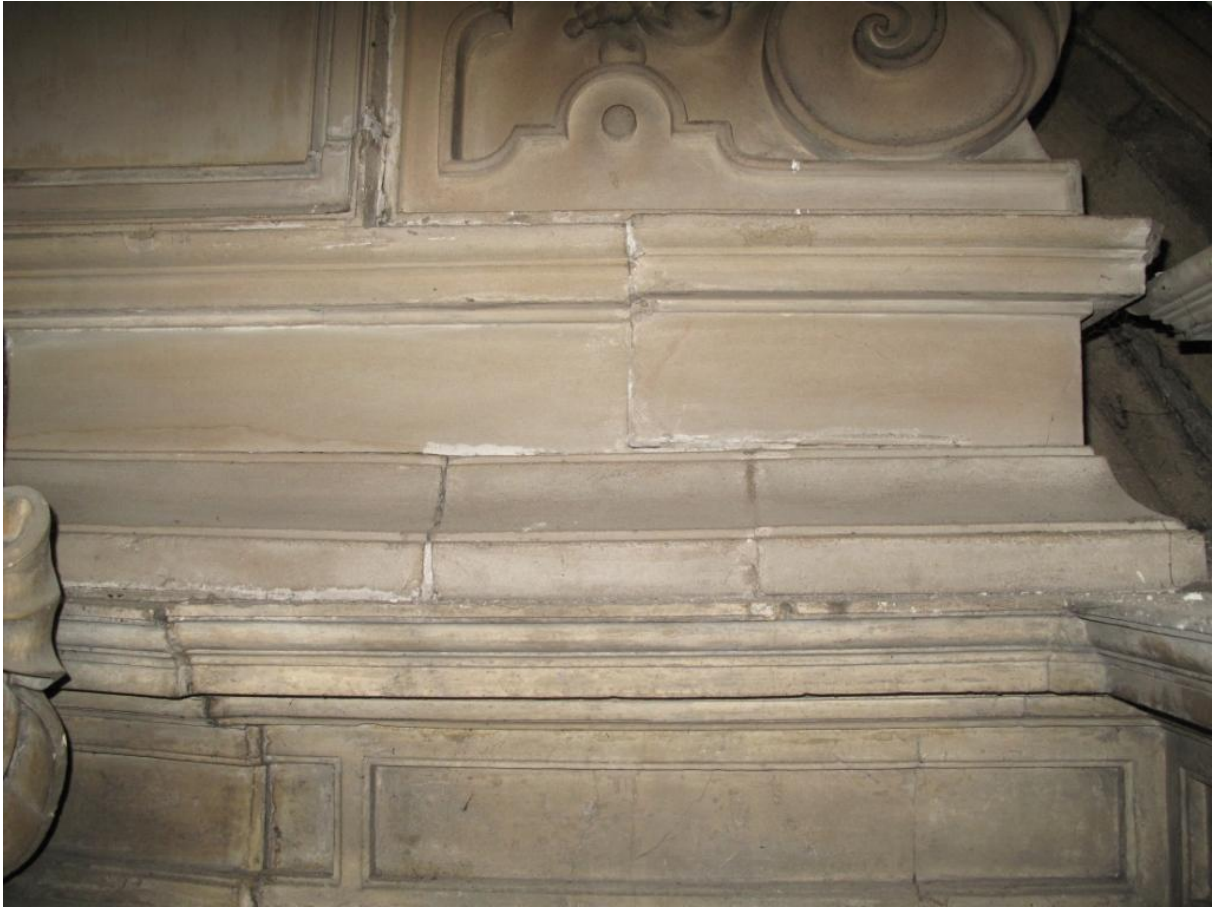
08/075

Detail of the movement in the joints at the eastern end of the entablature.

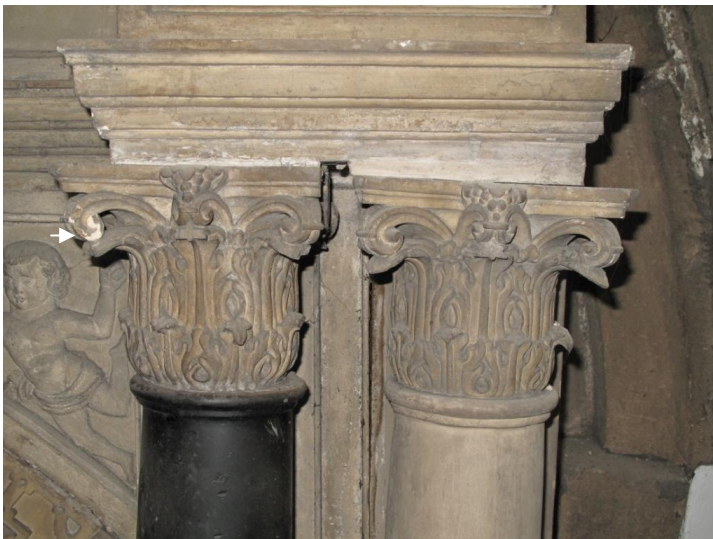
08/078

The eastern capitals.

The wide wedge shaped joint between the capital of the sandstone column and the architrave is the consequence of the depression of the centre of the arch and probably some movement within the column as the pressure on it was lifted.

Note also the impact damage on the capital (white arrow).

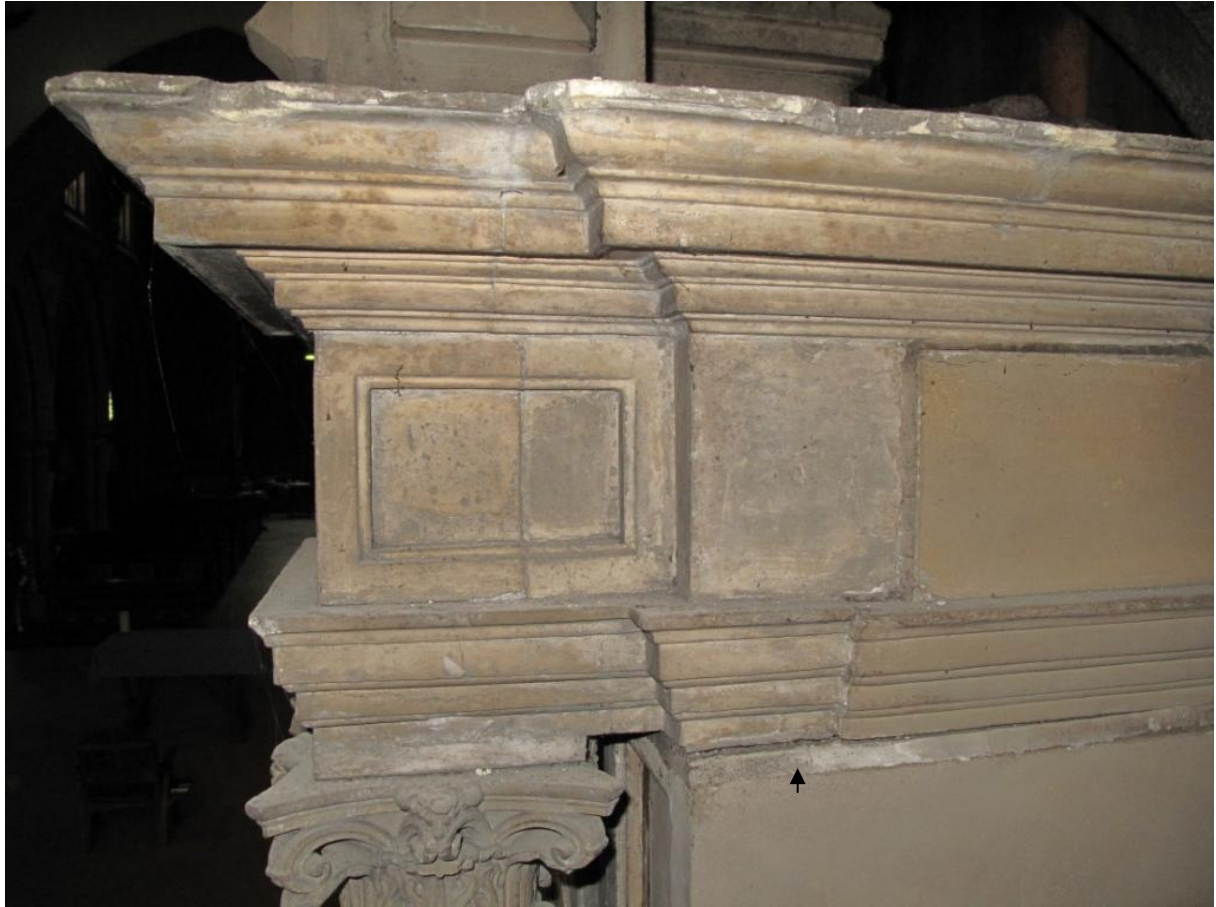
08/081

The eastern elevation of the entablature.

Note the very wide joints between the architrave and the ashlar (below) as a consequence of the depression in the centre of the arch (black arrow).

The stones of the architrave and the frieze to the north side of the entablature are not in alignment and appear different in character from the southern stones. It was previously noted that similar changes appeared to have been made at lower level on this elevation. Is this all evidence of a substantial earlier restoration or has the monument been moved at some point and required alteration or repair? Was this part of the re-ordering required by the extension of the Savile chapel in 1495, or perhaps at some other period?

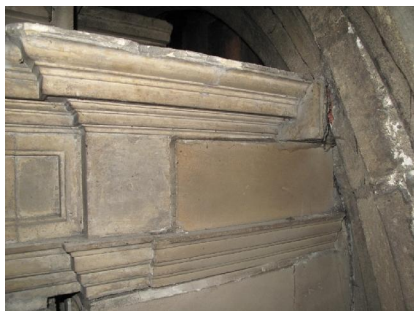
08/082

Oblique view of the above detailing the misalignment of the stones.

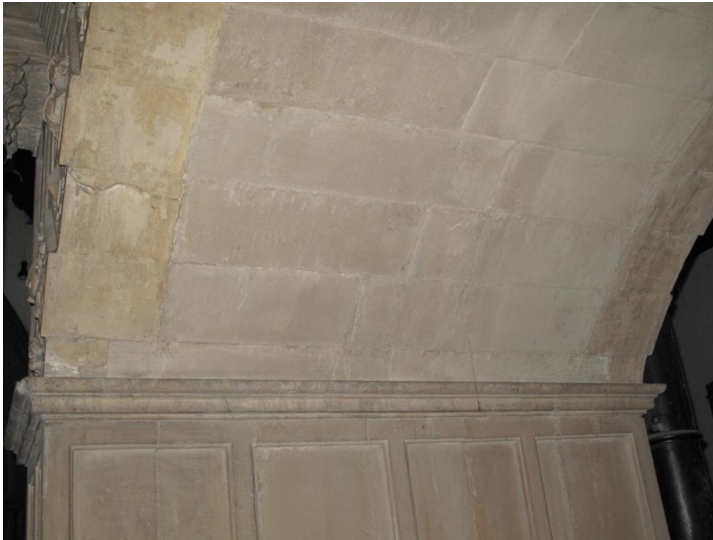
08/097

Note the different character of the stones used for the reveal and for the general ashlar works; once again using a combination of limestone for carved areas and sandstone for the plain blocks.

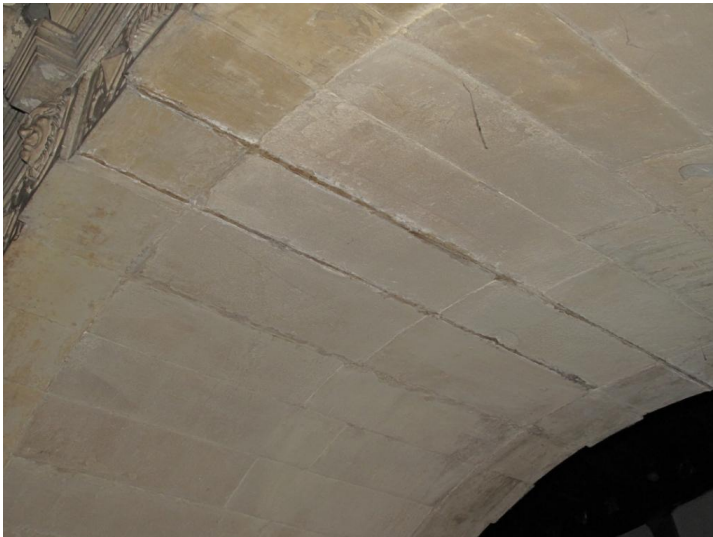
08/098

Note that the pointing in the joint of the row of stones east of the keystones has been replaced with a mortar different from the other pointing.

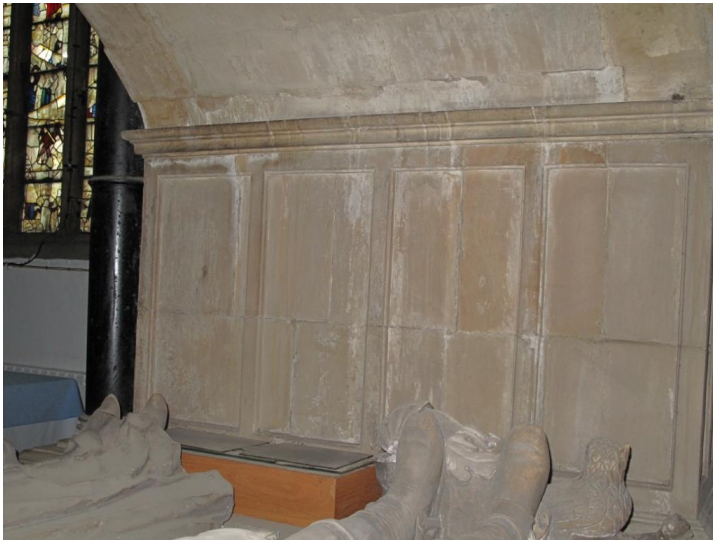
08/099

The eastern end would appear to have been affected more than the western end by the efflorescence of soluble salts.

The increased discolouration of the stone surface may also indicate increased transportation of minerals from within the stone to the surface which in turn would indicate high levels of moisture moving through the structure.

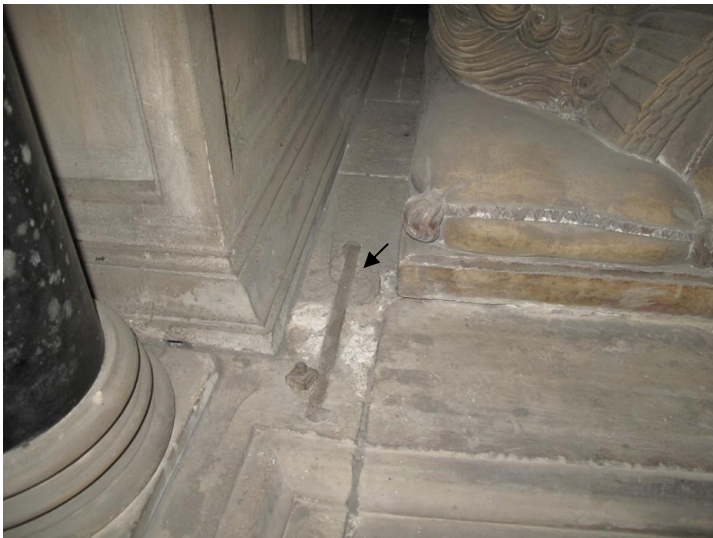
08/102

Detail of the western end of the chest adjacent to the head of the effigy of Sir George.

Of note here is the exposed ferrous tie bar (black arrow).

Along this elevation are old nuts and bolts indicating that there might once have been a set of rails on the monument.

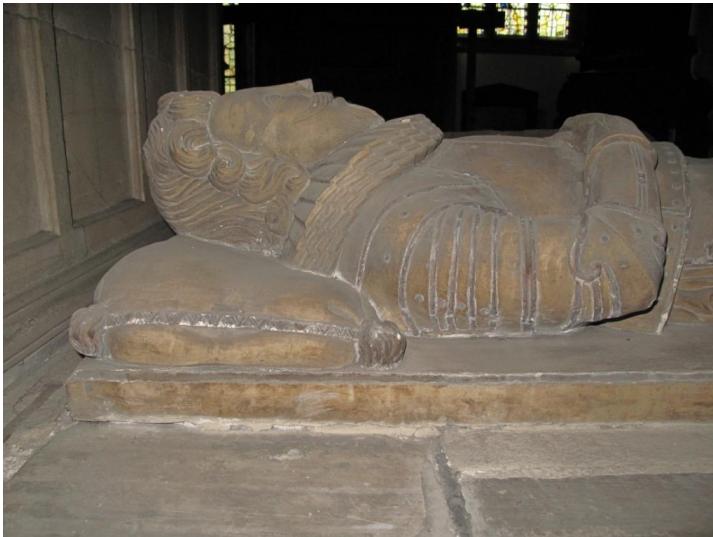
08/104

Detail of the western end of the effigy to Sir George.

Note the residue of white deposited on areas of the carved details such as the braiding on the pillow and the joints in the armour. This needs to be checked by a paint specialist to ascertain if it is the remains of painted decoration.

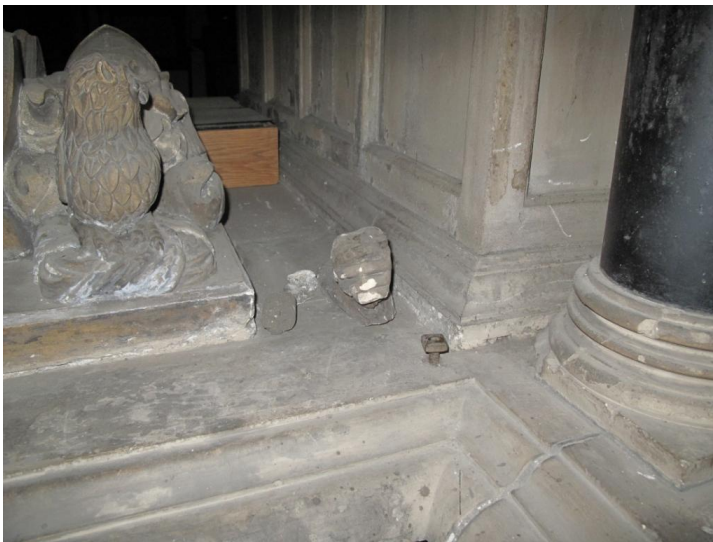
08/107

Note the various items stored on the monument; including fragments of stone, a section from core drilling and a wooden box with pieces of glass.

One of the old bolts can be seen clearly in this picture.

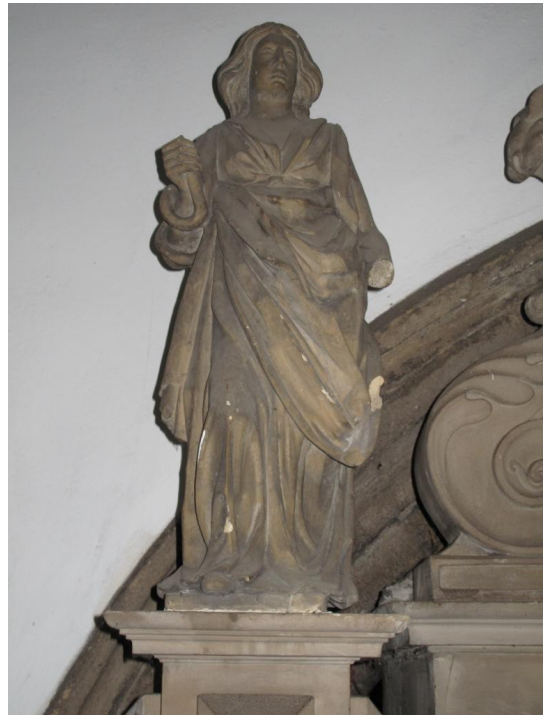
08/117

Above left; Detail of the western elevation of the west side allegorical figure on the pediment.

Above right: detail of the south elevation of the west side allegorical figure.

Even at this level the monument has suffered from impact damage which most probably occurs during the use of ladders or other access during inspection and maintenance operations.
