**St Michael & All Angels Church, Thornhill.  
Conservation report on the internal monuments**

**General description and Detailed condition survey of the  
monument to Sir George and Lady Anne Savile – south  
elevation**

**Prepared for:  
Thornhill Parish Church Council  
June 2010**

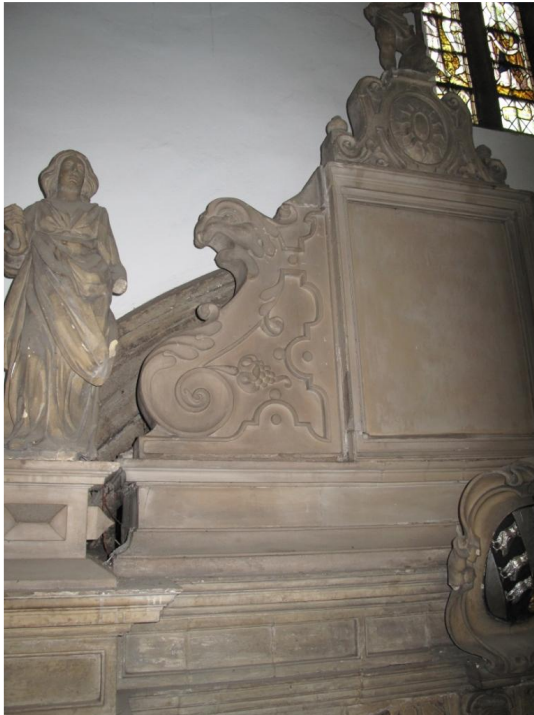
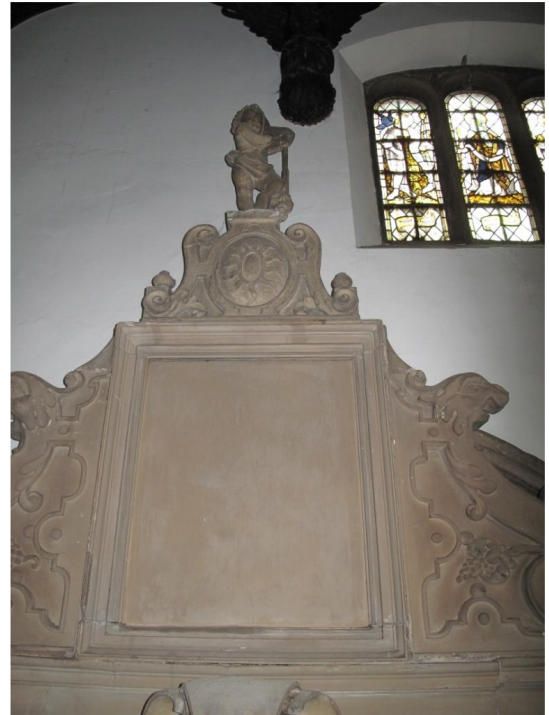
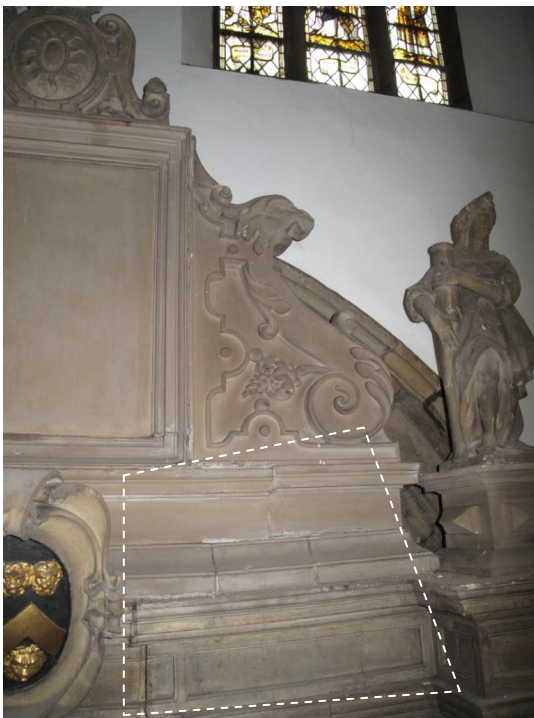
Above and left: details of the south elevation pediment.

There is evidence at this level of the structure being affected by the settlement that is occurring at lower level within the spreading of the arch.

This is particularly pronounced in the joints of the eastern side as indicated.

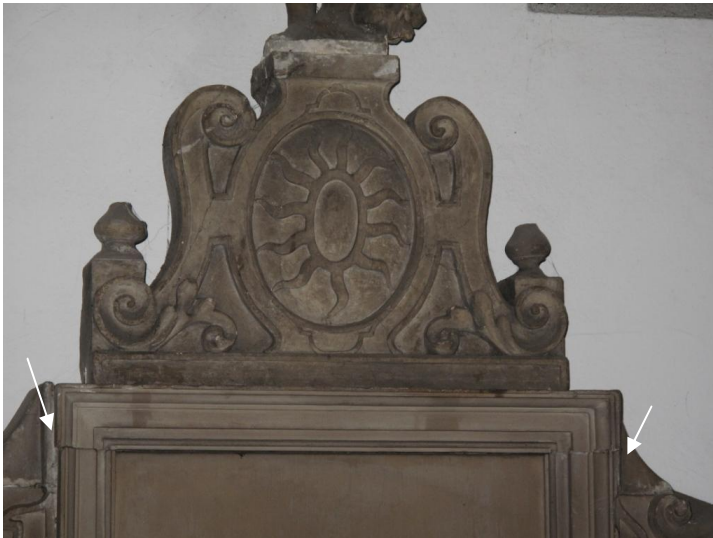
08/125

Detail of the pediment support to the central cherub.

There is some misalignment in the joints indicating movement. It is not considered to be recent movement and most probably not progressive at the current time: it should however be monitored.

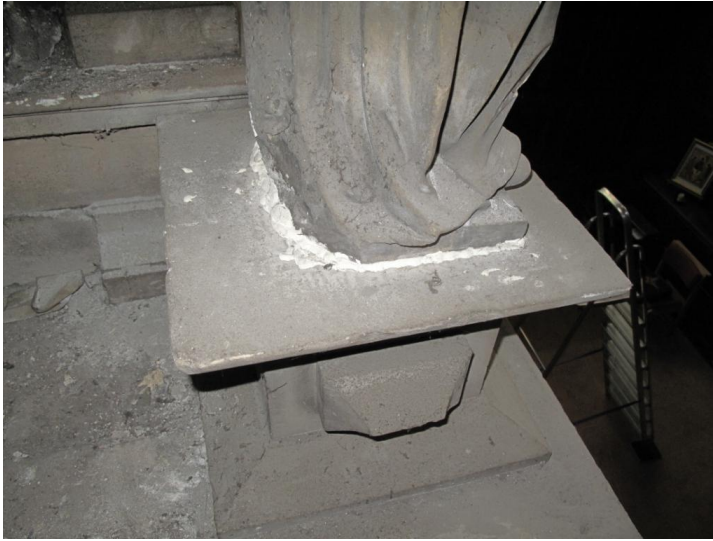
08/139

There is evidence of relatively recent work to re-fix or stabilise elements high up on the monument.

This view of the western allegorical figure indicates fresh plaster pointing or bedding at the base of the figure.

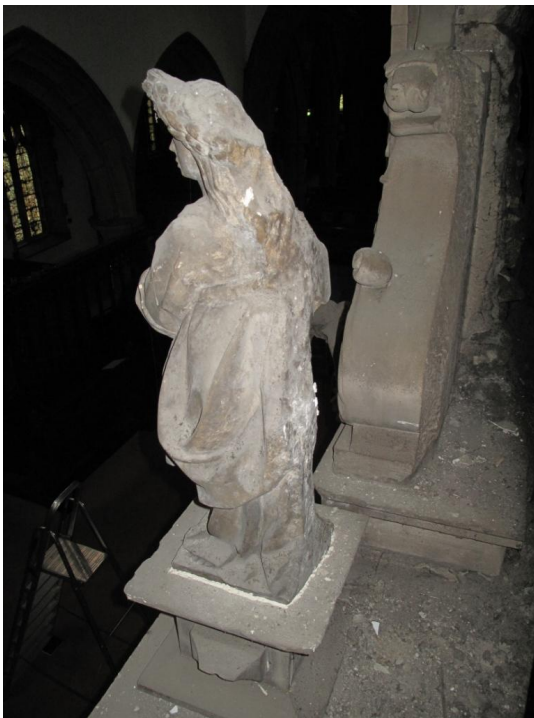
08/132

Left: The eastern figure has been treated similarly to the above.

Below: The western elevation of the pediment top which supports the cherub showing the installation of a modern metal angle bracket.
