**St Michael & All Angels Church, Thornhill.
Conservation report on the internal monuments
Section 3
Sir George and Lady Anne Savile Monument
North elevation detailed condition survey**

**Prepared for:
Thornhill Parish Church Council
June 2010**

**By
MARTIN HOLDEN
SCULPTURE AND ARCHITECTURAL CONSERVATION SERVICES
Dalshangan
Carsphairn
Dalry
DG7 3SZ**

Detailed condition survey – north elevation.

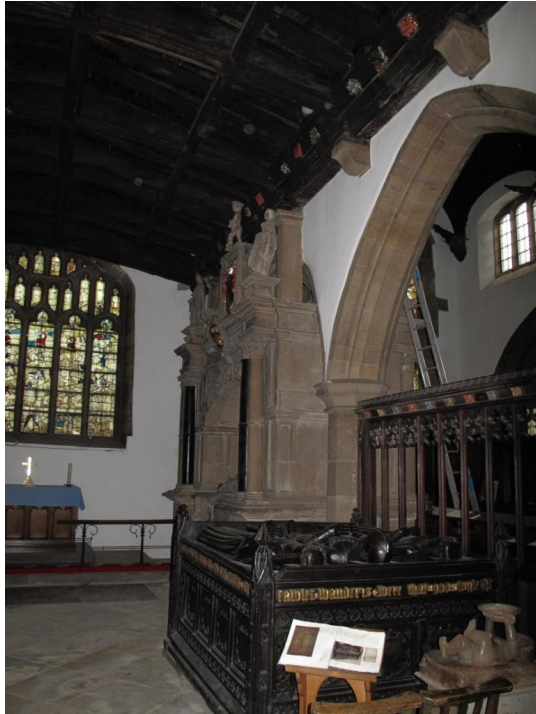
08/148

General view of the location of the north elevation looking east.

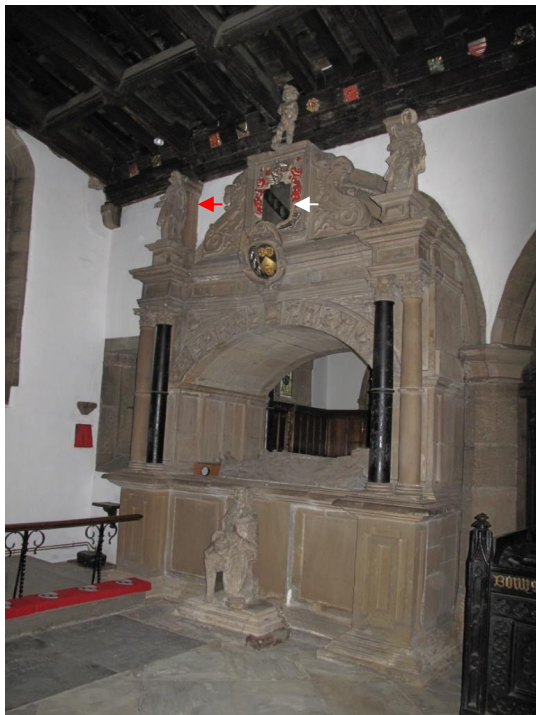
08/149

General view of the north elevation.

The elevation is basically symmetrical with the south elevation differing visually by the incorporation of the coat of arms in the upper detail of the pediment (white arrow); and structurally by the inclusion of stone piers which appear to transfer load from the corbels supporting the ceiling onto the top of the monument (red arrow).

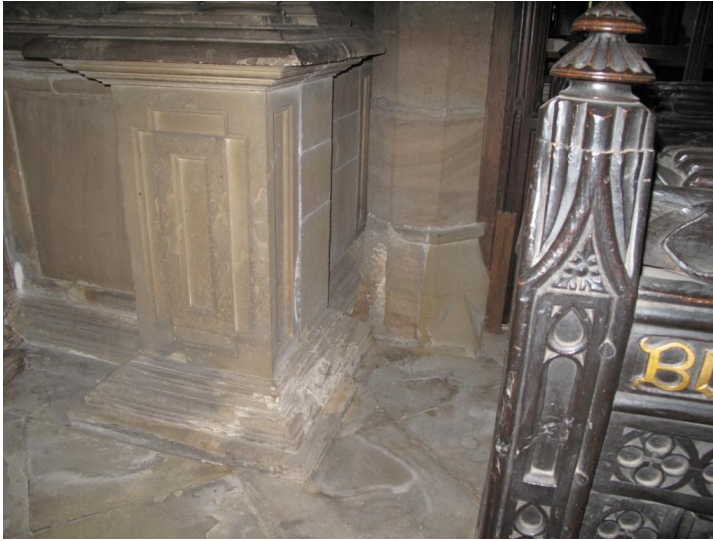
08/150

Western end of the north elevation of the chest.

The floor on the north side of the monument is stone with no secondary covering. This offers a more permeable structure. Compare this with the south elevation where the Victorian tiles and carpet present a more impervious structure.

Notwithstanding this, the monument is suffering from moisture rising into the stones together with soluble salts.

This is apparent in the discolouration on both the floor and the monument in the view above and the detail below.

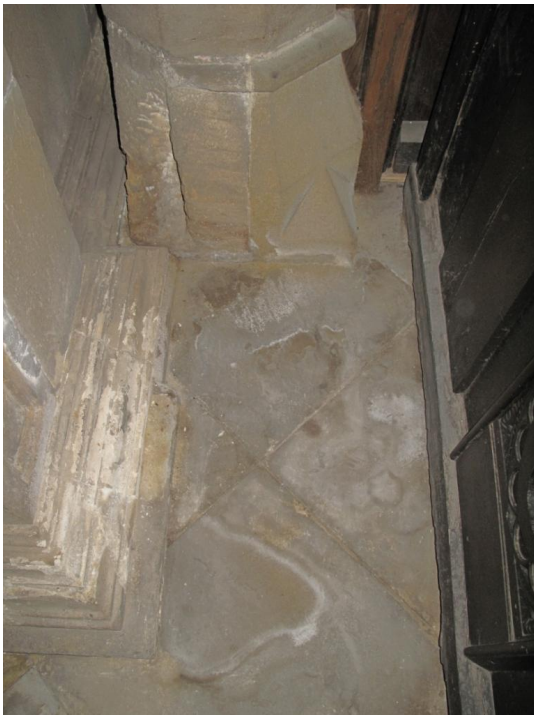
08/151

Detail of the stones of the floor at the western end of the north elevation.

The plinth of the monument can be seen to be suffering badly from moisture and salt damage.

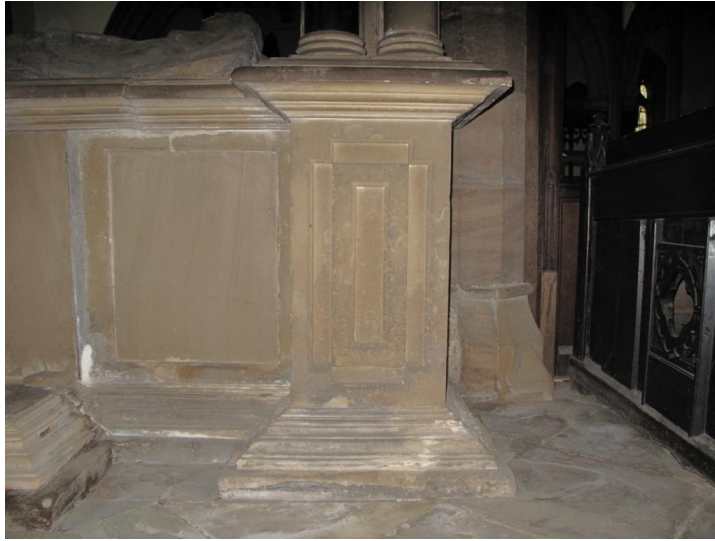
08/152

Western end of the plinth.

Note the various types of pointing in the joints indicating past restorations and maintenance.

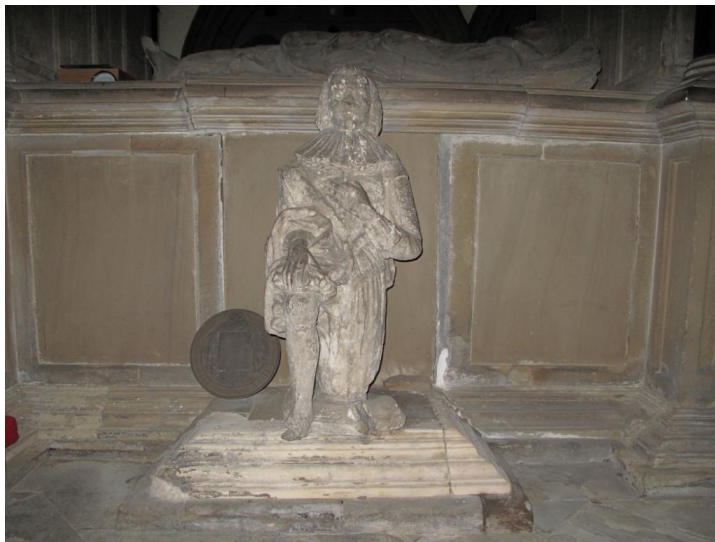
08/153

Central area of the north elevation of the chest and the figure of the second son of Sir George and Lady Anne.

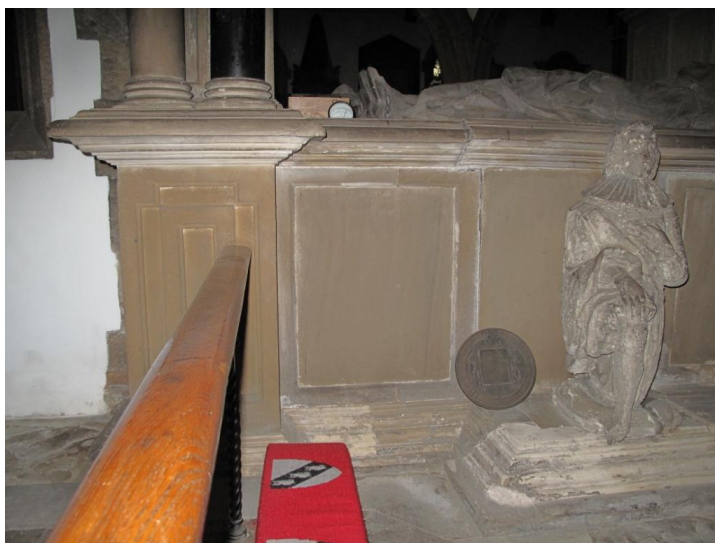
08/154

Eastern end of the chest.

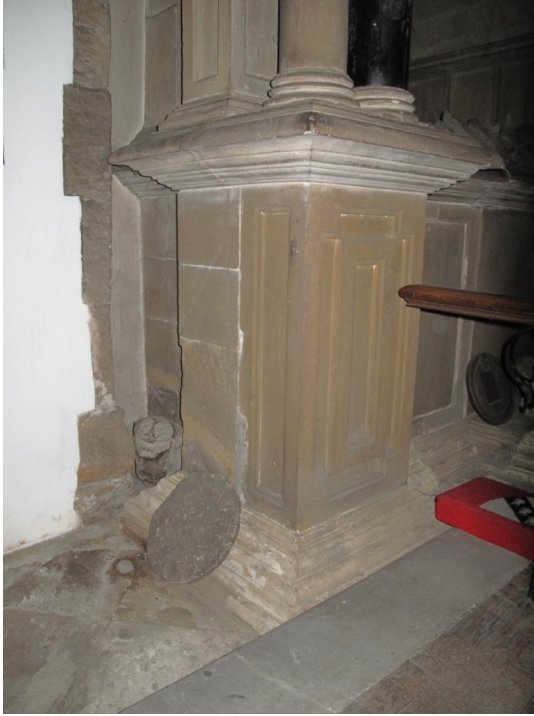
08/151

The eastern elevation of the chest also has strong indications of moisture and salt damage. This has been dealt with in detail within section one of this report.

Below the photograph shows the presence of salt efflorescence at higher level on the chest end panel (black arrow). At present there is not significant erosion in this particular area as a consequence of this. This is in contrast to other areas and it might suggest that this is a relatively new incursion?

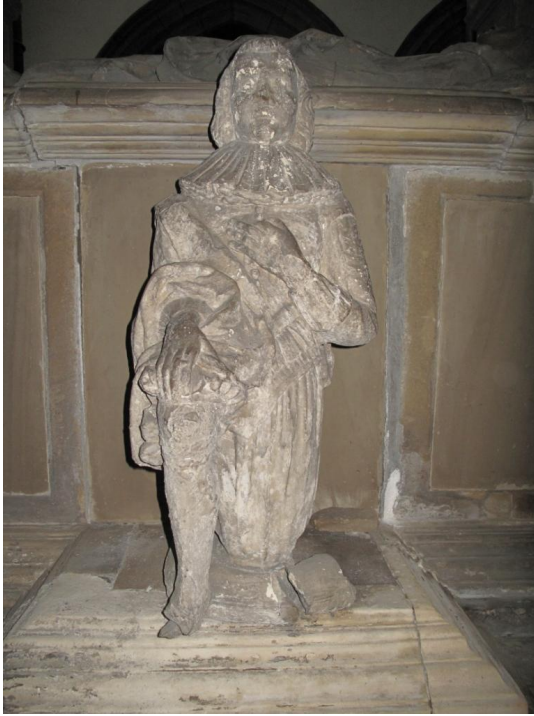
08/166

General view of the kneeling figure.

Note the presence of a possible surface coating and the extent of subsequent exfoliation which is comparable to the south side figure.

The plinth to this sculpture is suffering badly.

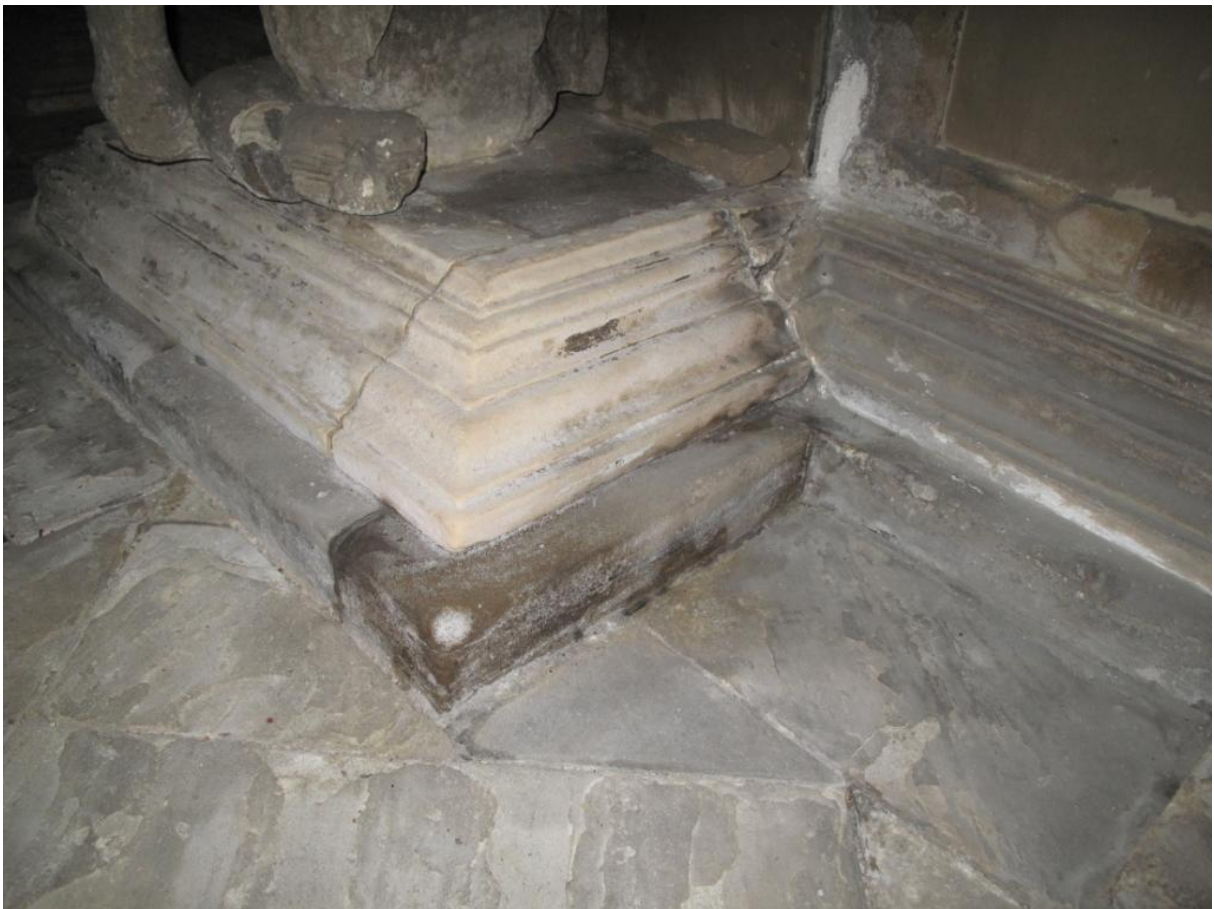
08/167

Below is a detail of the western end which was extremely damp with active and progressive salt efflorescence at the time of the survey.

The salts may be deliquescent and exacerbating the situation; the areas with high salt growth appear damp.

North-west corner of the plinth to the kneeling figure.

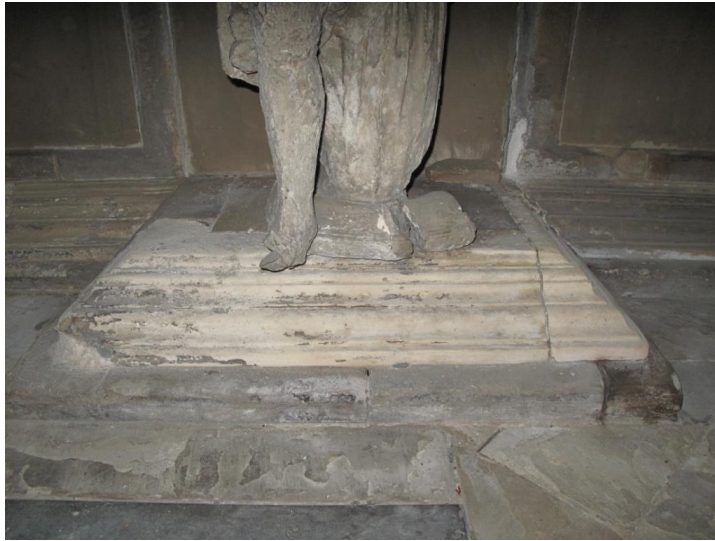
08/164

Left; Front elevation of the plinth to the kneeling figure and,

In general the very clean appearance of the plinth stones indicates severe ongoing exfoliation of the stone surface as a consequence of salt

erosion.

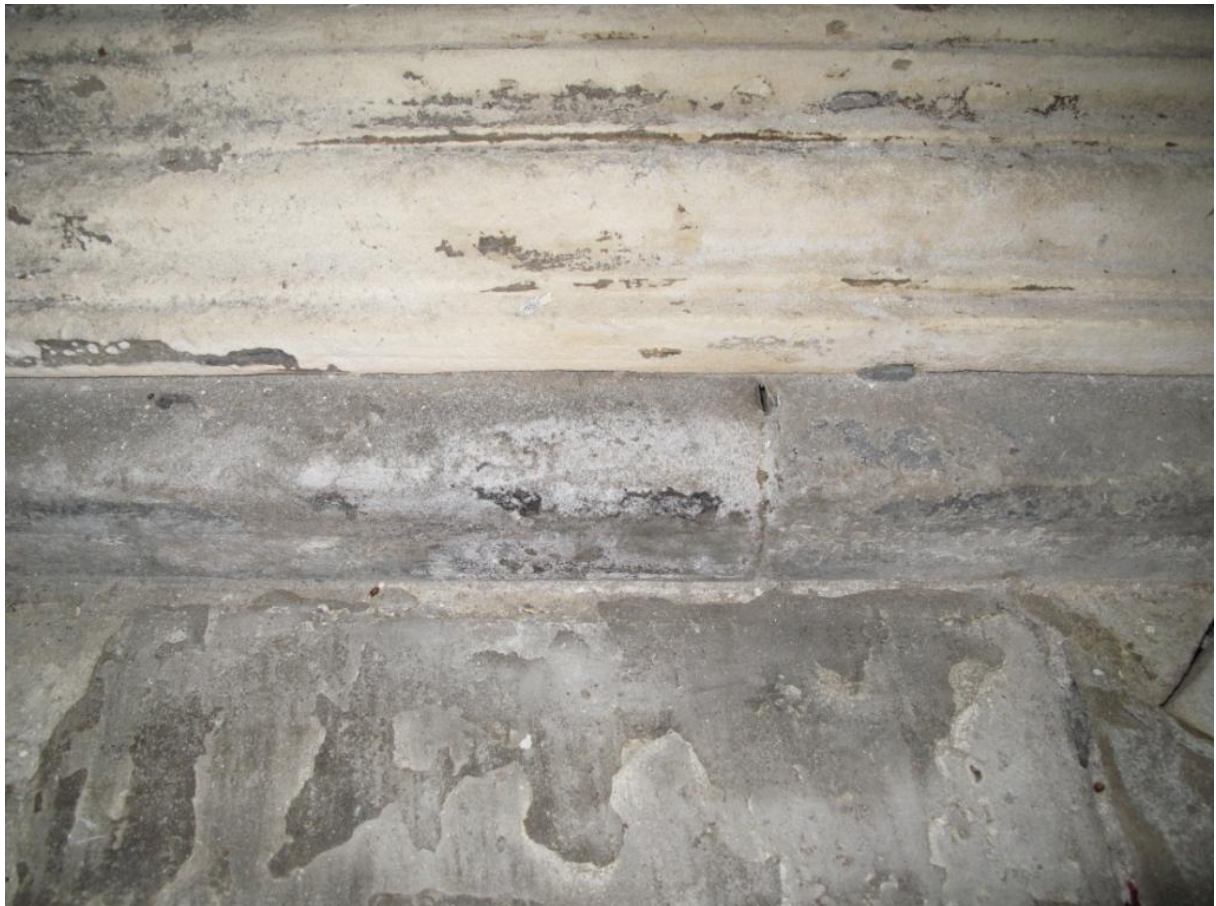
8/165

Below; detail of the slat growth on the lower edge which appears to be recent and progressive.

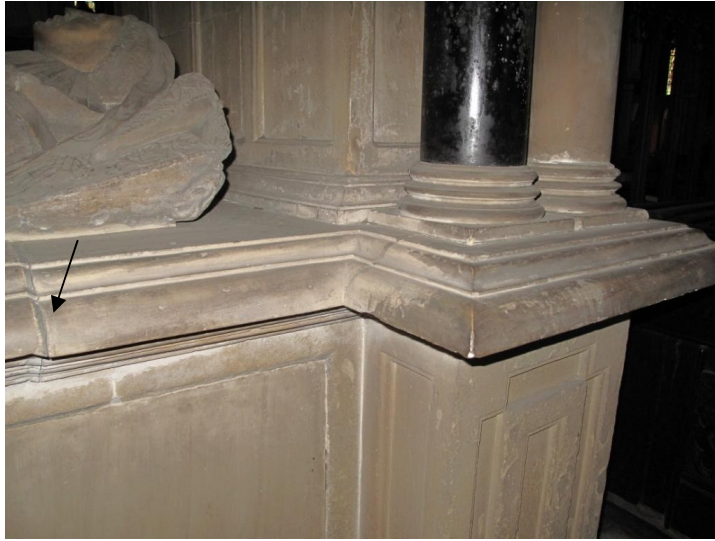
08/173

The top stones of the chest are showing signs of previous movement that has been pointed and made good: Indicated by the black arrow in the photograph to the left and in the photographs below.

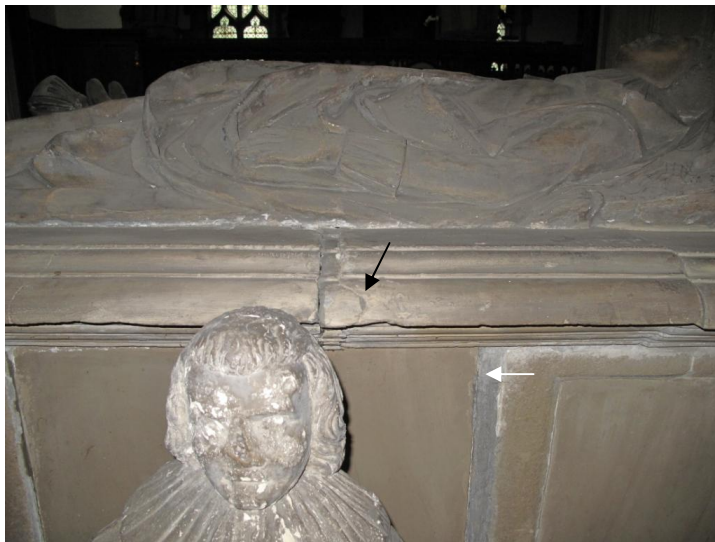
08/175

Note also the extensive dark re-pointing in the eastern joint of the panel below; indicated by the white arrow.

The joint at the eastern end of the plinth (see below) has also moved outwards and away from the centre as the western end has.

direction.

This is indicating thrusts in a north eastern and north western

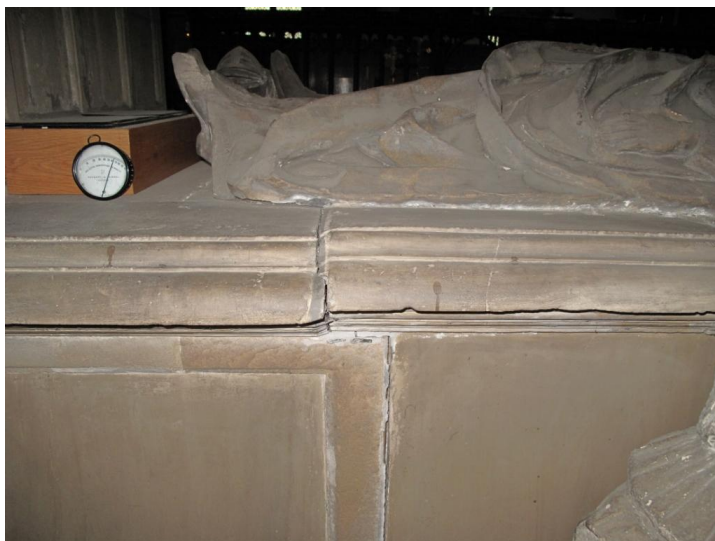
08/176

In this crack the remedial works demonstrate that the movement has continued as there is subsequent opening of the joints. This does not have the appearance of shrinkage. None of the evidence is appearing to be fresh but it could be very gradual but ongoing movement that is barely discernible by purely visual means.

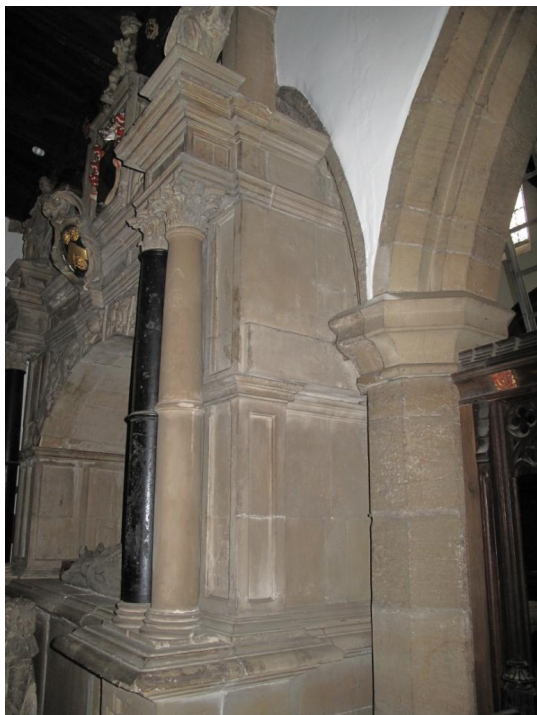
08/180

Overall view of the western elevation of the canopy section of the tomb.

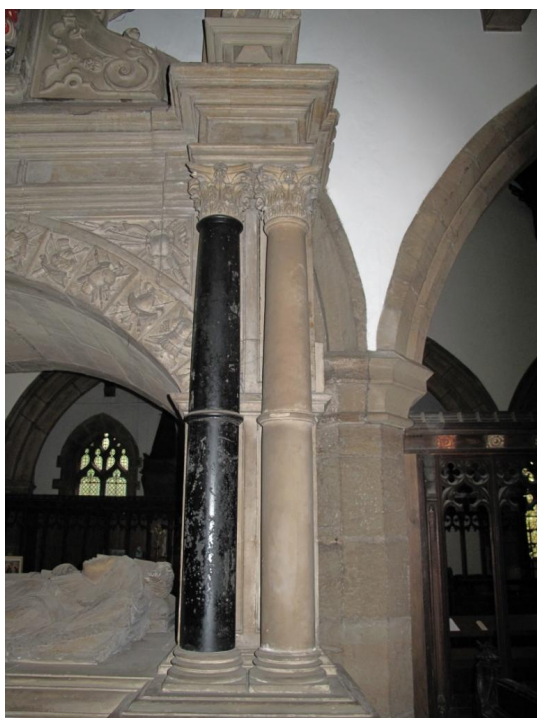
08/181

General view of the western columns.

At this level the overall condition of the north elevation is comparable with the south elevation.

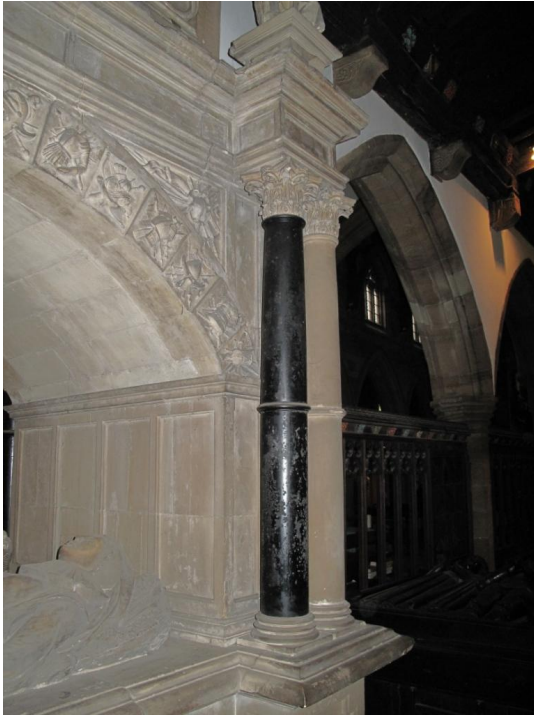
08/182

Looking south west at the columns and the underside of the canopy.

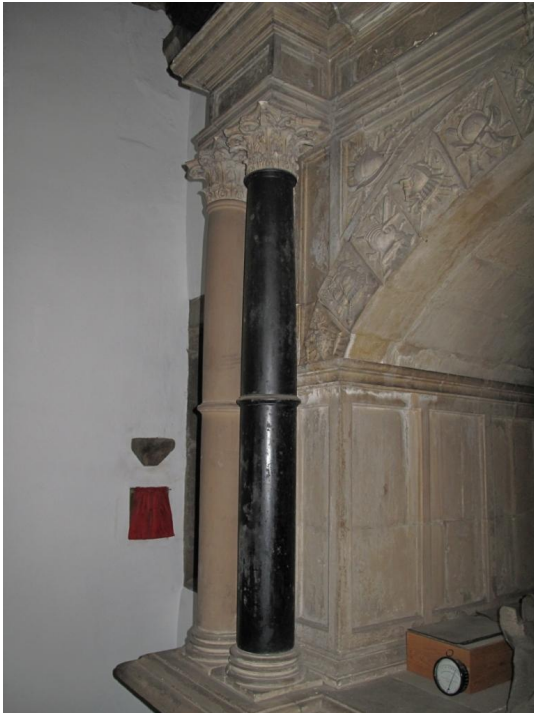
08/183

The eastern end columns.

At the time of the survey there was a thermo hydrograph resting on the tomb (white arrow) – the purpose of this was unknown but may relate to ongoing investigations on the adjacent stained glass in the eastern end of the Savile chapel.

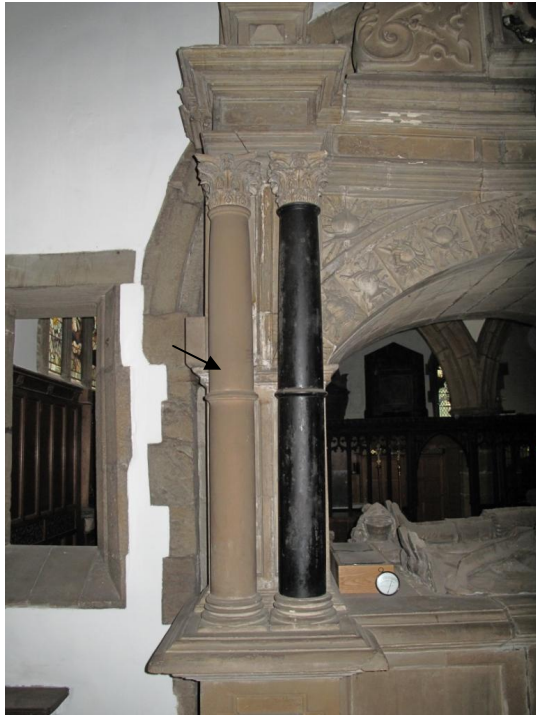
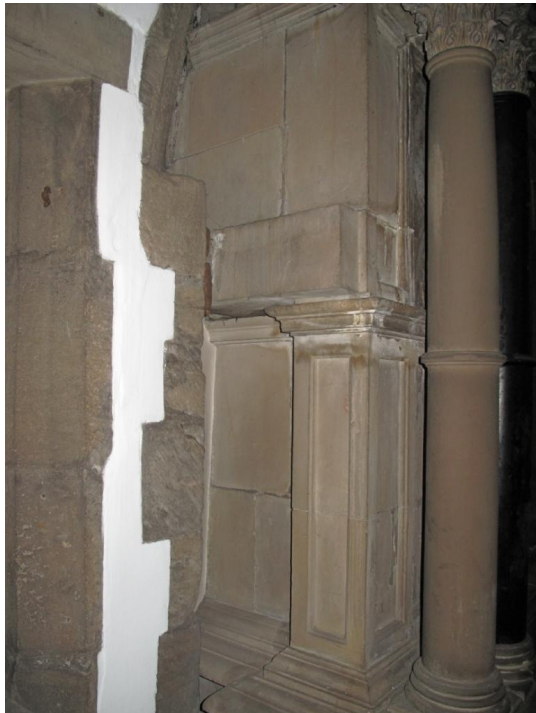
08/184

Left: Eastern columns - front elevation.

Below: Eastern columns and eastern return.

Note the intense discolouration in the area at the top of the pilaster block.

For some reason it appears that moisture and salts concentrate with in this section.

Has there been a previous leak in the roof that has lead to a concentration of salts within this area?

This might require more detailed on site investigations.

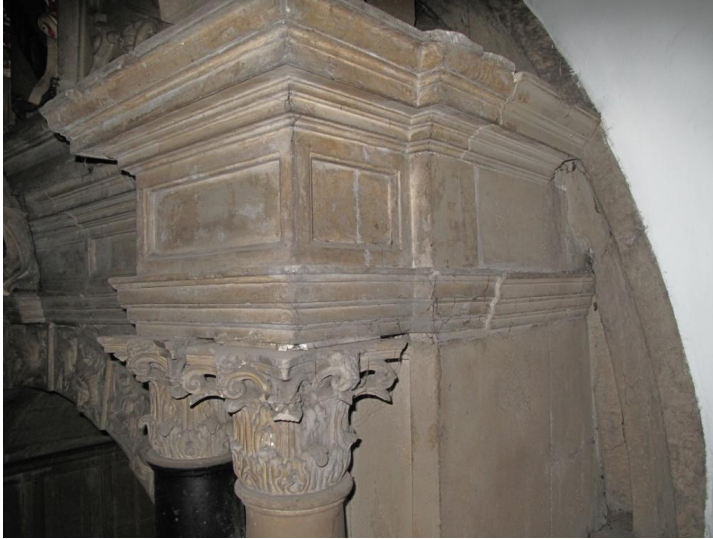
08/187

The western elevation of the north side entablature exhibits wide joints indicating movement within the structure.

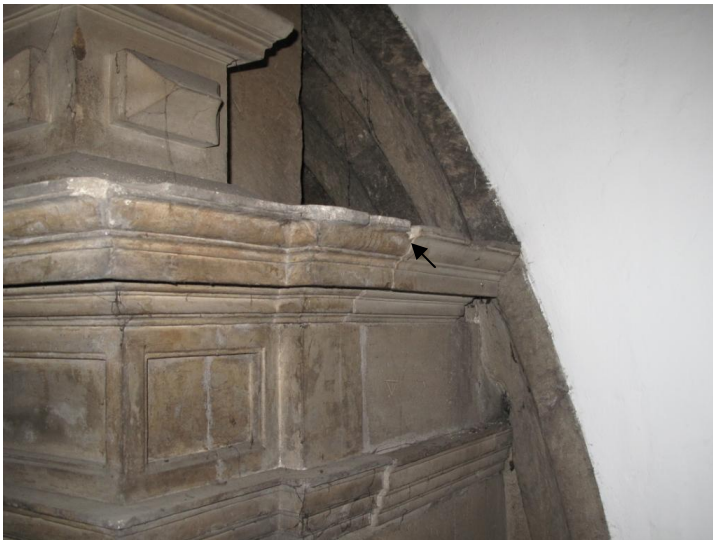
08/189

Detail of the western return.

Note the misalignment in the joints indicating previous movement.

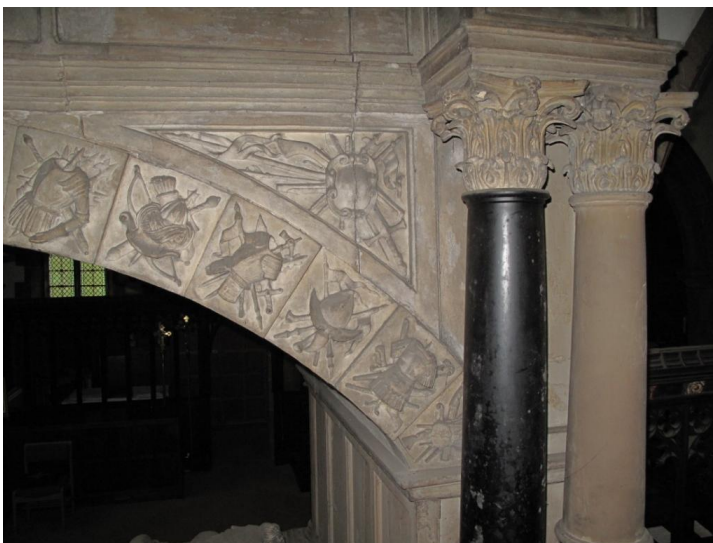
08/193

The western spandrel has movement in the joints comparable with the spandrels of the south elevation indicating a consistent problem of movement within the structure of both elevations of the monument.

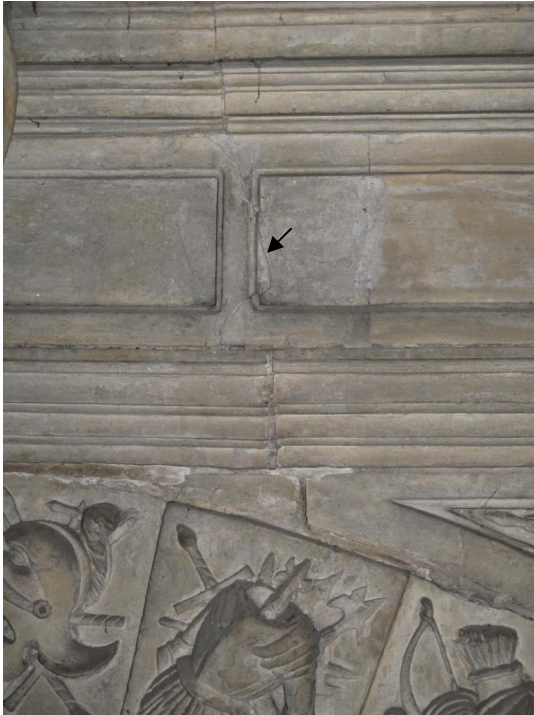
08/198

Detail of the western spandrel showing the movement across the vertical joint. Note also the cracked stone as indicated by the black arrow.

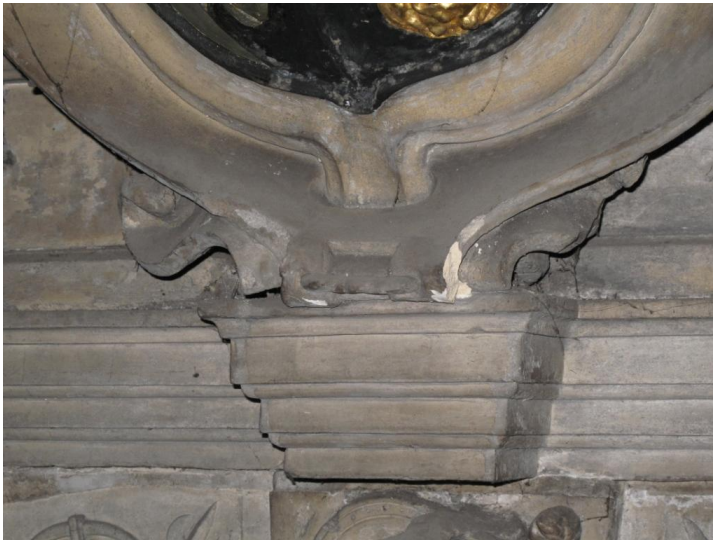
08/200

Detail of the shield showing recent impact damage. This seems to have been a problem generally across the monument even at high level which indicates that perhaps ladders are being placed against the structure – if this is the case it is to be discouraged.

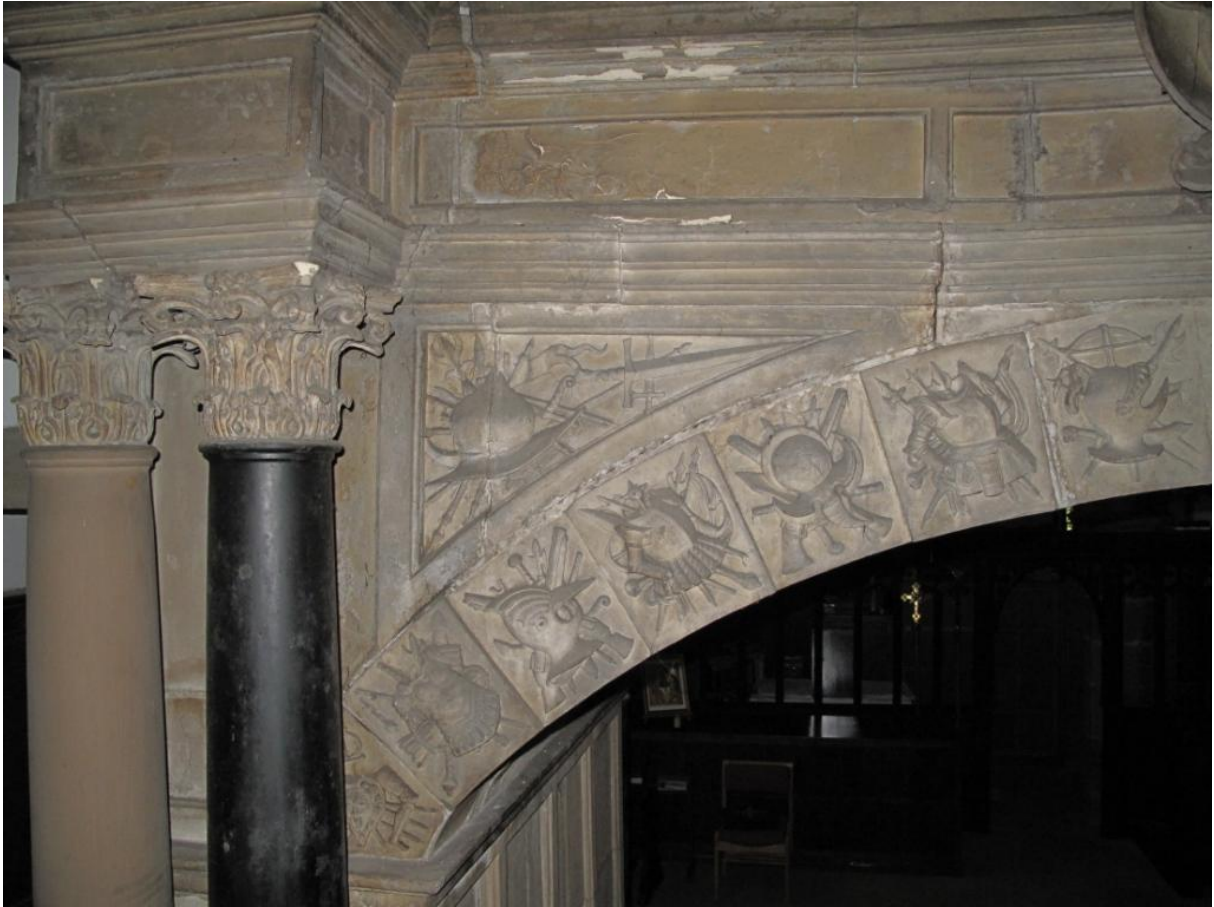
08/201

General view of the eastern spandrel: As noted previously the joints have been progressively opening as the monument spreads and have been re-pointed on a number of occasions but as clear here the movement has continued since the last intervention which is of unknown date. The open joints resemble movement in the structure rather than shrinkage in the mortars.

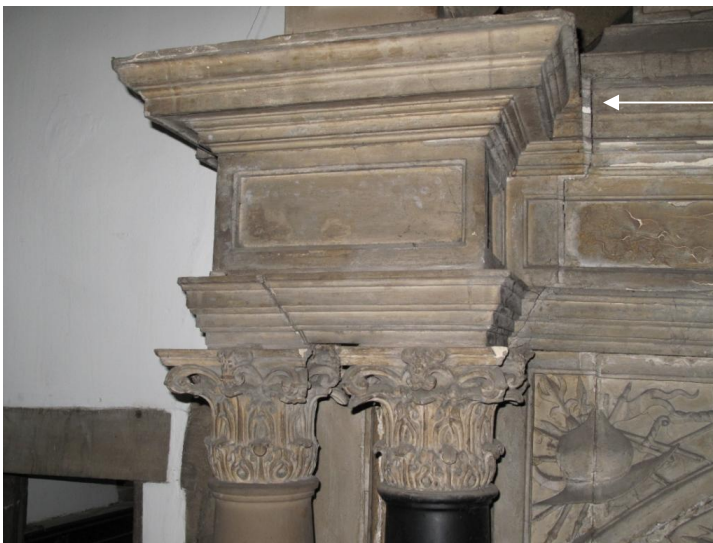
08/206

Detail of the open joint.

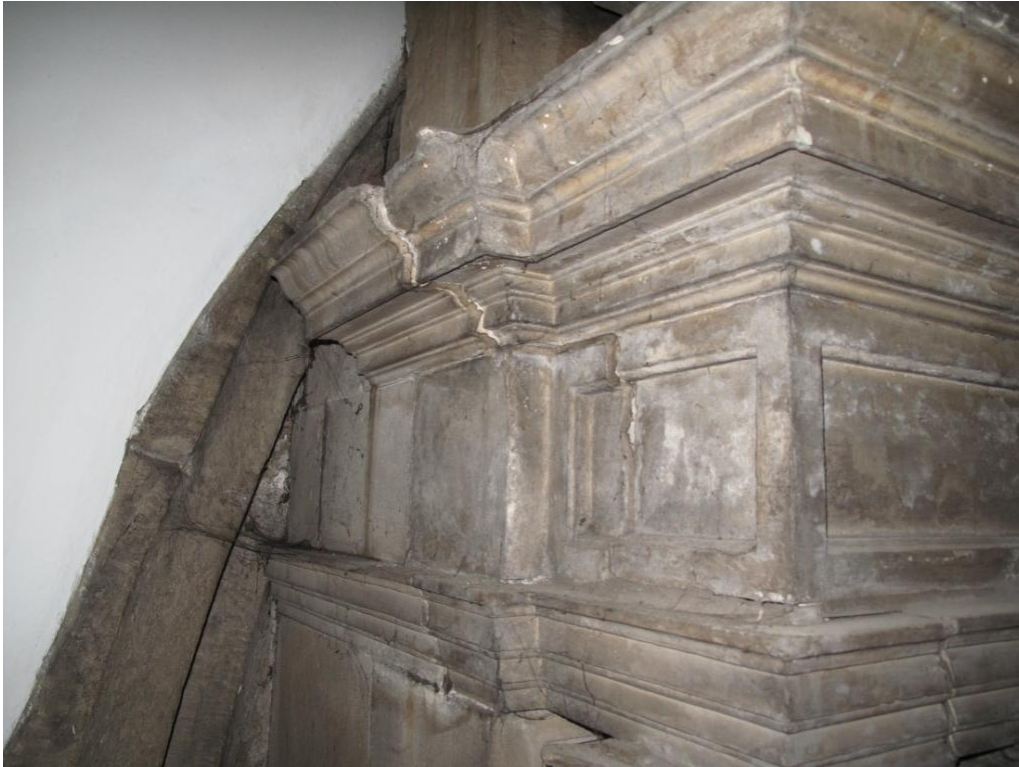
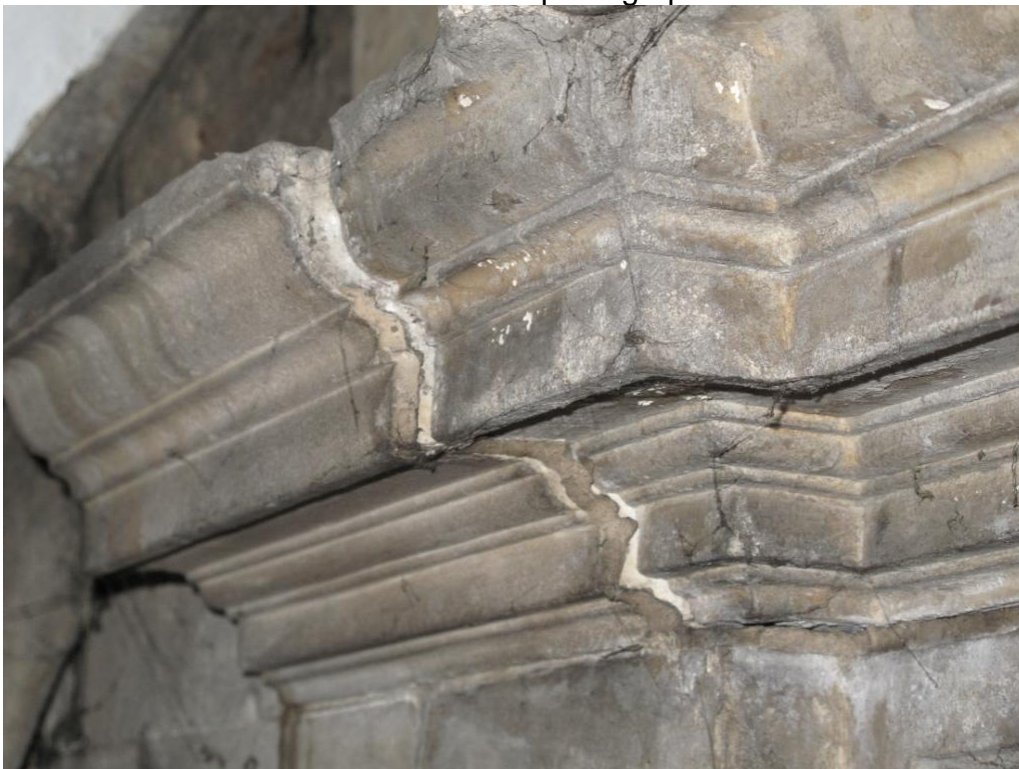
08/211

General view of the entablature eastern return showing the movement present in the stone as indicated and detailed in the photograph below.

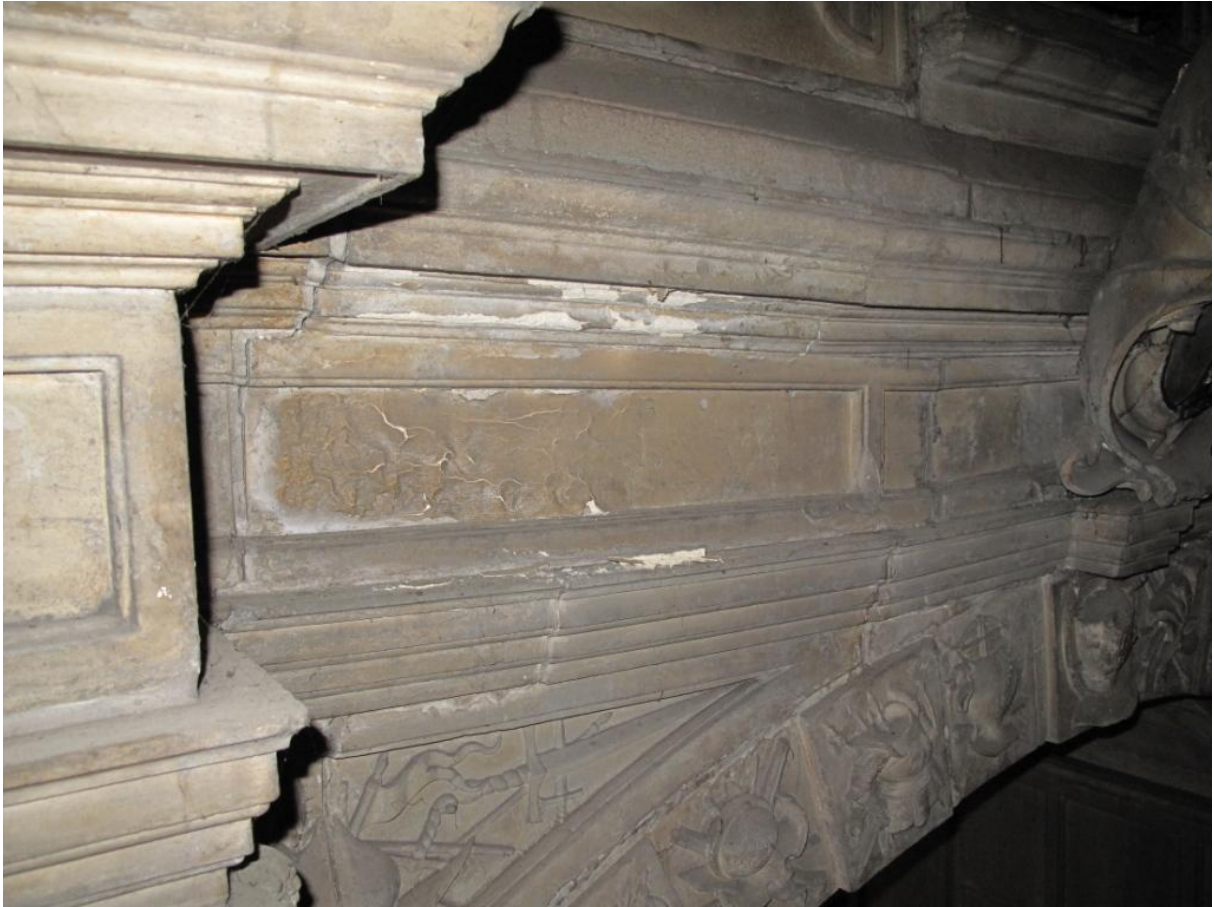
08/213. The entablature above the eastern spandrel.

It has been previously noted that the stone appears to have been coated with an unknown material. The blistering shown on this stone is further evidence of this and supports the proposal that further investigation is required to try and ascertain what this is and indeed if it is original or a restoration coating. Experience based on other church projects indicates that in the 19th century it was not uncommon for monuments to be cleaned and coated with oil based toning layer to homogenise the surface appearance. Another possibility is that the stone was treated with a linseed (or other) oil at an early stage of its life or at some point when it was showing signs of being friable.

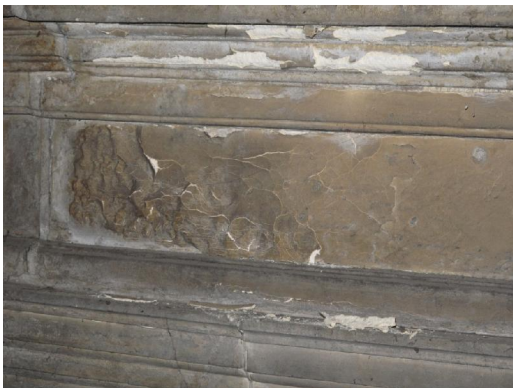
08/229

A hardened finish coat might prevent the structure from “breathing” and the severe surface exfoliation shown here may be a consequence. At the time of survey flakes of surface were on the ledge below.

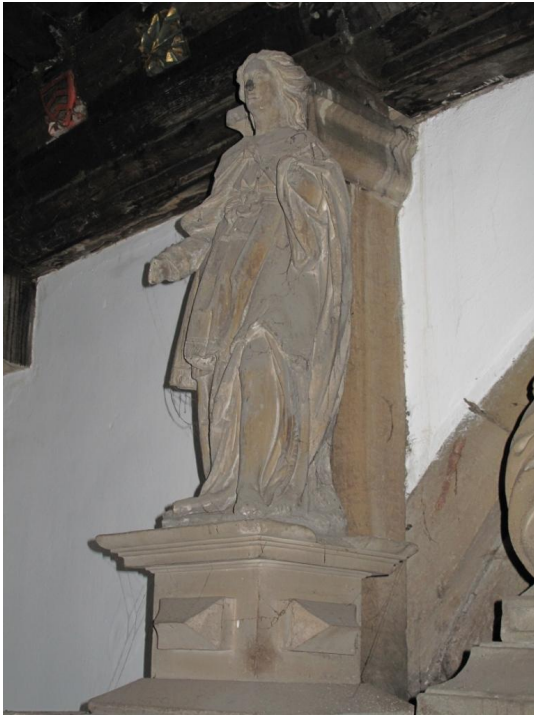
08/224

The eastern allegorical figure.

Note the adjacent stone pillar apparently supporting the stone corbel above (see also the western pillar below).

Should any proposal be agreed to dismantle the monument the function of this pillar would need to be investigated by an engineer and consideration given to any support it may be providing to the roof above.

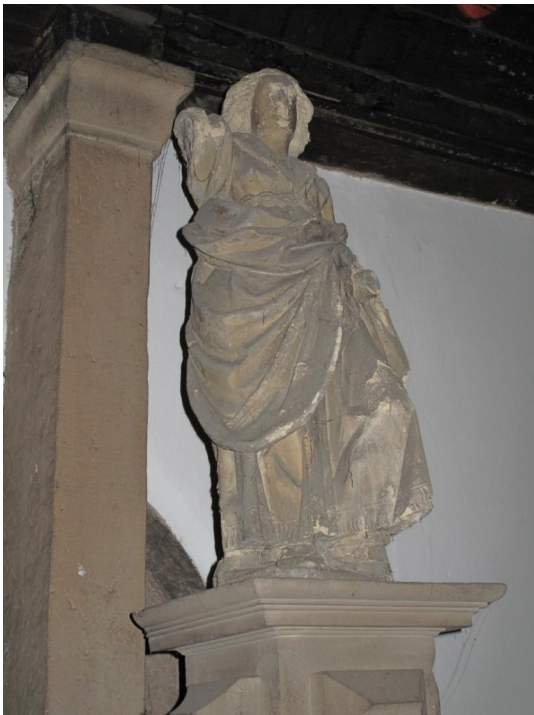
08/223

The western allegorical figure.
