St Michael & All Saints Church, Thornhill.

Conservation report on the internal monuments

Section 5

Monuments 2, 3, & 4 in the Savile Chapel

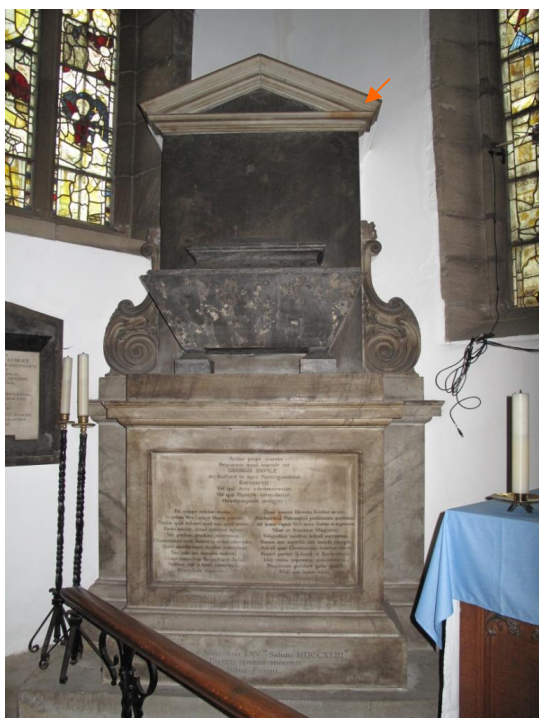
08/247

The surface of the marble is extremely discoloured with absorbed dirt and with deep staining.

There are a number of areas where the surface is discoloured as a consequence of rust stains caused by the corrosion of internal ferrous cramps. These will be detailed throughout this report but two typical areas can be seen in the adjacent photograph – in the centre of the inscription and on the pediment as indicated by the orange arrow.

It appears that rudimentary cleaning has been carried out around the text on the main inscription and the inscription on the base.

As with the other marbles within the church the surface has lost most of the polish it would have originally had – this is likely the consequence of condensation and may also be partially due to previous cleaning – this is particularly noticeable on the black and gold sarcophagus which would appear a rich colour when originally finished but is currently barely distinguished from the background. The dirtiness of the surface currently leaves the memorial bland and without the contrast it would have been intended to have.

This memorial would benefit greatly by being cleaned to remove the surface dirt. On site trials would need to be undertaken to establish both the appropriate method of cleaning and the most acceptable level of cleaning.

Following cleaning the marble surfaces should be treated by the application of a micro-crystalline wax in order to provide a measure of protection to the surface against both humidity and to inhibit the absorption of soiling in the future. For the black marbles a pigmented wax would be most appropriate.

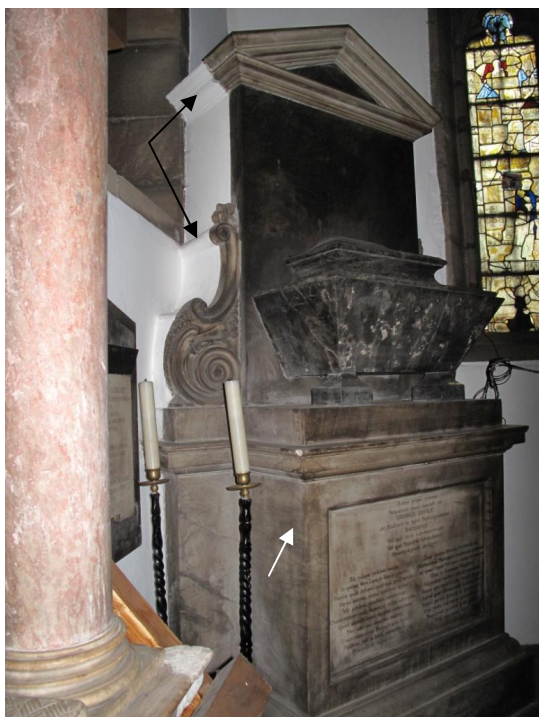
08/249

There are a number of impact damages across the surface. Many are old and discoloured but as can be seen clearly here there is recent impact chip on the North West corner of the plinth (white arrow).

The back fill behind the memorial has been rendered to simulate the form of the monument; (black arrow).

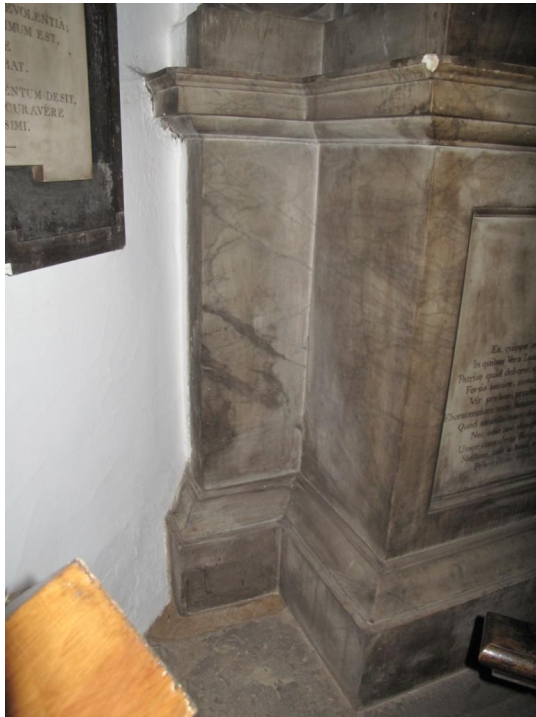
08/250

Detail of the north west elevation.

The figured marble is showing signs of deep brown discolouration particularly on the vertical corner adjacent to the inscription panel. The veins in the marble are generally an iron mineral and the discolouration may be a consequence of corrosion and movement of minerals within the structure of the marble. Corners in built structures tend to be points of increased evaporation encouraging moisture to migrate towards them thus transporting and concentrating dissolved minerals.

This type of discolouration would remain even following cleaning.

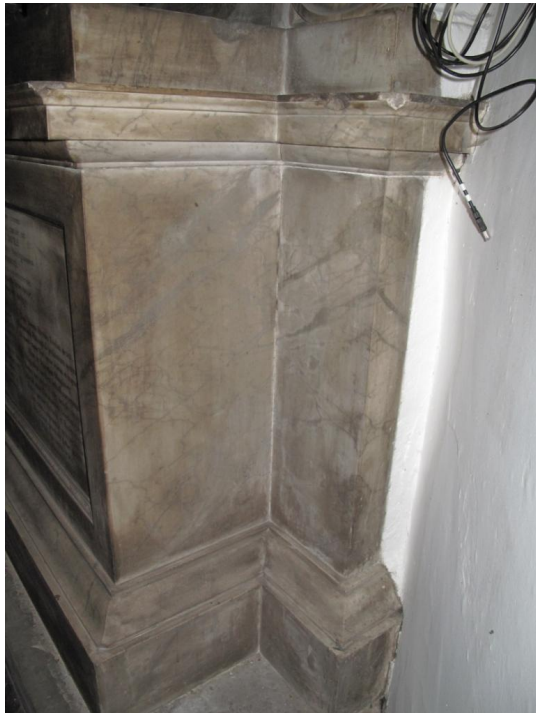
08/259

Detail of the south east corner.

Discolouration of the marble is comparable to the opposite elevation as detailed above.

Note also the chipped corners which in this case appear not to be so recent.

The cable in this photograph is temporary and associated with works to monitor the adjacent stained glass window by the use of sensors and data loggers.

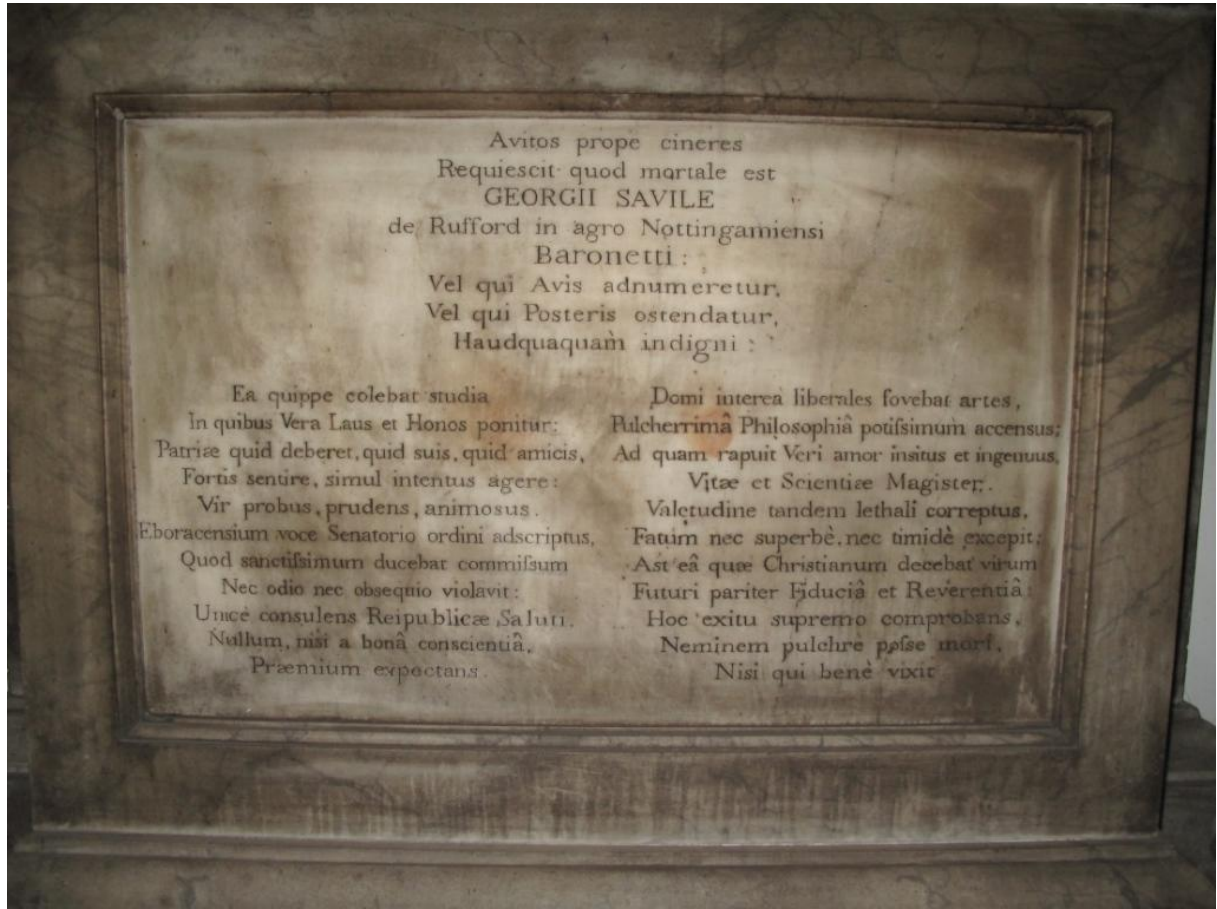
08/254

Detail record of the inscription panel. As discussed above the intense rust stains are associated with buried ferrous cramps.

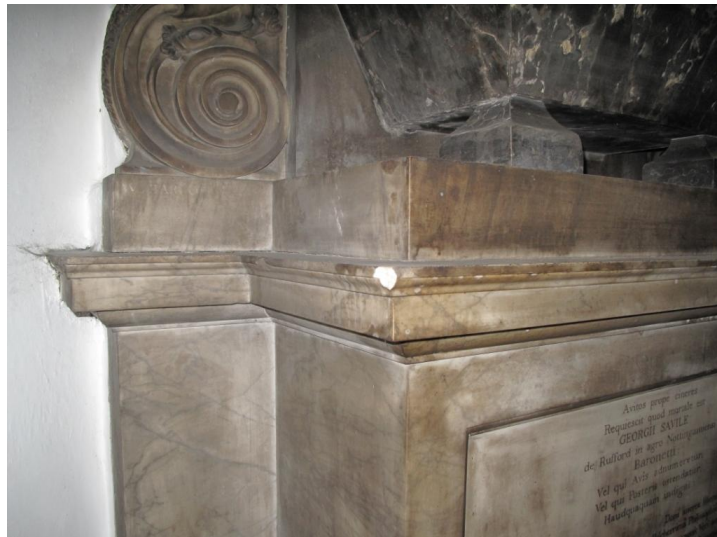
08/255

Detail of the north-west corner of the plinth top and sarcophagus base with the impact damage as discussed above.

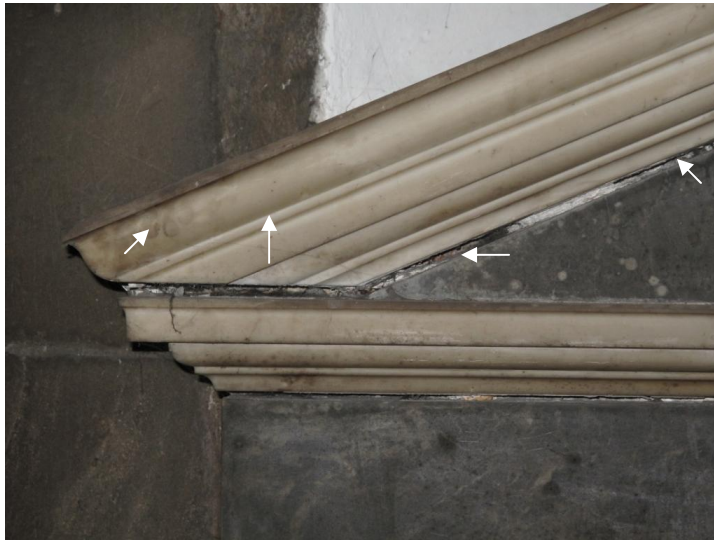
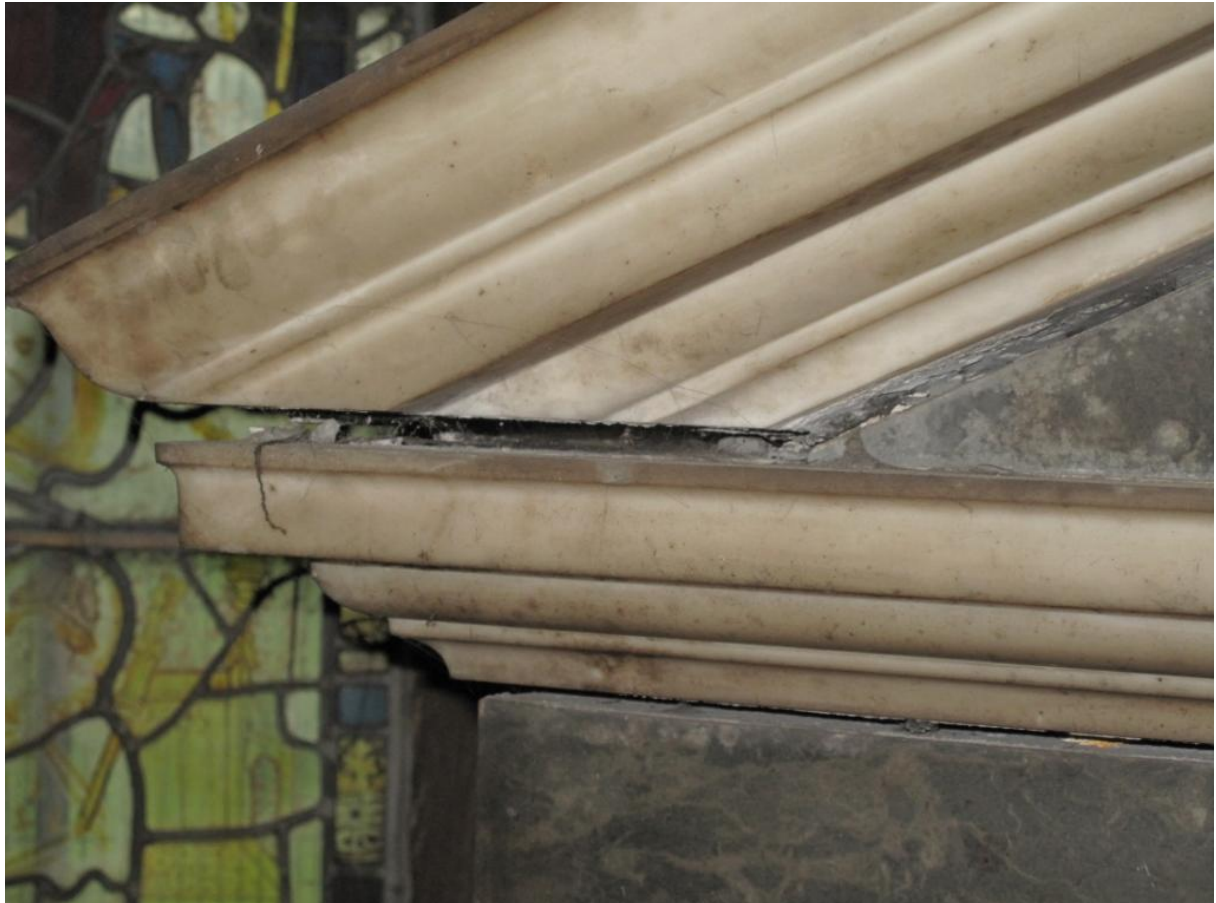
08/271

Left and below are detailed photographs of the north-west end of the pediment.

Note the gaps in the joints as indicated by the arrows. The internal cramps are corroding and jacking apart the stones.

The joints are relatively clean indicating a progressive and comparatively recent movement.

The monument is suffering from corrosion jacking in the joints of the pediment and the sarcophagus. At the current time the joints are expanding to accommodate the pressure and there is no sign of damage occurring within the sections of marble. However it is probable that the turn down sections of the cramps will begin to corrode and it would be likely that the pressure exerted would then break the marble.

Due to the risk of failure in the structure from ongoing corrosion of the cramps it would be advisable to plan to deal with the problem by full or partial dismantling of the memorial enabling the replacement of the ferrous cramps with non-ferrous cramps. While it would be possible to effect repair of the currently corroded cramps by partial dismantling it should be considered prudent to prevent future problems by undertaking a full dismantling and replacement. It would also enable the provision of a damp proof membrane between the memorial and the floor and walls of the building.

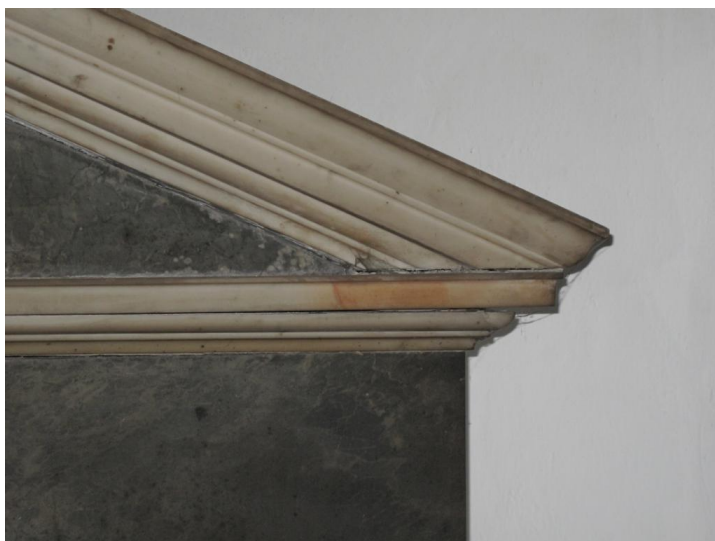
08/273

Detail of the south east end of the pediment showing movement in the joints.

Note also the intense rust stain in the marble in this area.

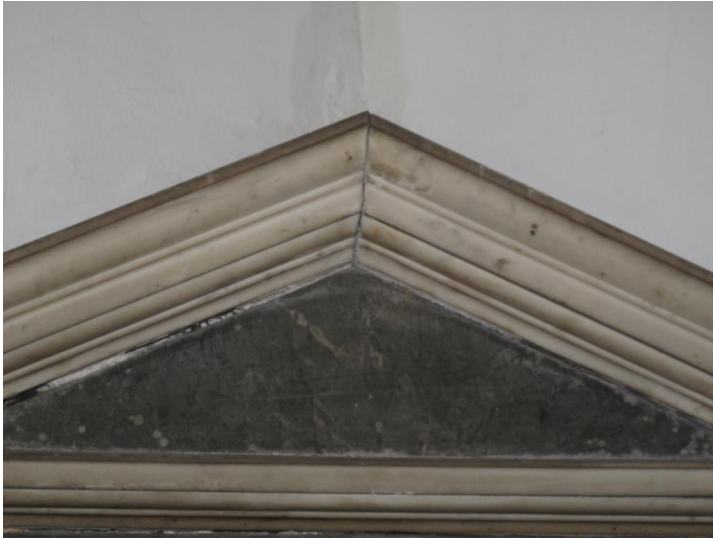
08/272

Overall view of the centre of the pediment which shows the movement in all the joints.

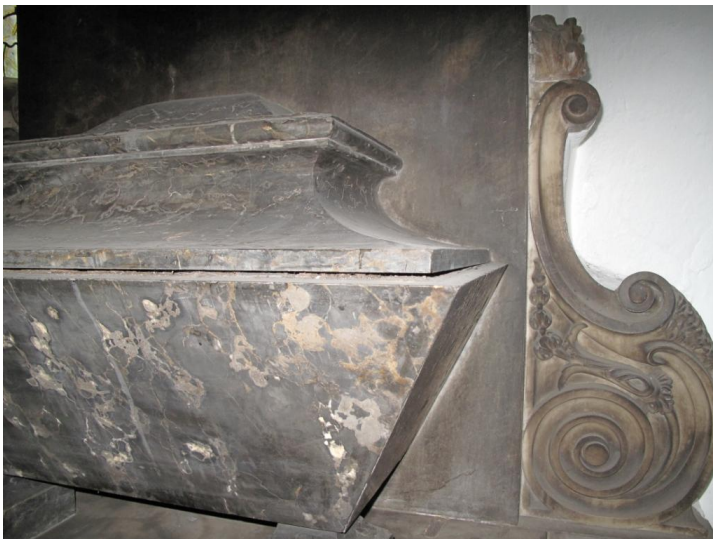
08/278

Detail of the south east corner of the sarcophagus showing the movement in the joint between the lid and the main section.

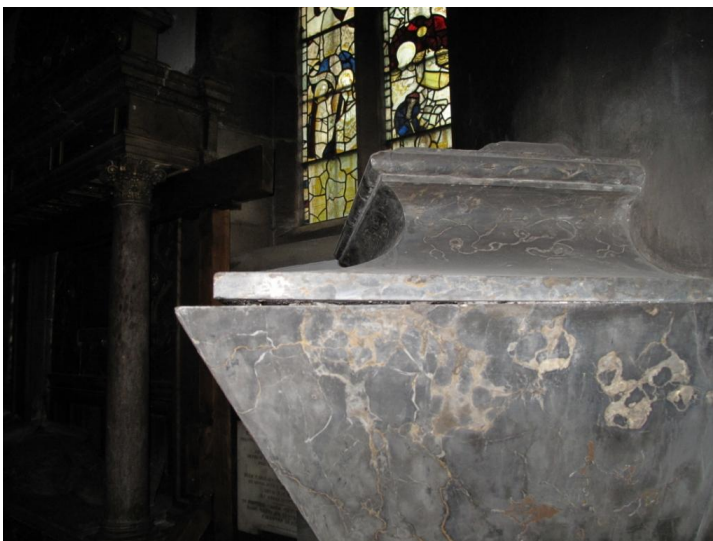
08/283

Detail of the east elevation of the sarcophagus showing the jacking upwards of the lid along the front joint.

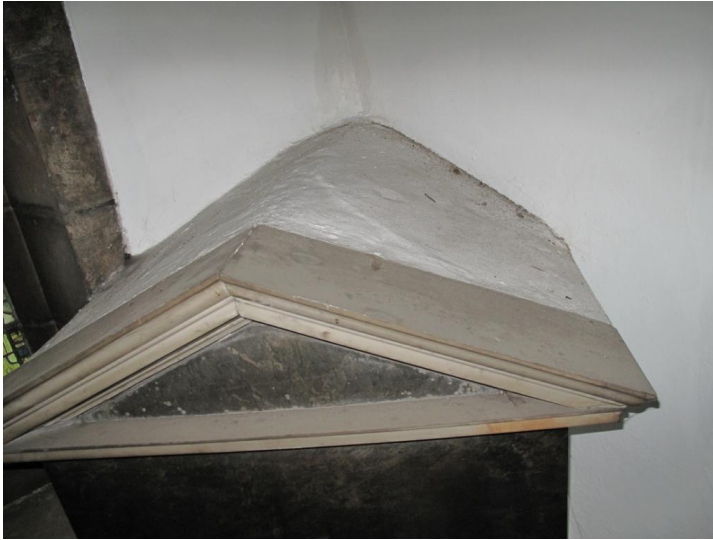
08/276

Photograph looking down on top of the pediment showing the rendered and painted infilling between the marble and the wall.

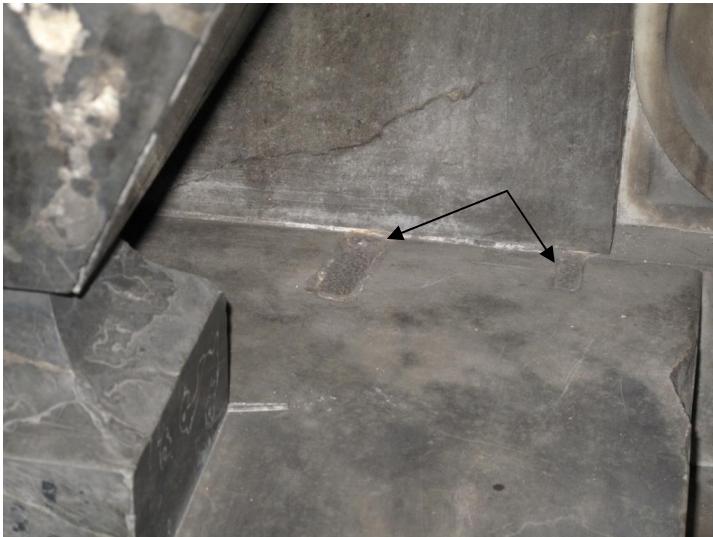
08/279

Looking down on top of the main chest at the joint with the back panel adjacent to the south east corner of the sarcophagus; this shows visible iron cramps which although exposed remain in relatively good condition.

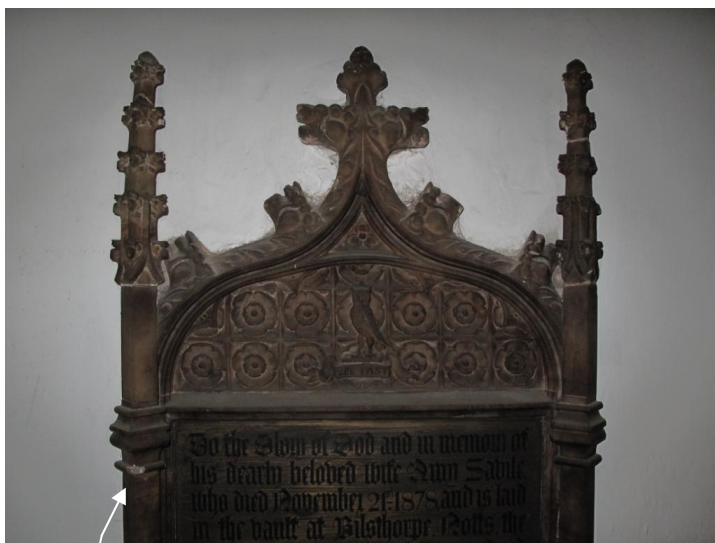
09/159

The alabaster is heavily discoloured with dirt which covers the natural appearance of the veined stone and distorts the details of the gothic carving.

Generally the monument remains in good physical condition but with some minor chipping (white arrow) in common with other memorials in the church.

The visual appearance of the memorial would greatly benefit from cleaning of the alabaster followed by an application of micro-crystalline wax.

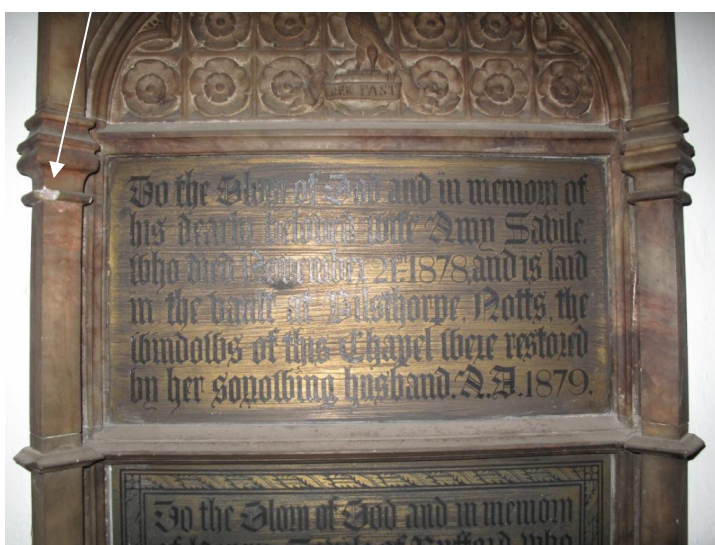
09/160

The brass inscription panels are discoloured and have a distinct horizontal streaking. The latter may be the consequence of an applied coating which is discoloured.

The brass plaques are somewhat disfigured by the discoloured streaky coating that appears to have been applied to the surface making them increasingly difficult to read.

The coating should be examined and if possible removed from the brass plaques. The brass may require gentle polishing followed by an application of micro-crystalline wax.

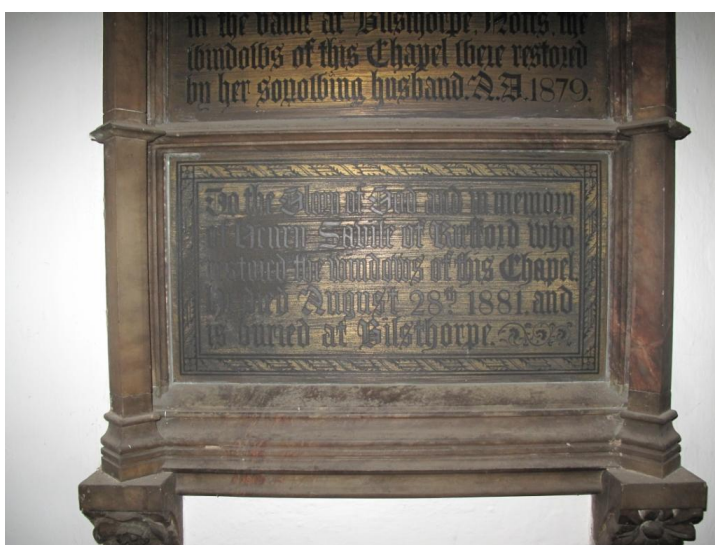
09/161

The painted or pigmented wax filled lettering remains in good condition.

During the works the pigmented infill to the plaques should be checked and consolidated if required.

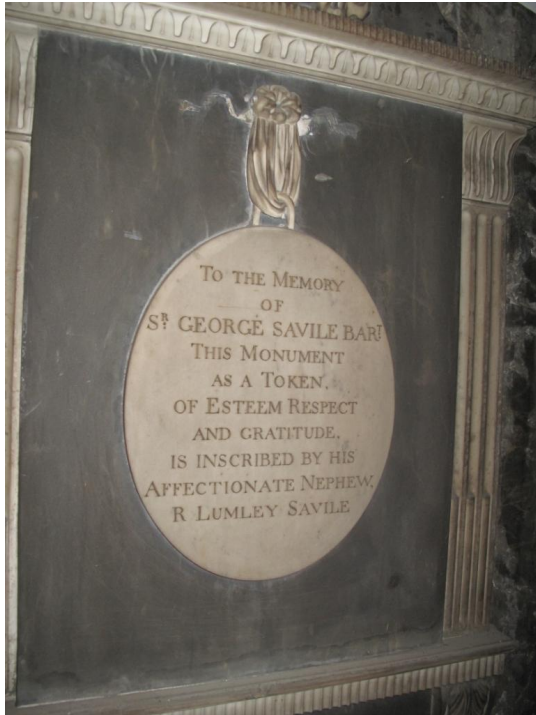
09/148

The surfaces all have a heavy covering of ingrained dirt consistent with all the other memorials in the church. The upper surfaces of the owl are particularly noted for the discolouration and soiling by dirt (see further details in the following photographs).

The level of soiling destroys the intended polychrome effect of the chosen marbles.

The ribbon from which the medallion hangs has been partially lost but the original form is retained by the residue of plaster originally used to adhere it to the background.

At the time of survey part of the detached ribbon rested on the white marble cornice.

The memorial is badly disfigured by dirt and would greatly benefit from cleaning. On site trials would be required to ascertain the appropriate method and level of cleaning. It is likely that a variety of techniques will be required to ensure a balanced cleaning. Considering the current condition it is likely that some deep staining will remain in the marble.

The detached sections of marble ribbon should be adhered back to the memorial in order to ensure that they are not lost. The outline preserved in the plaster remains should be carefully preserved and consideration given to restoring the integrity of the design by reforming the missing sections of ribbon. This could be carried out in carved marble or more cost effectively in plaster painted to simulate the colour of the surrounding marble. Resin replication is an option but most resin casts discolour with time and it is considered better to use a painted repair which although not initially visually so close to the appearance of marble will remain generally more stable in the longer term.

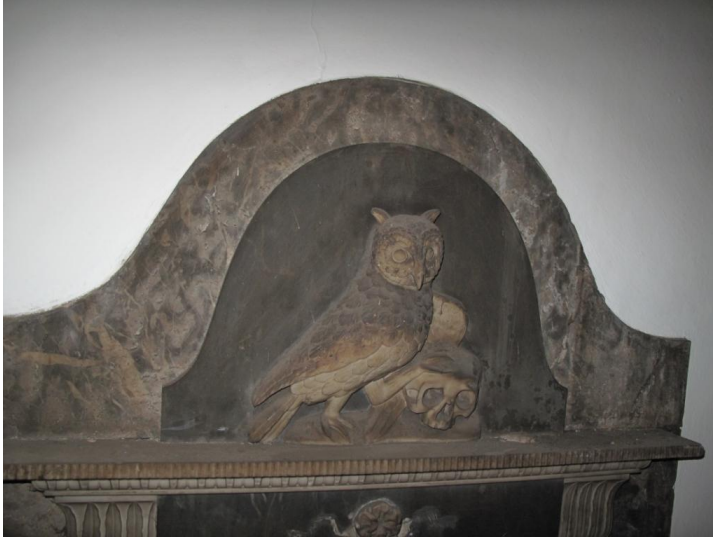
09/143

The contrasting colours of the memorial are lost due to the covering of dirt.

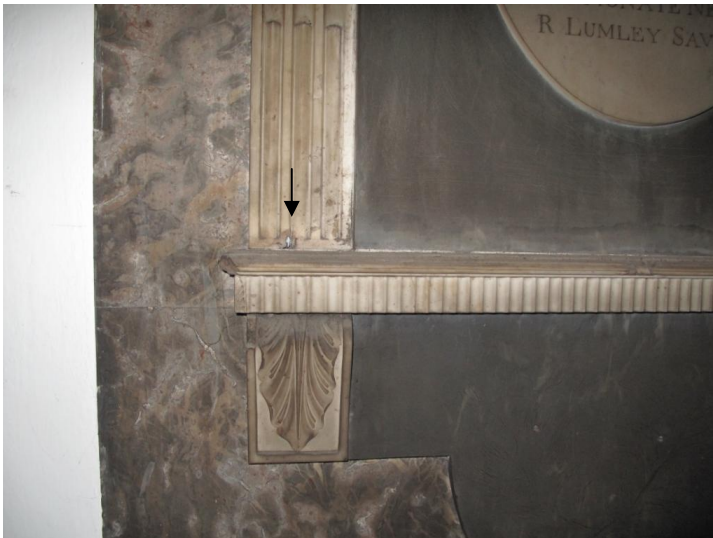
09/150

A small restraint fixing has been exposed by the loss of the marble from around it.
