# **St Michael & All Saints Church, Thornhill.**

## **Conservation report on the internal monuments Section 6**

**Monuments 5, 6, & 7 located in the base of the tower.**

Prepared for:  
**Thornhill Parish Church Council**  
**September 2010**

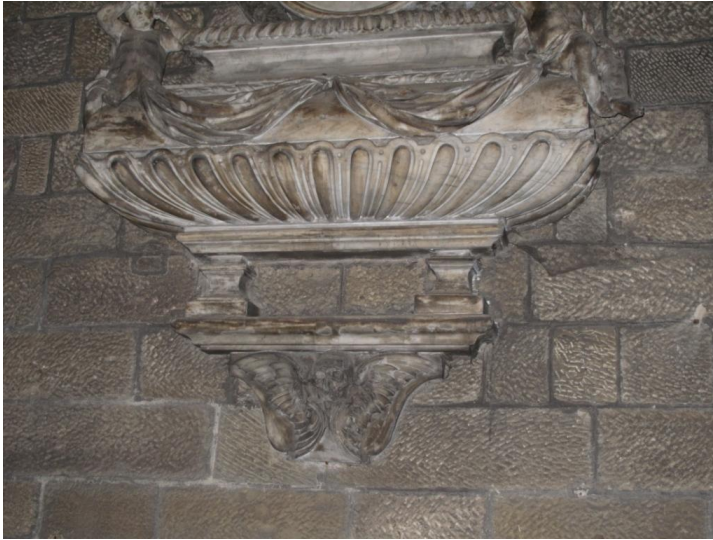
09/170

All parts of the memorial are heavily discoloured with deep staining and surface soiling which is very disfiguring and disruptive to the details of the carved form. This is particularly noticeable on the skull and the foliate wreath.

The monument is badly disfigured by the extremely dirty appearance and would greatly benefit from being cleaned. On site cleaning tests would be required to ascertain the appropriate method and level of cleaning.

The application of a micro crystalline wax coating following cleaning would be a sound measure for reducing the problem of dirt being absorbed by the surface in the future.

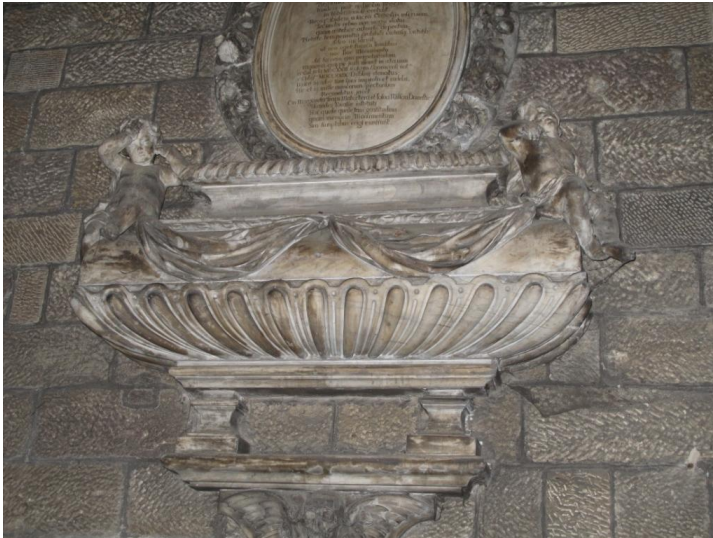
09/171

Although hanging high on the wall the monument appears to be securely fixed at the current time and no obvious sign of corrosion and expansion of cramps was visible.

Periodic monitoring of the joints is essential to ensure it remains secure.

Scaffold would be required for the cleaning works and this would also enable more detailed inspection to locate and understand the existing fixings. This information should be brought into the maintenance recommendations of the treatment report and be used to assist in the future monitoring for signs of movement or corrosion within the cramps.

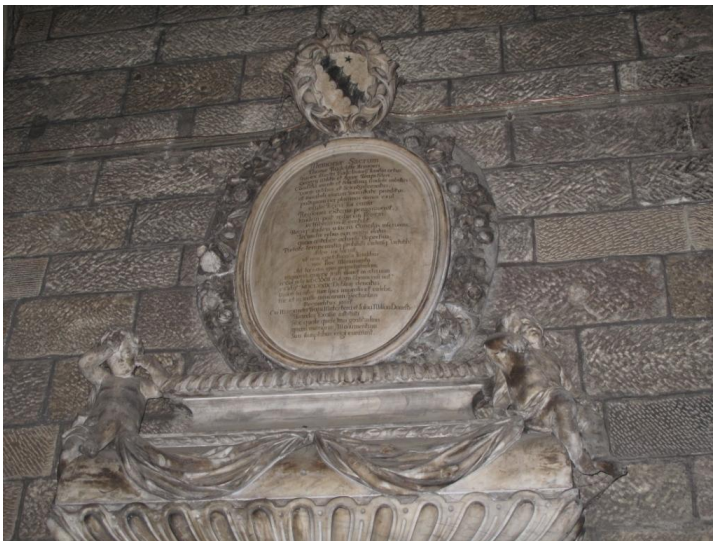
09/172

The foliate wreath framing the inscription panel has been pointed with a mortar that appears to be cement based and would appear to be a later origin than the original date of the memorial. Is this an indication that it has been moved to the current location? Or is this indication of a repair having been carried out?

The pointing and mortar around the frame should be checked and replaced with a suitable lime mortar if it is found to be too hard and potentially deleterious to the long term preservation of the monument.

Where defective the pointing in the joints should be replaced. This should be based on the original pointing which is most likely to be plaster of Paris.

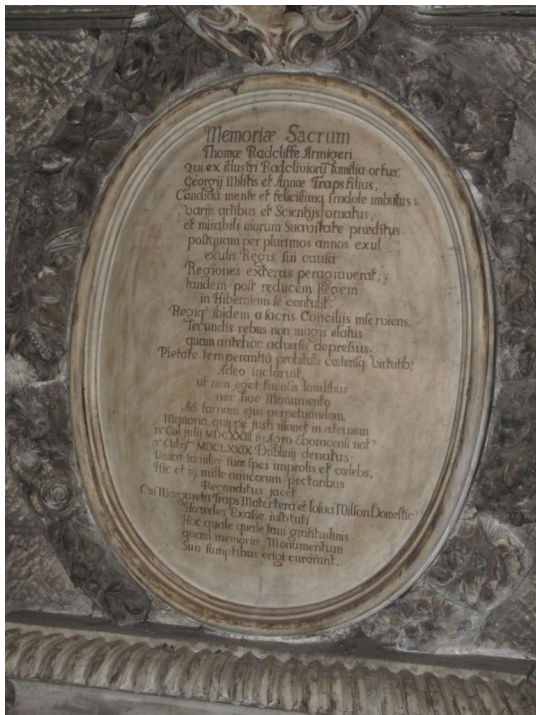
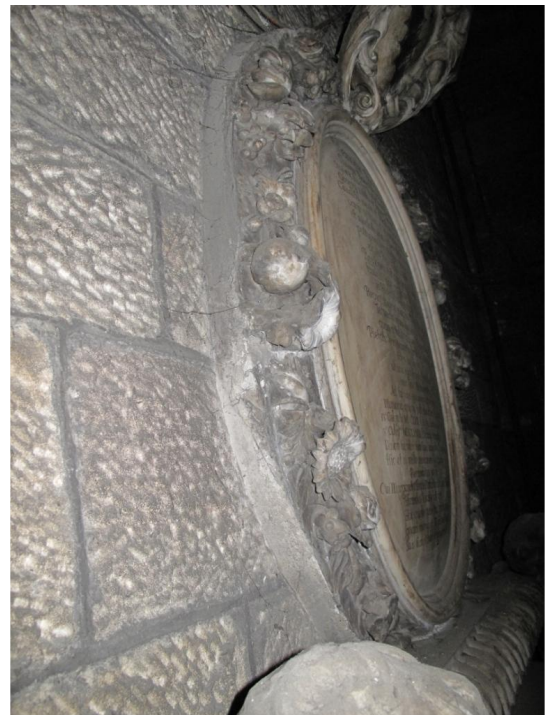
Above left is a record of the inscription; the photograph also shows how badly disfiguring the dirt is.

Above right is the east elevation of the inscription medallion showing the cement based pointing that has been carried out.

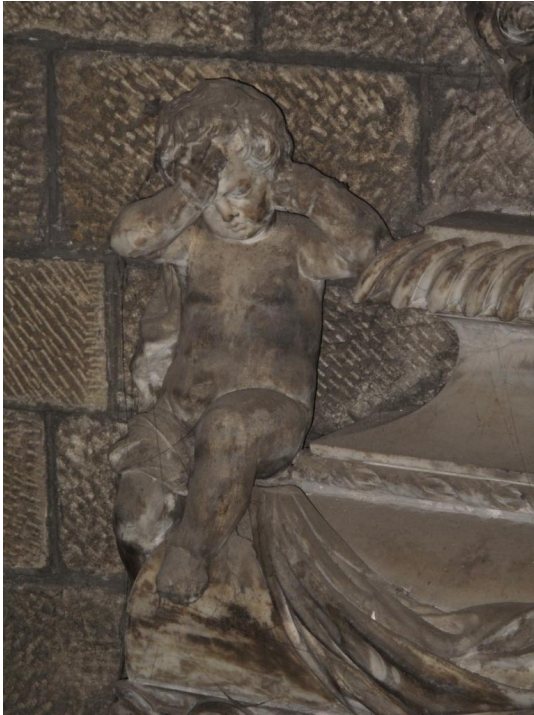
09/176

Detail of the eastern putto.

The surface of the marble has heavy oily looking soiling – perhaps coal tar from domestic chimneys and the industrial past in this region?

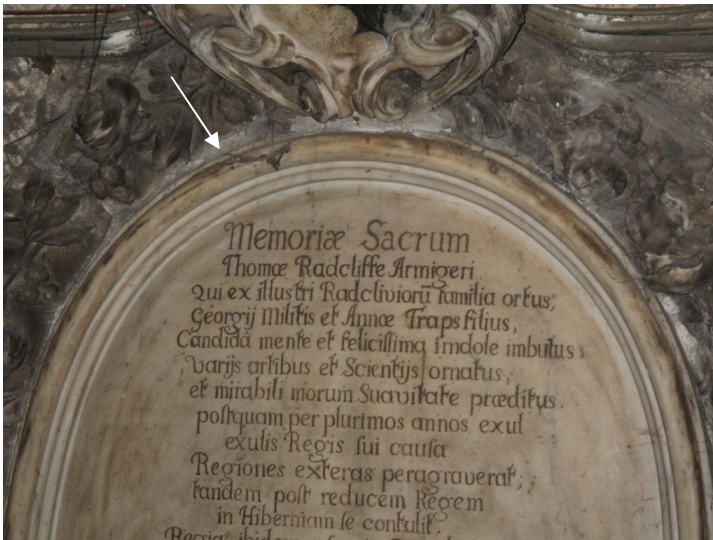
09/179

Detail of the top area of the inscription showing mortar around the edge which is similar, and cement based in appearance, to the mortar used to point around the outer edges as highlighted above.

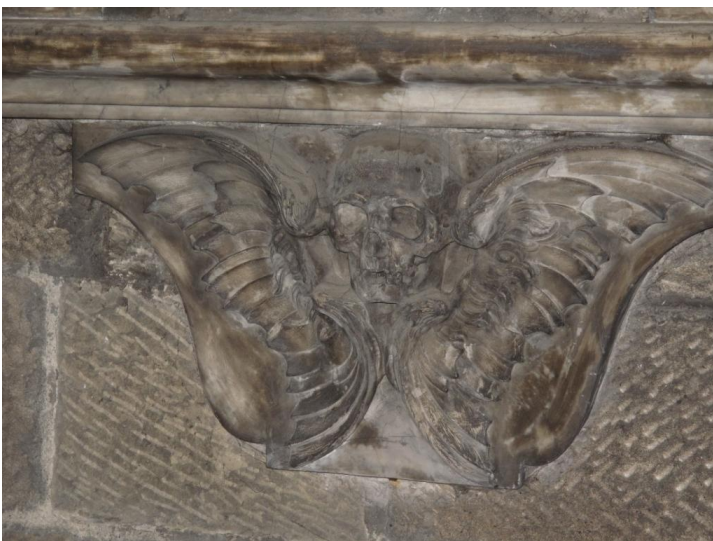
09/184

Detail of the winged skull.

This is likely to be an embellishment and not a structural corbel. The Shelf and sarcophagus legs above are likely to be corbelled to the wall.

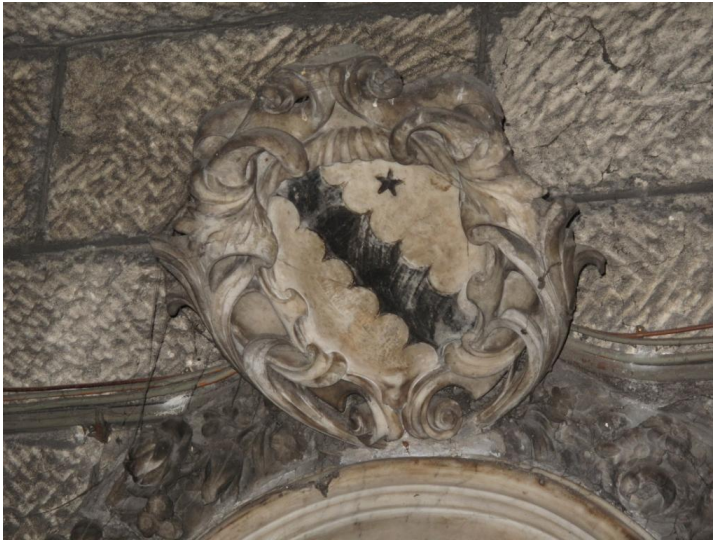
09/180

The crest leans forward but on site inspection indicates that it appears to be secure upon its original fixing.

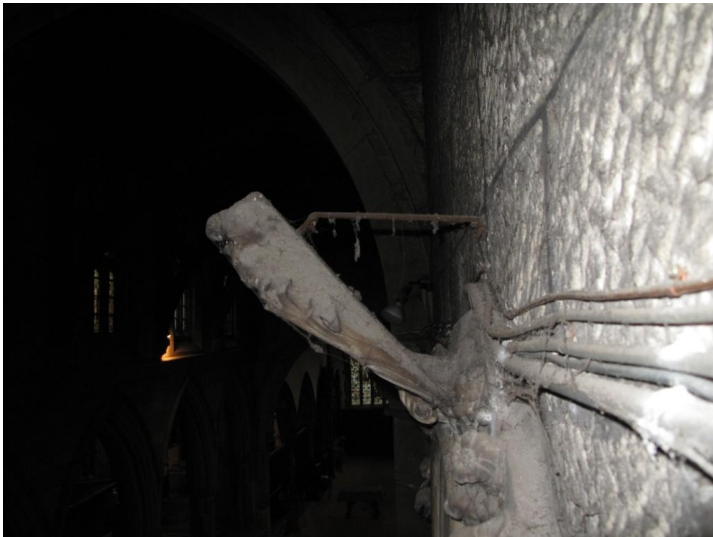
09/190

Looking towards the east behind the crest.

Note the metal fixing bar which is shown in greater detail below.

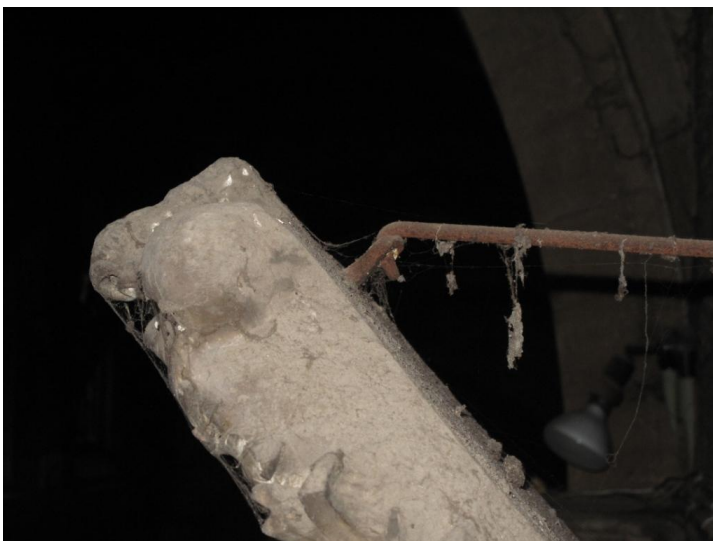
09/192

The metal bar has only superficial surface corrosion, is likely to be made from wrought iron and appears in a condition fit for purpose.

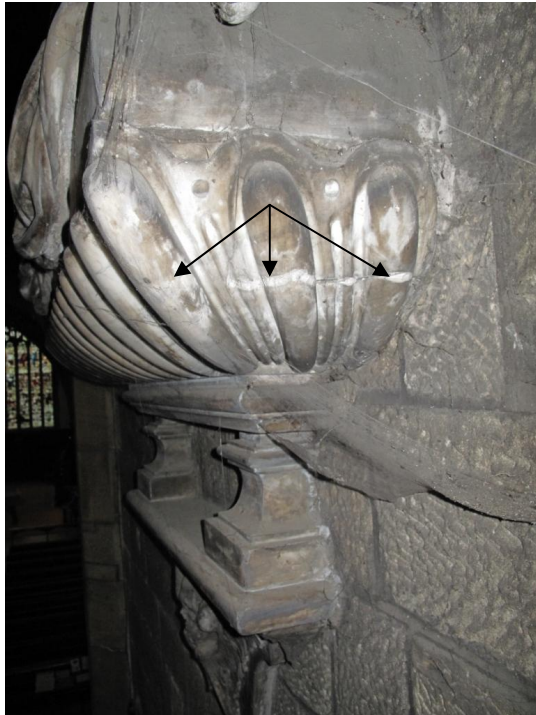
09/185

Detail of the western elevation of the sarcophagus looking east.

There is a flaw in the marble as indicated but this is not considered to be a structural concern at present.

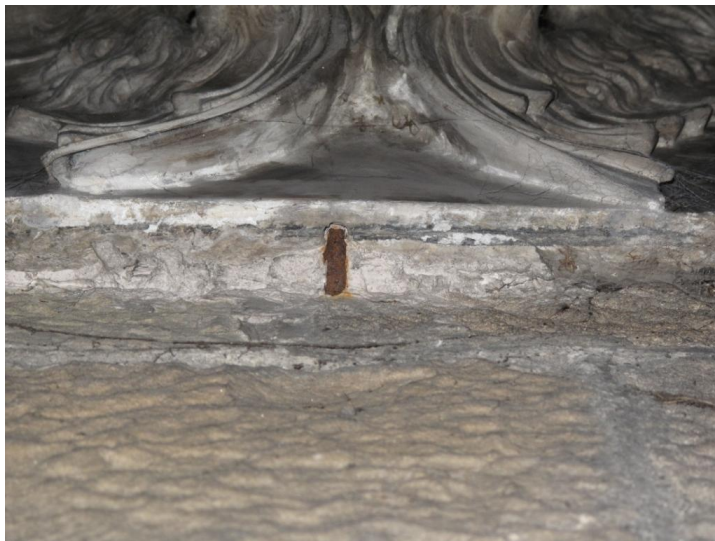
09/197

Underneath the winged skull is a ferrous metal tie bar which appears to restrain the bottom of the carved stone. It would offer some measure of support but would not provide sufficient to allow the skull to act as a corbel.

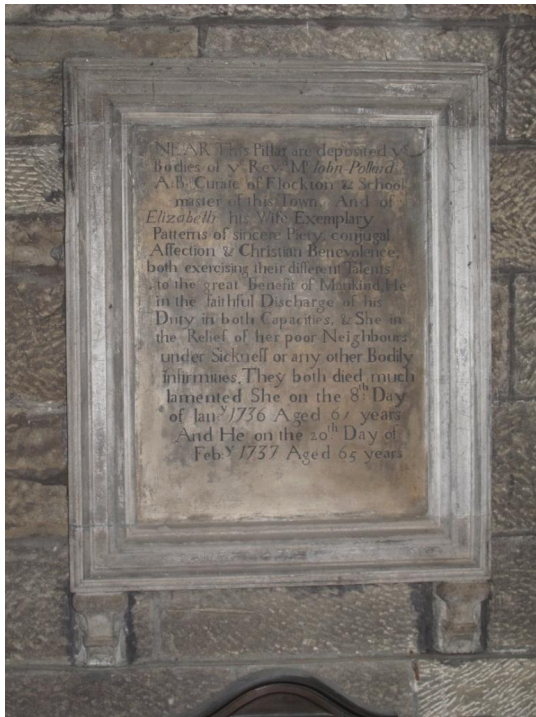
09/202

General view of the monument.

The inscription panel is heavily stained and disfigured but the lettering remains clearly legible and in good condition.

The limestone frame and corbels are also very dirty.

The corbels appear to have been pointed with a dark cement mortar not contemporary with the date of the memorial. This might indicate repair works or that it has been moved sometime in the late 19<sup>th</sup> century or later.

The top restraint was not established at the time of the survey but there was no indication of movement that gives cause for concern.

The memorial would benefit from cleaning.

Following cleaning the inscription panel would benefit from an application of micro-crystalline wax.

The surrounding frame should be checked for any friability and localised consolidated carried out if required using an acrylic emulsion. The frame should also be checked to ascertain if it has been coated - this is a reference to the general requirement in the church to investigate the possible use of coatings on limestone memorials relating to the treatment of the Sir George and Lady Anne Monument.

It should be monitored closely for signs of movement or corrosion within the cramps. In particular when a conservator is working within the church with suitable access the top restraint should be investigated and checked to ascertain that it remains in good condition.

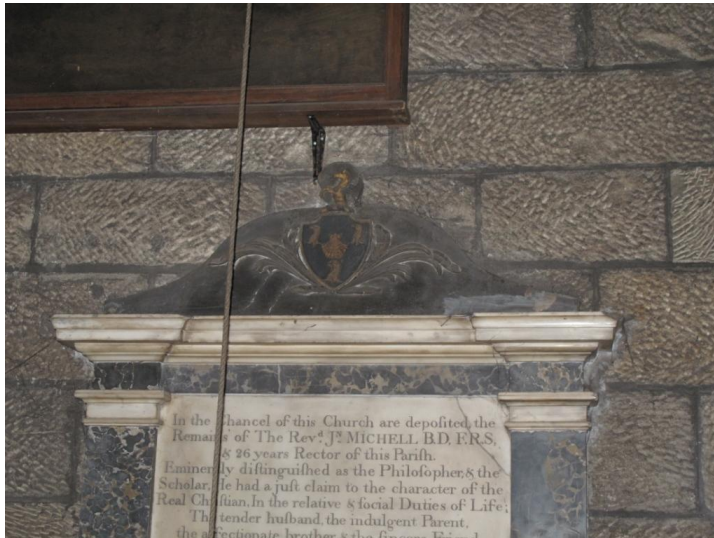
09/213

The pediment and entablature.

The surfaces of the memorial are cleaner and less stained than many of the others within the church. This raises a question as to why? Has this been brought into this location from some where else within the building where it was previously protected or was it even brought from another building?

The monument would benefit from cleaning of the surfaces to help restore the intended polychrome effect of the different marbles. On site trials would be undertaken in order to establish the appropriate method and level of clean.

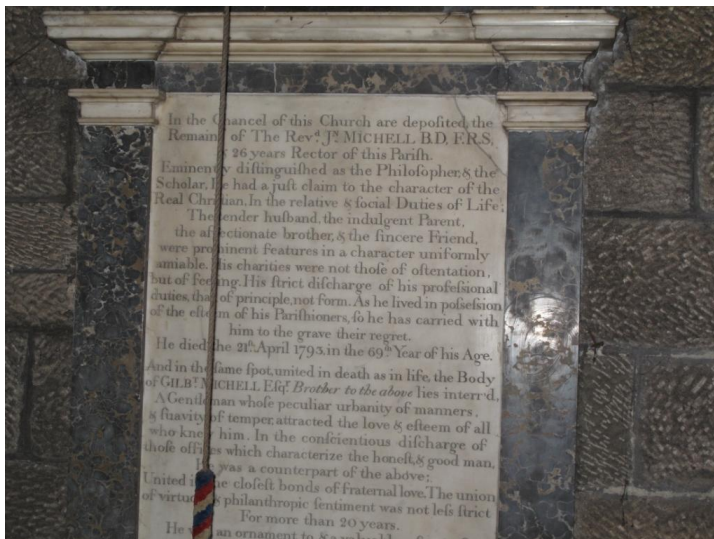
09/214

Upper section of the inscription panel.

Thorough cleaning may have been carried out but the lack of deep staining on the inscription panel for example is at variance with the adjacent and opposite memorials.

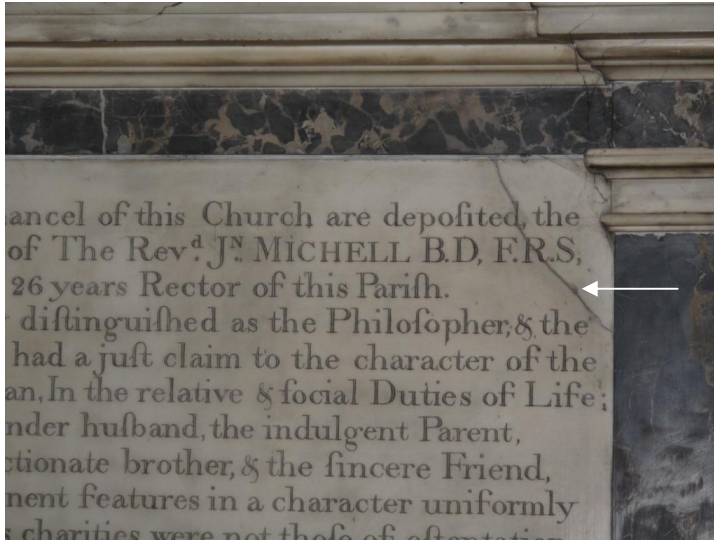
09/217

The upper east corner of the inscription panel has been broken but the section remains firmly in place.

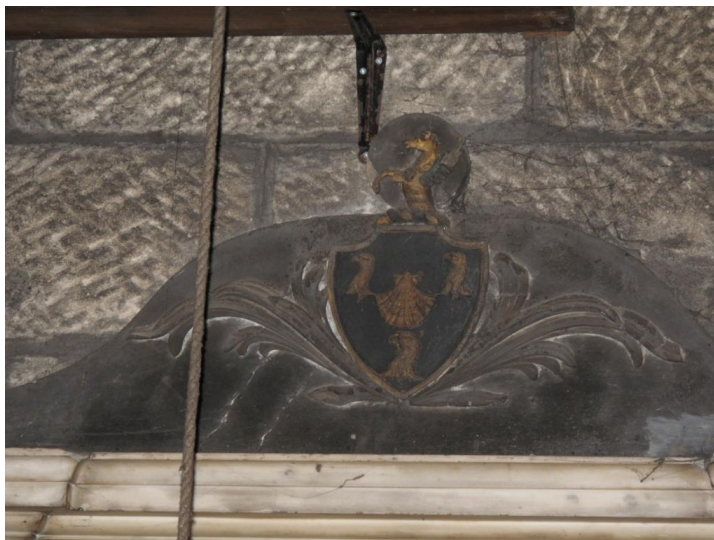
09/218

Detail of the crest on which traces of paint and gilding can be seen.

The painted crest should be examined by a specialist and be examined closely to ascertain if it requires any consolidation to preserve it: If agreed consolidation should be carried out.
