St Michael & All Saints Church, Thornhill.

Conservation report on the internal monuments

Monuments 8, 9, 10, & 11 on the south wall of the south chapel

Prepared for:
Thornhill Parish Church Council
September 2010

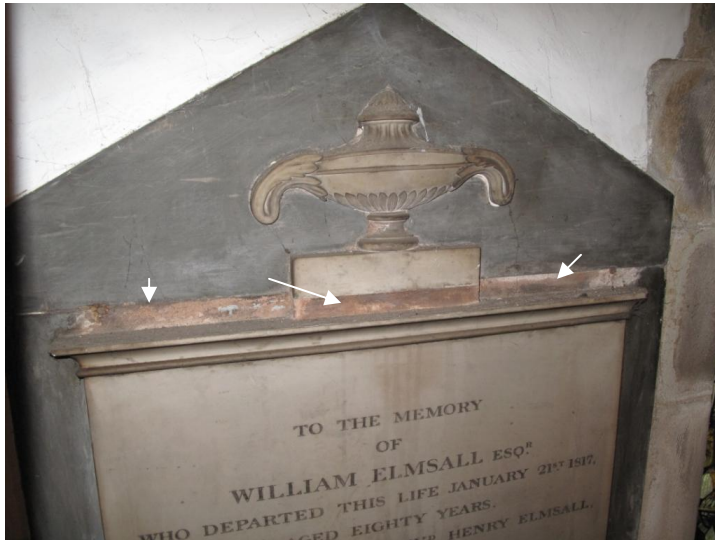
09/241

The white marble is relatively clean and unstained in comparison to other memorials within the church. The black marble has become grey due to the loss of polish from the surface.

It appears that the top of the cornice has lost part of the moulding – old plaster from a joint remains (as indicated by the white arrows).

The memorial appears to be stable at the current time but it is likely that all the fixings will be ferrous and ongoing monitoring will be necessary.

This memorial is relatively clean in comparison to others memorials in the church but it would benefit from being lightly cleaned and given a protective coating of micro crystalline wax. It would be advised to undertake the cleaning to the adjacent memorials first and to ascertain to what level this monument could be cleaned without upsetting an overall balanced appearance.

The missing section is unfortunate but it is not considered necessary to replace it. The plaster traces could perhaps be left to provide future indication of the missing moulding.

Ongoing monitoring to ensure that the structure remains safe is recommended.

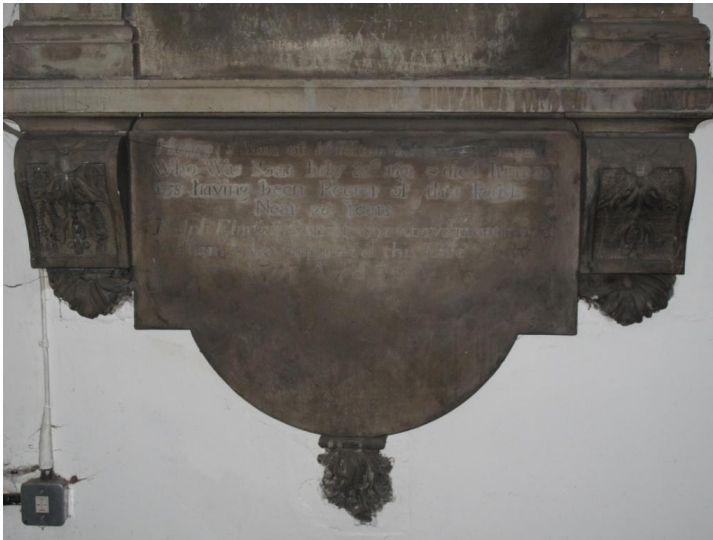
09/226

Detail of the lower inscription showing the extensive and disfiguring soiling that has built up leaving the inscription barely legible from normal viewing.

Note also the heavy staining to the corbels.

Cleaning of the monument would be of great benefit as the current soiling is extremely disfiguring and makes the inscription barely legible. On site tests would be required to establish the method and the desired level of cleaning. The marble surfaces should be given an application of micro crystalline wax.

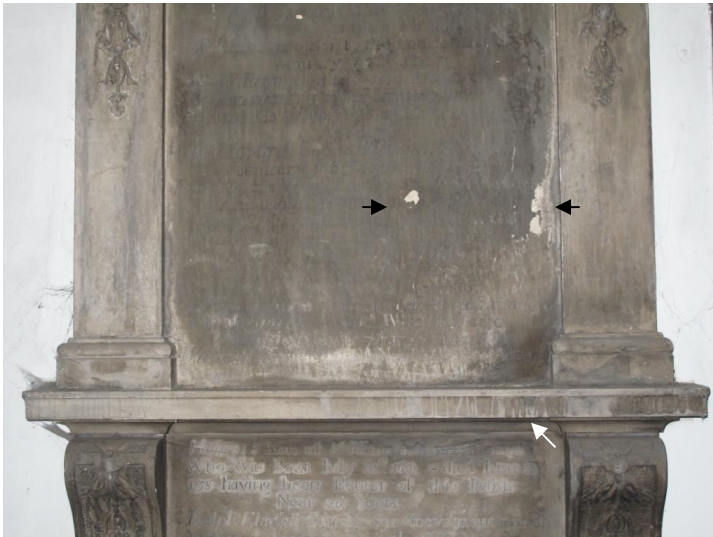
09/227

Detail of the lower section of the main inscription panel.

The surface of the panel is exfoliating as indicated by the arrows – the exact cause of this is unclear. It may be that the surface has hardened and formed a skin which is being forced off by moisture but further investigation would be required to ascertain the exact cause of the problem.

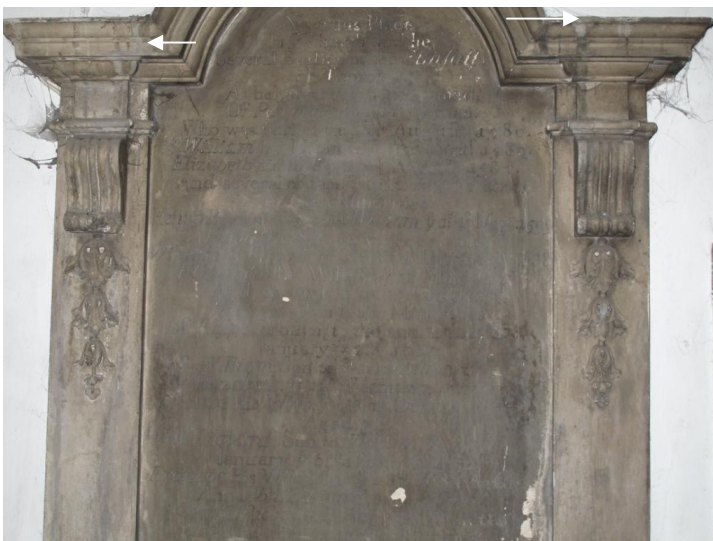
09/228

Detail of the upper section of the main inscription panel.

Note the water runs across the surface of the stone at various points as indicated by the white arrows in the photograph left and above. This is most likely from a leak in the roof above at some time.

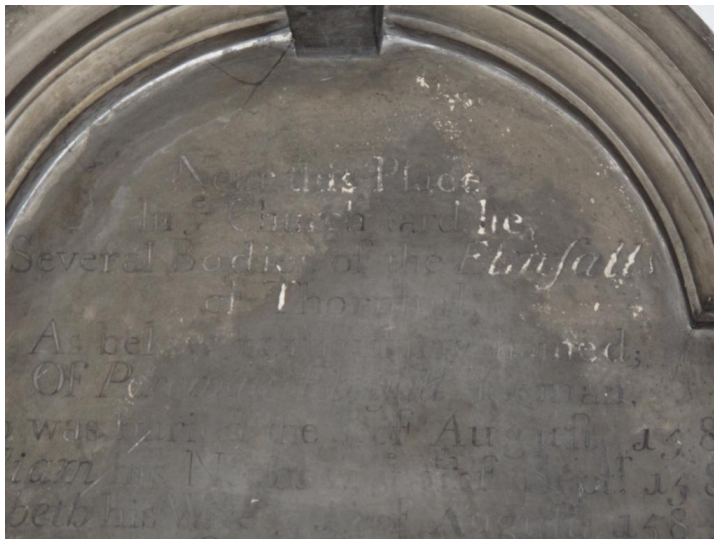
09/230

Detail of the lettering in the upper section: showing the presence of white infilling where the lettering elsewhere is generally black: the cause or reason for this is unclear but paint analysis may be able to provide an explanation.

Paint analysis of the inscription would be required to help ascertain the reason for the confusing white sections as detailed above.

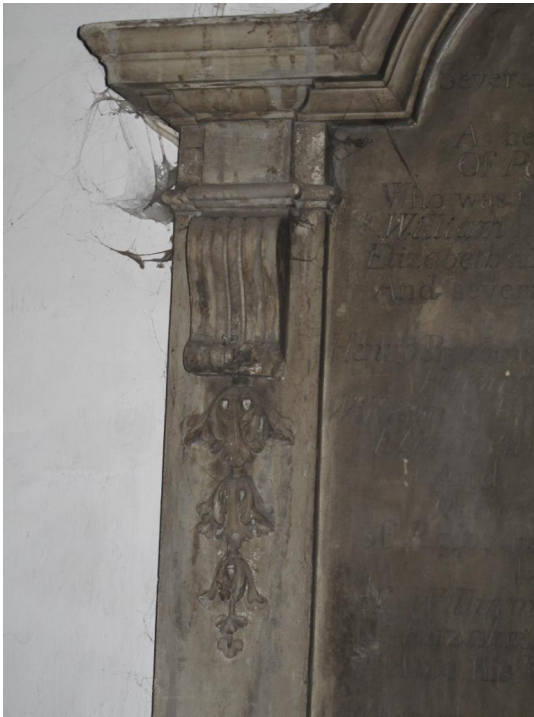
09/231

Detail of the east side cornice bracket showing a detail of the stains caused by water running across the surface – as suggested above probably as a consequence of the roof leaking at some point?

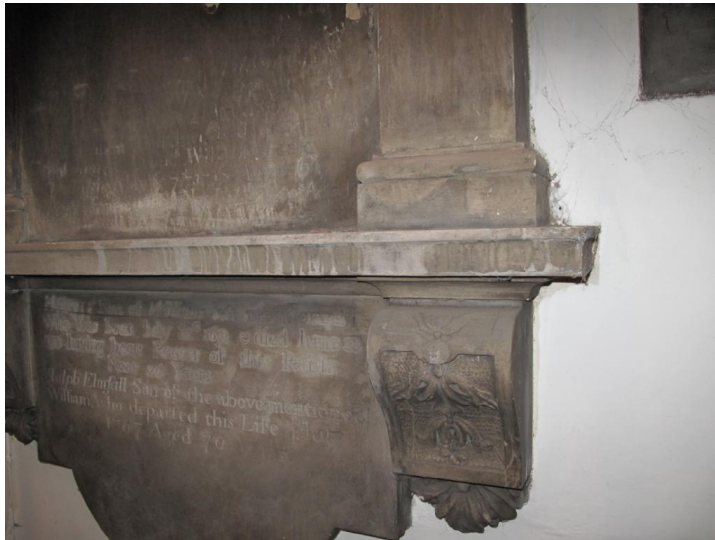
09/243

Detail of the west side shelf and corbel showing more detail of the water marks on the stone.

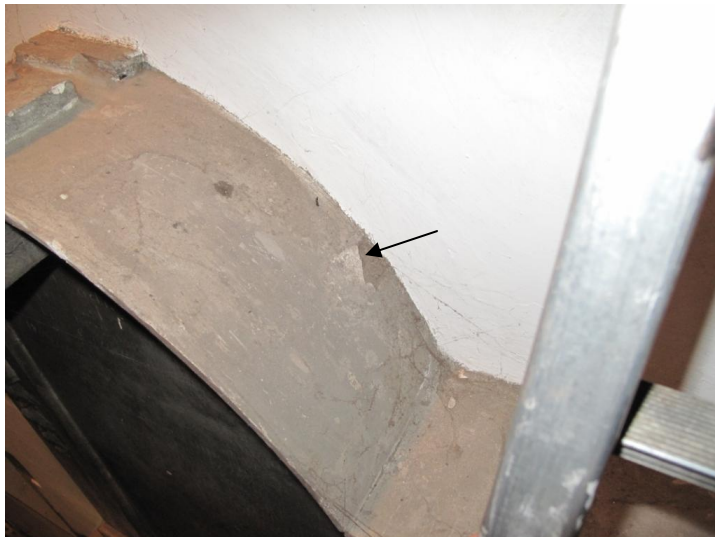
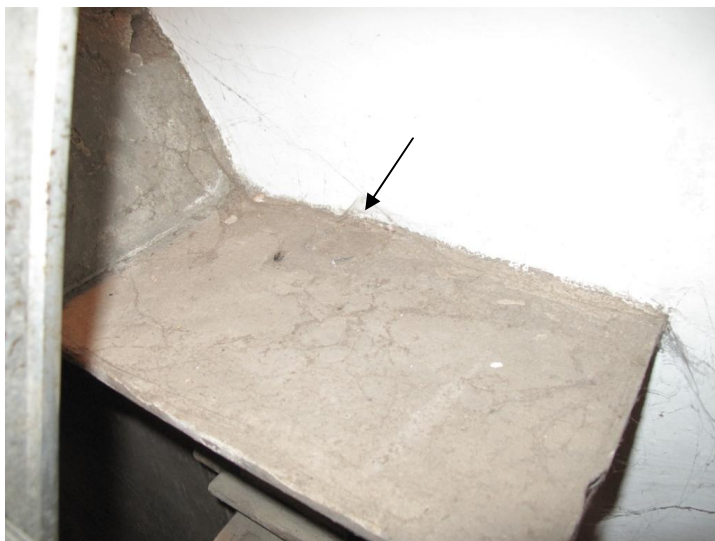
View looking down on the west side of the pediment.

The restraint of the monument is provided by metal cramps one shown buried in the surface as indicated in the photograph left and another buried as indicated in the photograph below.

It is likely that there are others cramps corresponding on the eastern side.

The monument was considered to be structurally stable but ongoing monitoring would be essential.

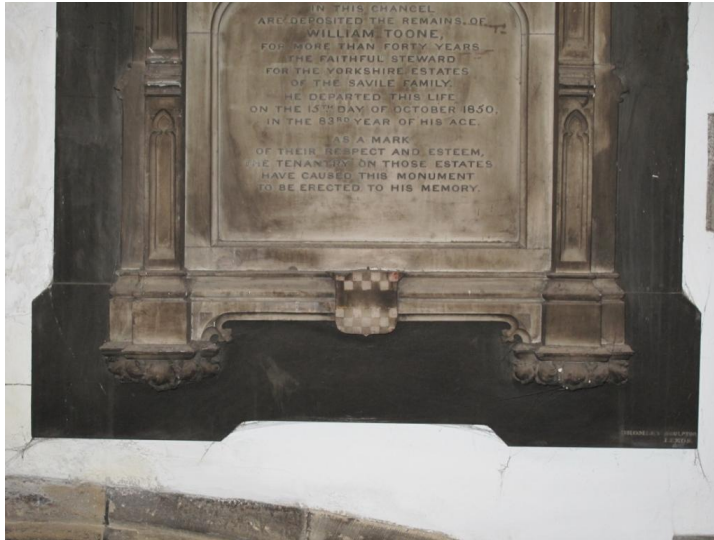
09/246

The surface of the white marble is very disfigured by dirt and deep staining particularly on the high points.

The inscription remains legible and appears as if some rudimentary cleaning has been carried out perhaps to make the lettering more legible.

The monument would benefit from cleaning as it is currently badly disfigured by heavy soiling.

On site tests would be required to ascertain the appropriate method and level of cleaning.

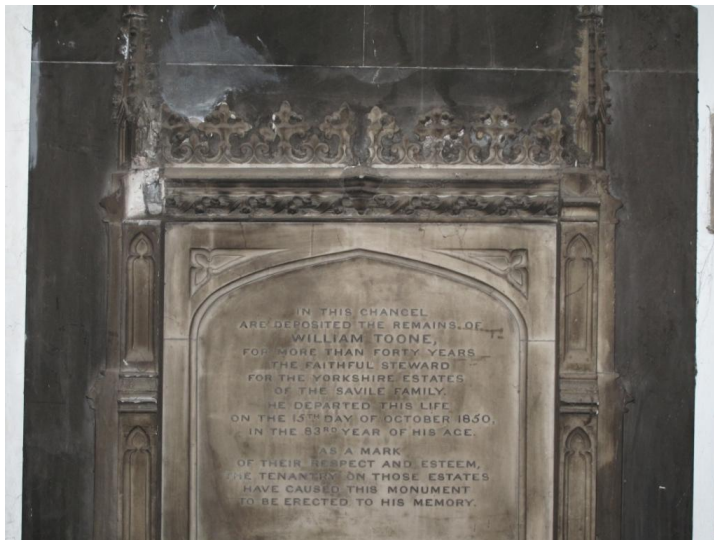
09/247

The entablature has sustained some loss and damage. The east pilaster capital is missing and several of the crockets have pieces missing.

There is also a white bloom on the surface of the black marble adjacent to the eastern spire which appears to be the consequence of plaster being smeared on the surface – perhaps the joint was re-pointed

and the bloom is the consequence of inadequate cleaning.

It is not necessary to replace the missing section of the pilaster but the embellishments should all be carefully checked and where found loose they should be fixed back to ensure their long term stability.

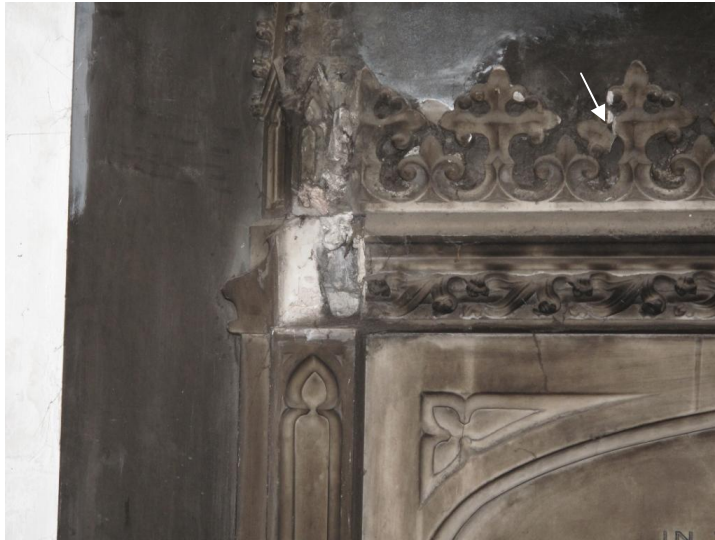
09/250

Detail of the missing eastern pilaster capital and damage to the crocket as indicated by the white arrow.

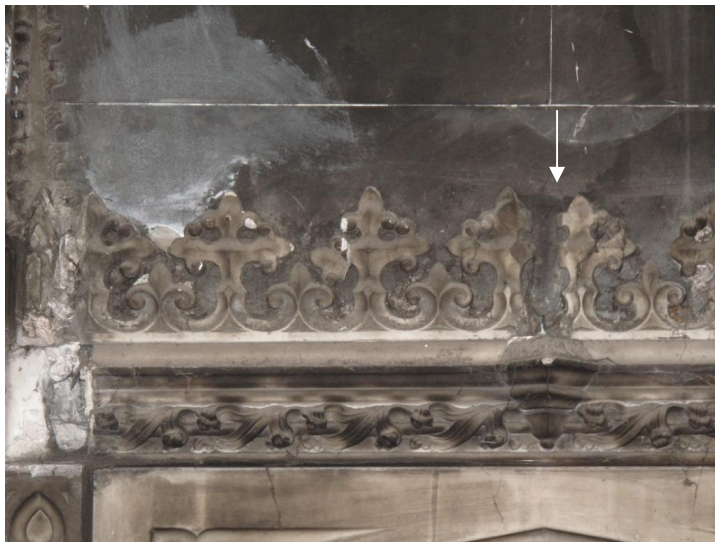
09/252

Detail of the crenulated top.

Is there perhaps a missing detail from the central location – both the east and west crockets are missing details that support this view and there is a halo remaining in the back ground that could be the outline of an emblem or cresting detail?

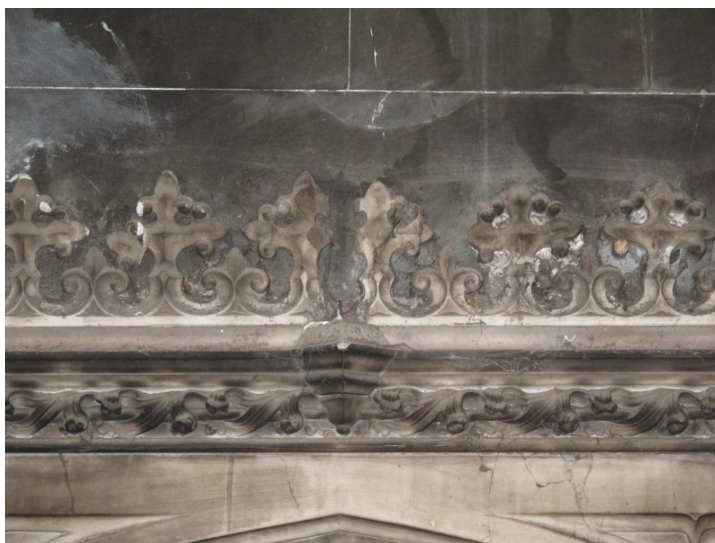
09/254

Detail of the central section showing the location of a possible missing carved detail.

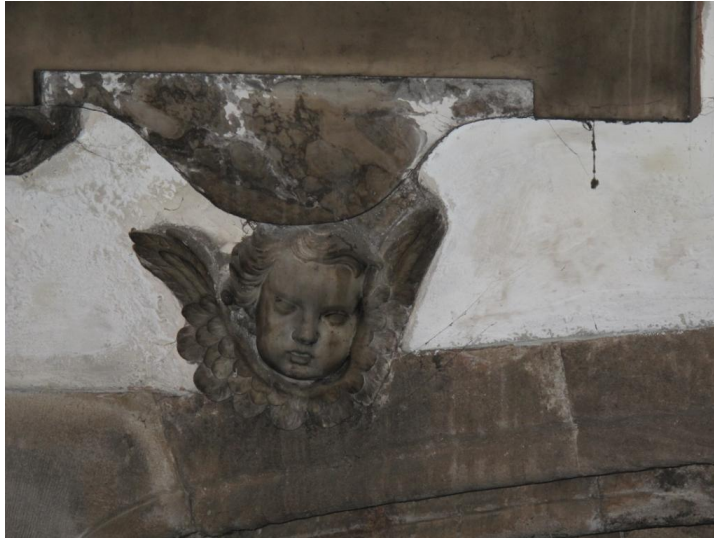
09/256

Detail of the cherub supporting the base of the memorial. The western wing is partially missing or cut away and the placing of the cherub sits somewhat uncomfortably within the design – is it perhaps not originally part of this monument? The surface of the marble is heavily discoloured with surface soiling.

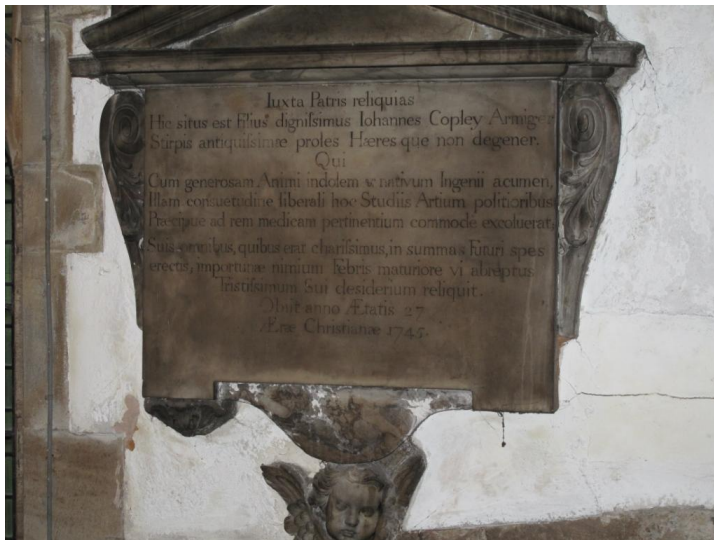
09/257

View of the inscription panel and surrounding elements.

The western corbel is missing and as shown in later photographs a ferrous bar is visible as the main support.

Note the intense deep red brown staining across the inscription panel.

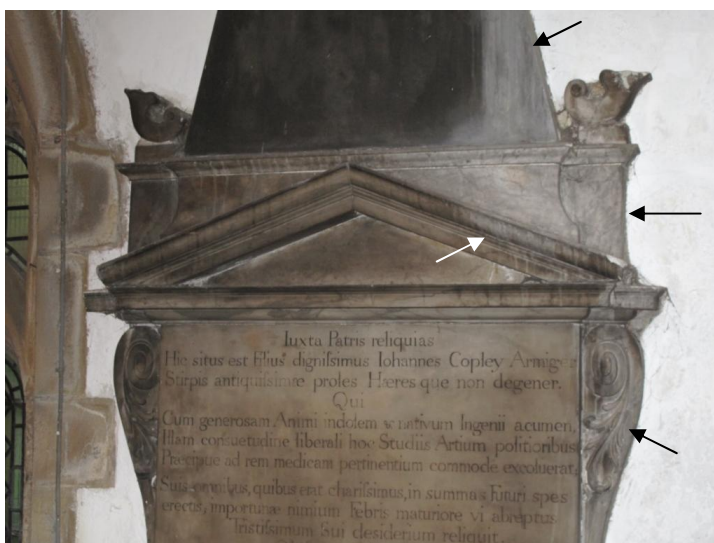
09/258

The monument has been subjected to water running across the surface most notably on the western side (black arrows). This has resulted in a markedly clean area and distinctive run marks across the moulding of the pediment cornice (white arrow). Compare this to comments made regarding the memorial immediately to the west of this one where water damage is also

noted.

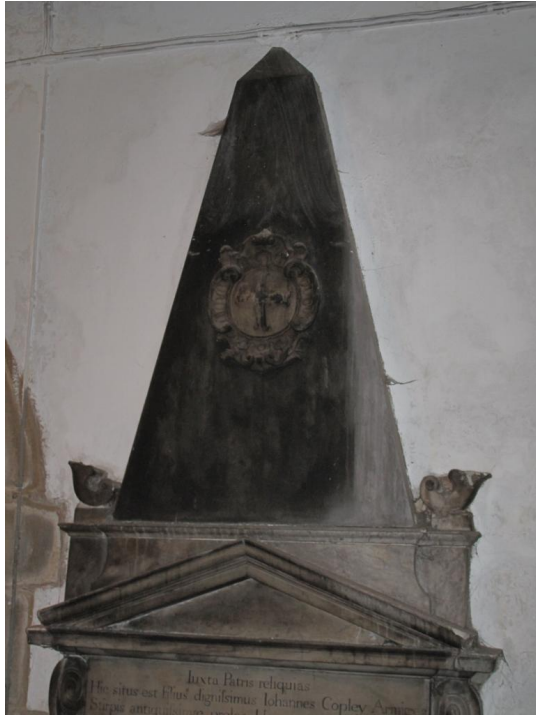
09/259

Detail of the upper sections of the monument showing clearly the impact of the water running across the surface.

The pale colour of the black marble is the consequence of the surface being etched. The intense black colouration comes by polishing and is easily lost.

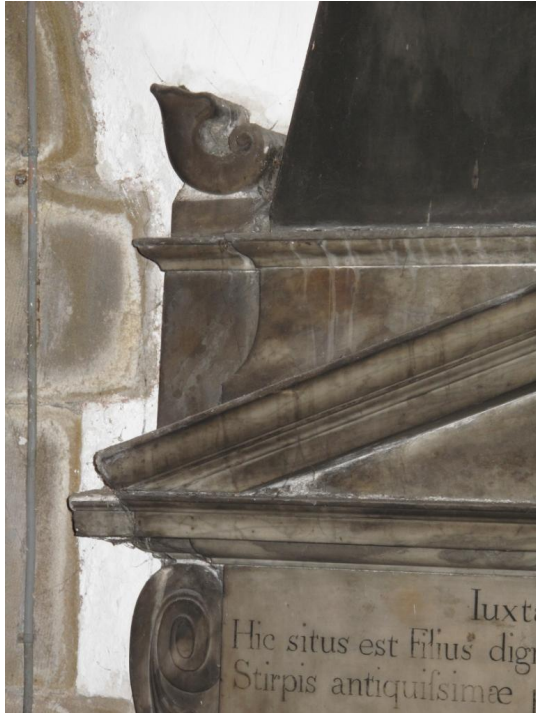
09/262

Detail of the east side horn with evidence of additional water runs across the surface at this point.

Note the heavy salt exfoliation on the stone work adjacent to the window. There is an ongoing issue of moisture and salts in the fabric of the building at this location.

The paint in this area should be checked to ascertain if it is permeable or whether it is exacerbating the passage of moisture into the stonework by being impervious.

The adjacent walls would benefit from more investigation to ascertain if the plaster is too impervious and whether the paint is also impervious. If this is the case there may be benefit to removing and replacing the wall finishes with breathable plaster and paint.

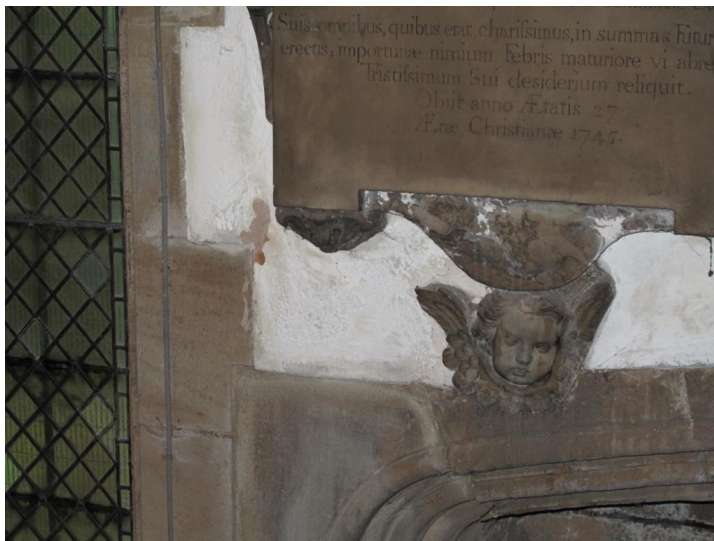
09/263

General view of the lower east side of the wall adjacent to the memorial: showing where the decorations are being disrupted by moisture and salts.

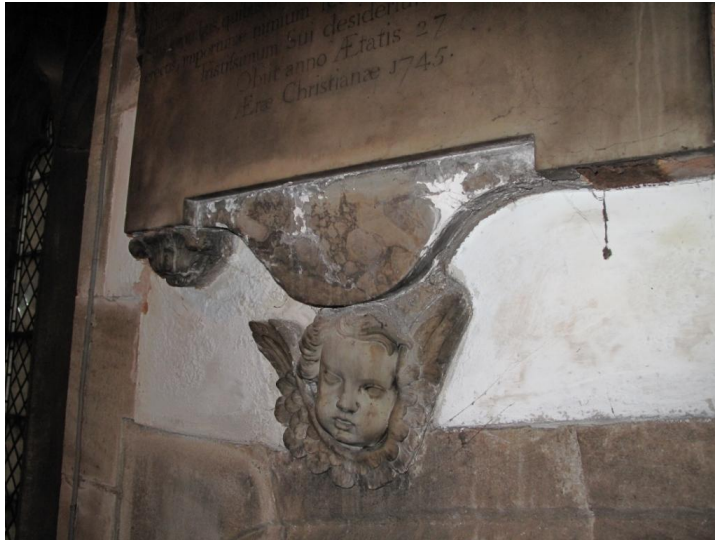
09/264

General view of the underside area adjacent to the east corbel showing where the latter is missing.

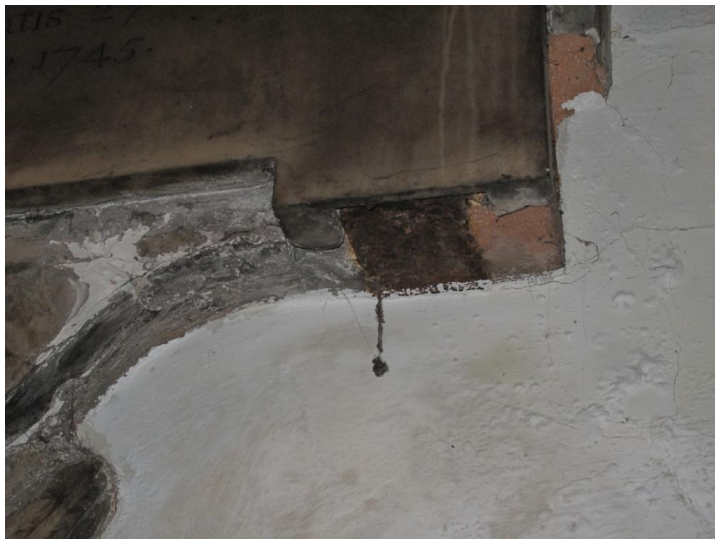
09/266

Detailed view of the structural metal bar set in the underside. It is likely that the marble corbels were never designed to be load bearing and may be surface mounted which would account for the loss of the western section.

The main supporting metal corbel that was visible at the time of survey appeared to remain in good condition although with surface corrosion it is not causing any stress from jacking at present. However the cramps located within the structure at higher level are obviously suffering and it is not possible to ascertain to what extent they have lost overall strength.

Even if dismantling is not to be undertaken in the short term cleaning would be highly recommended following on site tests carried out to ascertain the most appropriate method and the level of clean. The application of micro crystalline wax to the marble surfaces would be of great benefit. The exposed cramp should be treated to inhibit corrosion and consideration given to painting it.

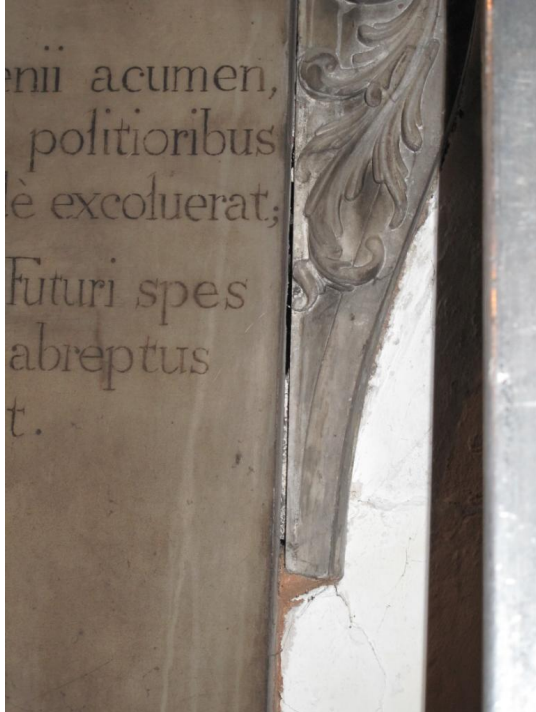
09/267

The joint between the inscription panel and the flanking bracket has apparently moved.

The movement in the joints is a concern as the memorial is located above a narrow passage much used during the life of the church and therefore the safety of the monument is paramount.

At the very least this monument must be monitored very closely and frequently to ascertain if any further movement occurs but preferably the monument should be dismantled and steps taken to introduce stainless steel fixings and to isolate it from the fabric of the wall by introducing a damp proof membrane.

If monitoring is the preferred option consideration should be given to checking and replacing all defective pointing to both prevent atmospheric moisture from easily affecting the buried metal and to aid in monitoring for future movement: the recurrence of cracking in the joints would be an easy visual indication of further movement.

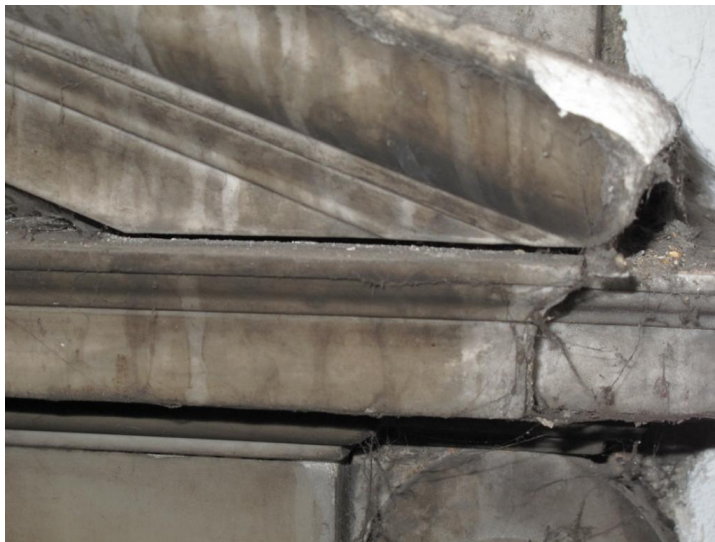
09/268

The cornice on the west side has been jacked upwards by the corrosion of an internal metal cramp.

Note also the impact damage to the edge of the cornice – this is also visible in the previous photographs.

The cramps on the eastern side have corroded and are jacking the stones apart.

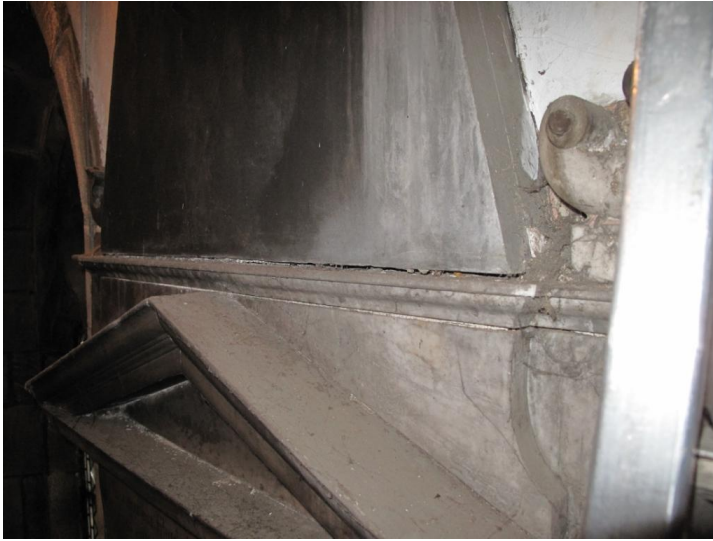
09/274

The western side of the obelisk is lifting due to the jacking from an internal ferrous fixing.
