## **Monument # 5 Thomas Radcliffe Armigeri † ?**

### **The Works**

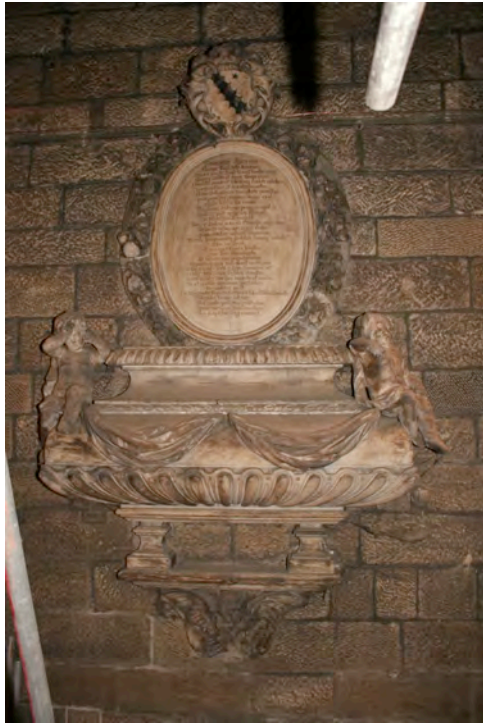
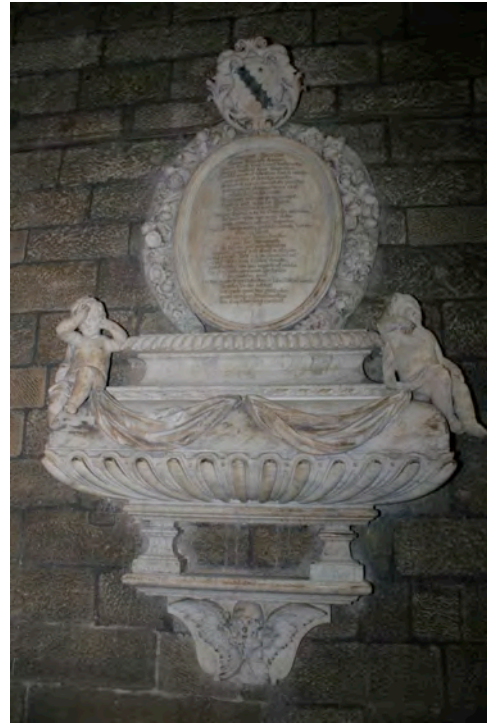
General views of the monument before and after all treatments, note the overall brown cast to the monument before commencing work and how the delicate foliate border around the inscription panel is completely lost.

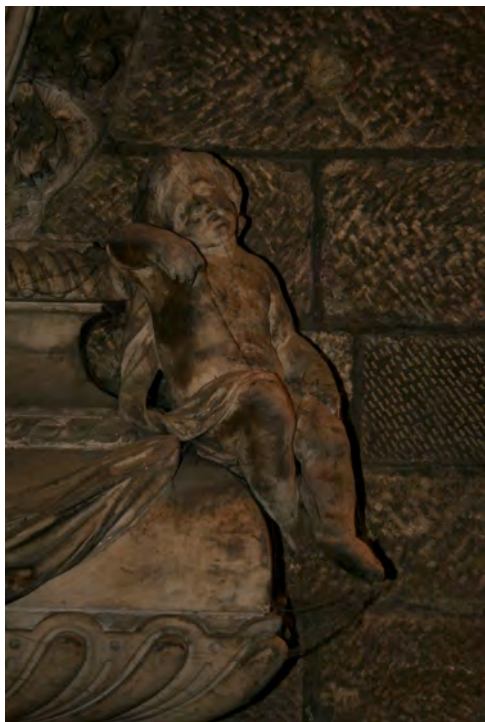
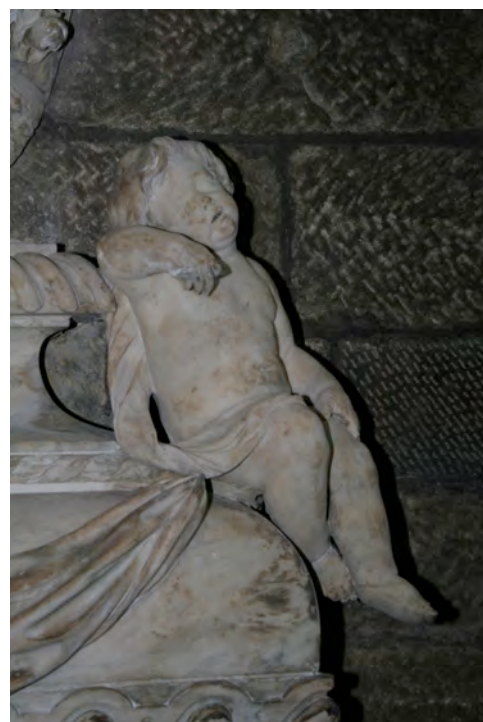
- 4.4 During the cleaning process a brown accretion/coating became apparent as it was not responding to any of the cleaning processes, including the mildly abrasive Solvol Autosol. The coating was quite thick and brittle and had the appearance of shellac under magnification. Where it was not well adhered to the substrate, very small areas could be removed with the steam cleaner, but at the risk of playing the steam over the surface too long, such that it starts to look over-clean. The fact that the material did not respond to any of the cleaning techniques or materials would indicate it was shellac that had fully cross-linked making it insoluble now.

General view of the right-hand cherub before and after treatment, note the residual brown marking which did not respond to any of the different treatments. Unfortunately this contrast is now enhanced due to the success of cleaning over the remainder of the monument.

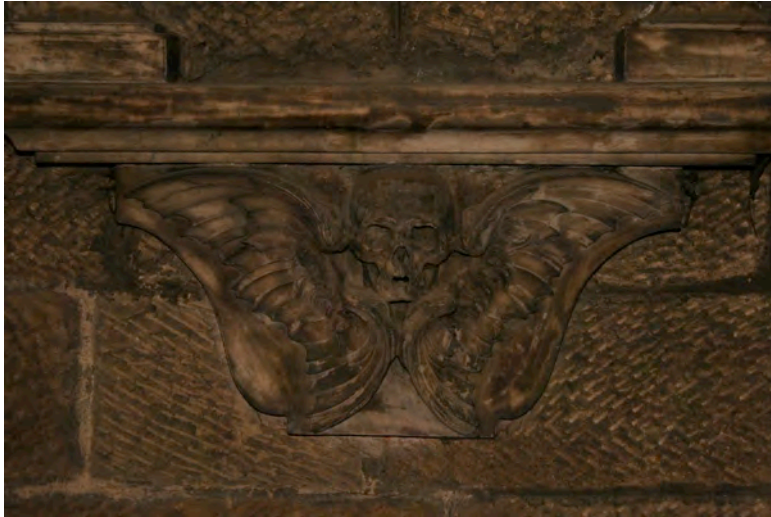
The winged skull before any treatments, note how the detail on this particularly fine carving is lost. Note also the extent of the brown coating to the moulding immediately above.

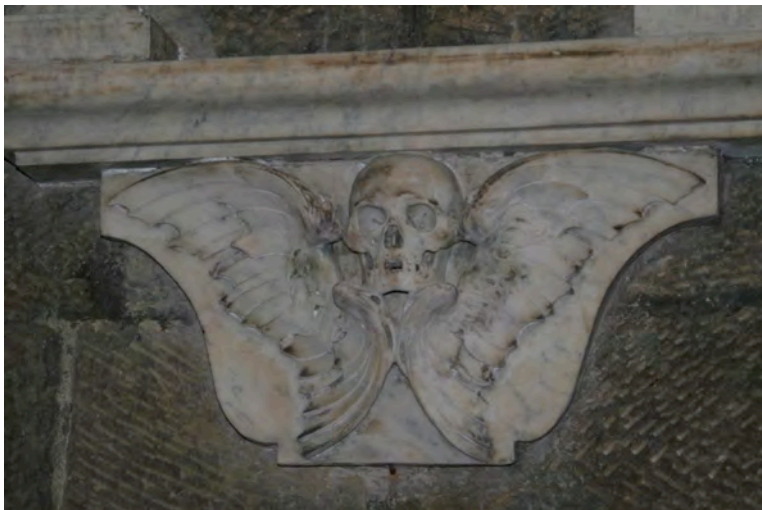
- 4.6 The winged skull did respond well to the different cleaning techniques but residual remains can be seen on the wing tips and proper right side of the skull.

After all treatments, note the fine, dark-grey veining in the marble is visible once again. The heavy brown coating has largely gone from the moulding above, with only tenacious remains.

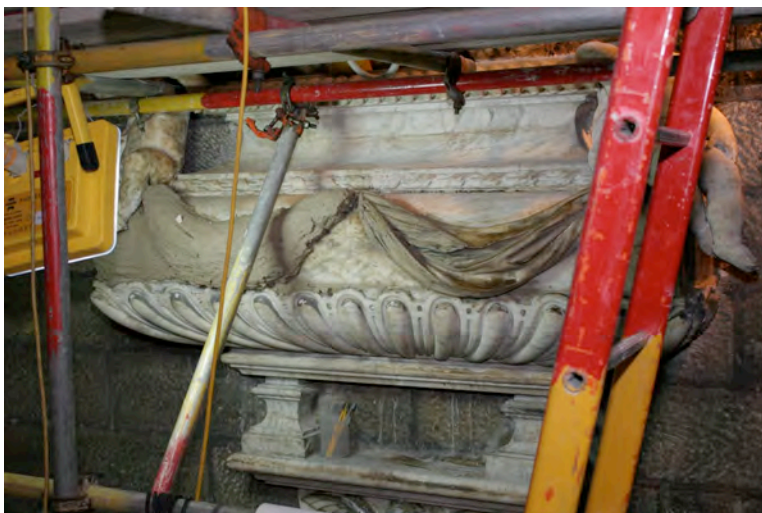
Context view showing the Sepiolite clay in place, on the left-hand swag having just been removed from the right. Once the poultice was removed completely, the areas were steam-cleaned to reduce the softened dirt.

- 4.3 The whole monument was degreased with acetone applied on cotton wool pads which removed much of the greasy accretion. All elements, excluding the inscription were then cleaned with a poultice of Sepiolite clay mixed with clean water, left for at least twenty-four hours and over the course of a weekend for areas where dirt was anticipated as being stubborn. Upon removal of the poultice the softened dirt was reduced/removed with low-pressure steam (a dental descaler). Areas of carving were cleaned further with 'Solvol Autosol' applied on tooth-brushes to restore some of the lustre to the marble and slow down soiling on these slightly rougher areas that had not been finished in the same manner as the plain moulded elements.

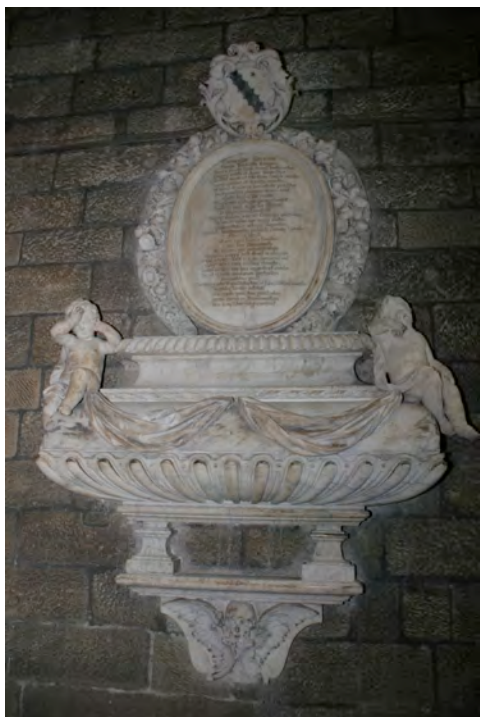
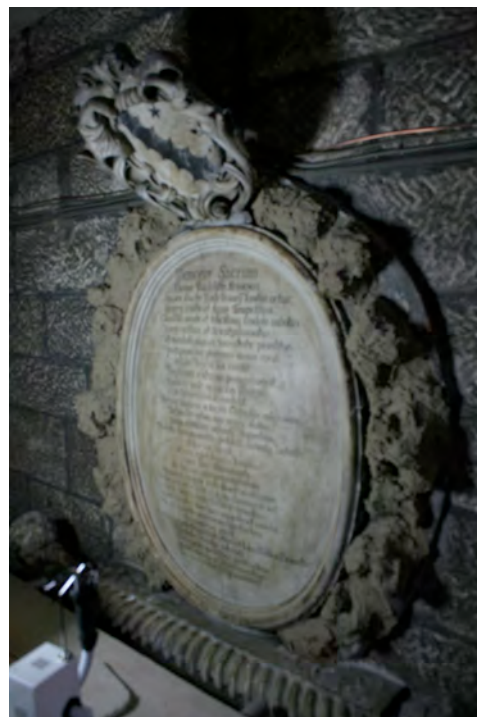
General view of the whole monument and the foliate border during poulticing. This was required twice on those areas carved in the round, due to the inability to 'finish' them in the same manner as flat/moulded marble, with the marble being rougher in texture, on a microscopic level. The steam cleaner used is in the foreground. Note despite the angle of the top shield it is held firmly by solid fixings and entry pinto the walling and marble respectively.

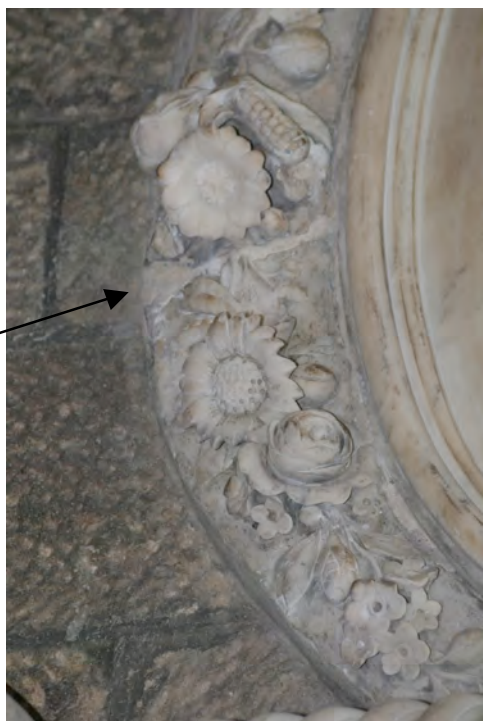
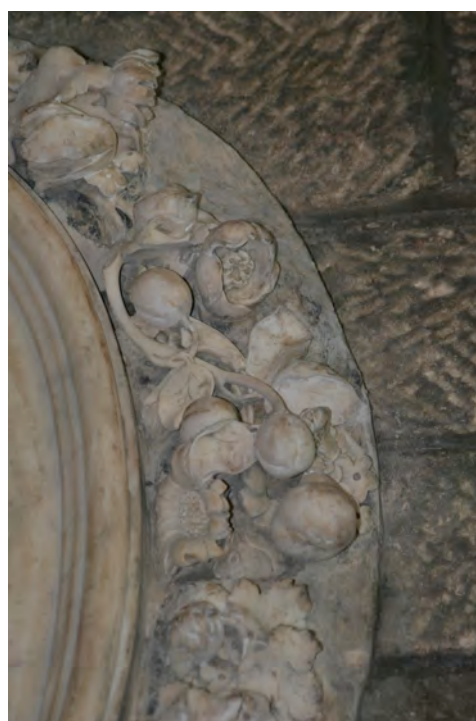
- 3.2 All individual elements were very solid, with no signs of resonance when banged with a clenched fist. Both sides of the foliate swags appear to have been damaged historically and joined together crudely, evidenced by stepped joints and misalignment. Despite this, all the individual elements were sound and displayed no signs of movement either historic or progressive. The angled heraldic shield which looked alarming from floor level is very solid, having been secured with molten lead into the ashlar and the rear of the marble and is likely to be canted over at such an angle to allow viewing from ground level. There were no signs of separation to either entry points. What little surface corrosion was present on the substantial iron-fixing was treated to prevent progressive deterioration.

Close up views of the level of detail to the foliate border, which could not be appreciated before cleaning. The carving is well executed with several of the stems pierced completely, highlighting the skill and care of the carver. Note one of the joints mentioned in the report which have all been rather crudely re-joined despite being solid.
