## **Monument # 6 John Pollard † 1737 & Elizabeth Pollard † 1736**

### **The Works**

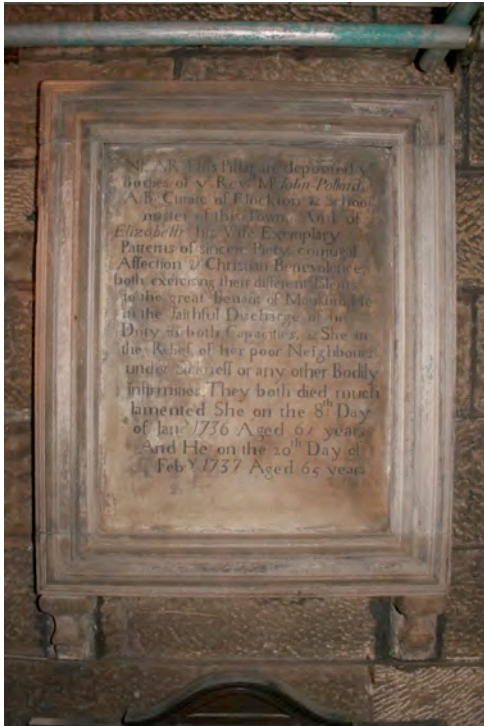
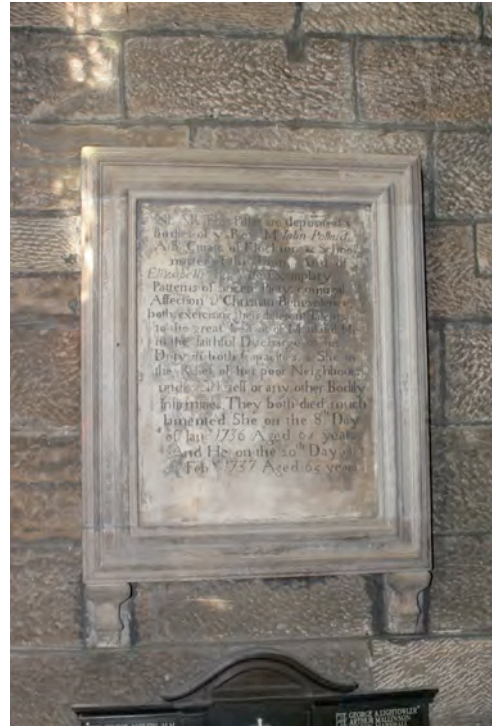
General views of the monument before and after conservation, showing the subtle level of cleaning achieved. Note the after image on the right was taken early afternoon with diffuse sunlight visible above, which later goes on to bath the inscription in direct sunlight. This will have had a negative impact on the surface over a prolonged period, with repeated heating/cooling cycles affecting the painted surfaces and possibly the reason why the stone was painted originally.

- 4.5 The different cleaning techniques were successful in removing as much surface dirt as possible without saturating the stone unnecessarily or compromising the fragmentary painted remains.

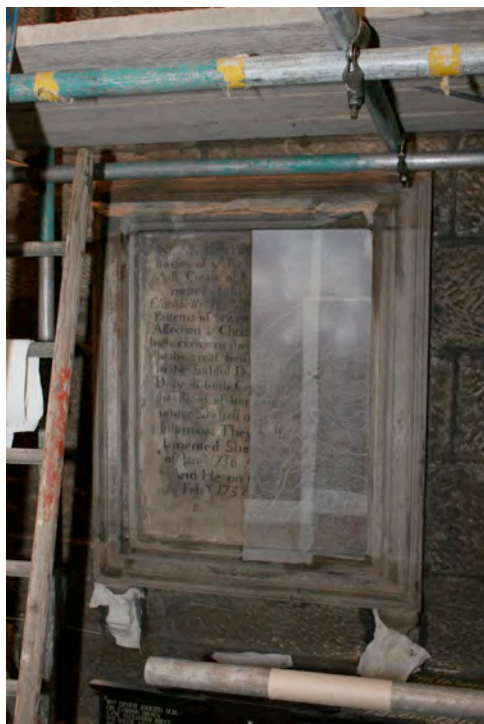
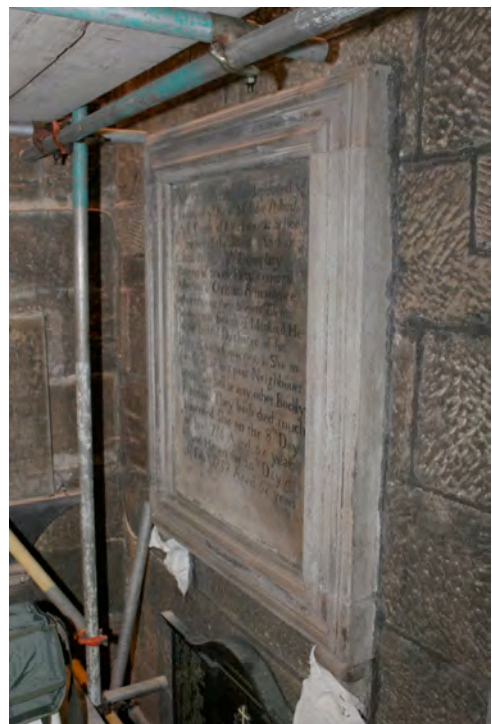
The left-hand image showing paper towelling in place, dampened with the cleaning solution, which keeps it at the surface, rather than saturating the stonework. The right-hand image shows the level of cleanliness achieved on the moulded border, with just the corbels left to clean.

- 4.3 Detailed vacuuming removed much of the accumulated dirt/debris from the coarse-grained, pore structure of the sandstone.
- 4.4 Due to the historic deterioration of the sandstone and loss of case hardened original upper surface, low-pressure steam cleaning was discounted so as not to adversely affect the stone further. As the dirt was slightly greasy it was decided to use a 1% v/v solution of de-ionised water and Synperonic A7 (a non-ionic surfactant). This was applied by soft stencil brushes using two beakers, one for soiled water and one kept clean, so as not to re-distribute dirty water. The inscription panel was cleaned by painting on the same solution to un-bleached paper towelling on the surface, to keep the active ingredient in contact with the delicate surface but not to saturate the stone where the substrate was visible, therefore keeping water to a minimum. Small sections were peeled back and the revealed area cleaned with larger, softer bristle bristles, with the paper towelling collecting the soiled run-off.

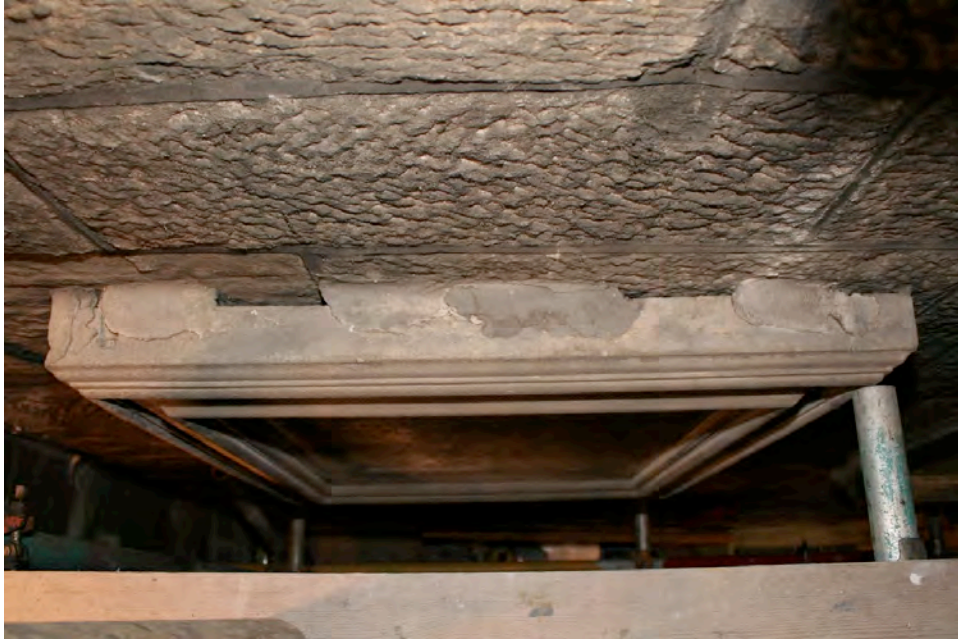
- 3.2 All architectural sections were solid with no signs of movement and or separation. Restraint fixings in the top bed were obscured by mortar, which was in a sound condition. It was assumed the fixings will be made from iron and there were no signs of iron staining in the aged but sound mortar, indicating that they were also in a sound condition. There was slight resonance in the inscription panel when banged with a clenched fist, although this is well held within the moulded border.

The top bed of the monument showing the location of restraint fixings securing the top moulded element to the wall. Note the small air gap between the tooled walling and the rear surface of the moulding, which will have prevented penetrating moisture transferring into the inscription panel. Note there were no signs of iron staining or corrosion jacking from beneath the mortar so it was left.

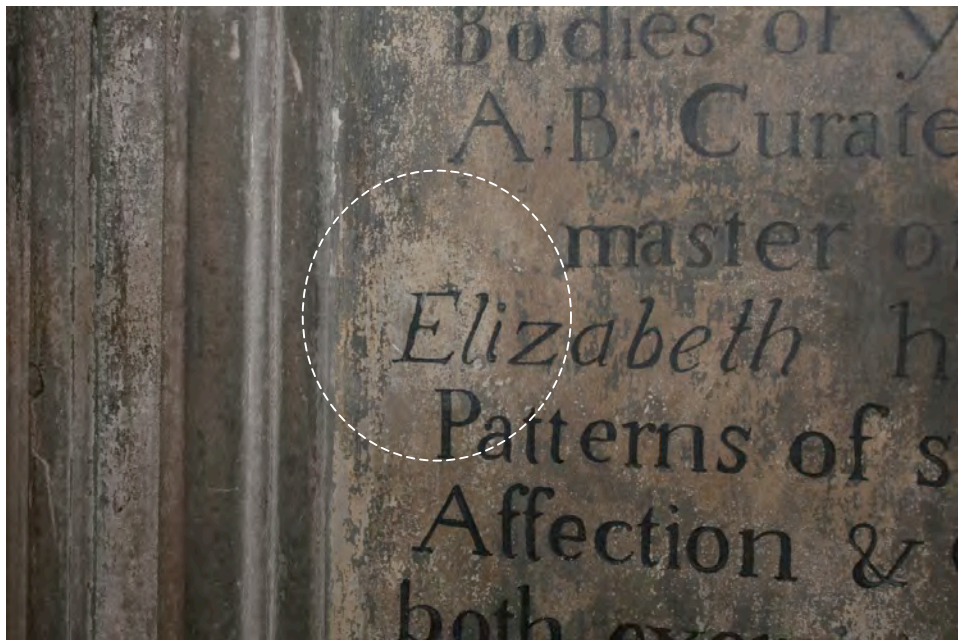
- 3.5 The inscription panel has been painted historically, probably to give the appearance of a more expensive material. Approximately 40 - 50% of that applied coating has been lost and what remains is stable and well adhered to the substrate. This would indicate the inscription has been re-painted at some point to make it more legible, although the materials did not appear to be modern when viewed under magnification.

Detail after a cleaning trial to the inscription panel, with the area highlighted illustrating the subtle level of cleaning achievable, without disrupting the painted flatwork or the inscription.

- 4.1 All elements underwent a preliminary dry clean with a vacuum cleaner to remove the heavy layers of dust especially from the top bed.
- 4.2 A series of cleaning and solubility trials were conducted on representative areas of the painted and un-painted surfaces, which were found to be non-fugative and non-soluble indicating an oil based material as opposed to a lime-based distemper or similar.
