**Monument # 7**  
**Reverend John Michell † 1793 & his brother Gilbert Michell † 1792**

## **The Works**

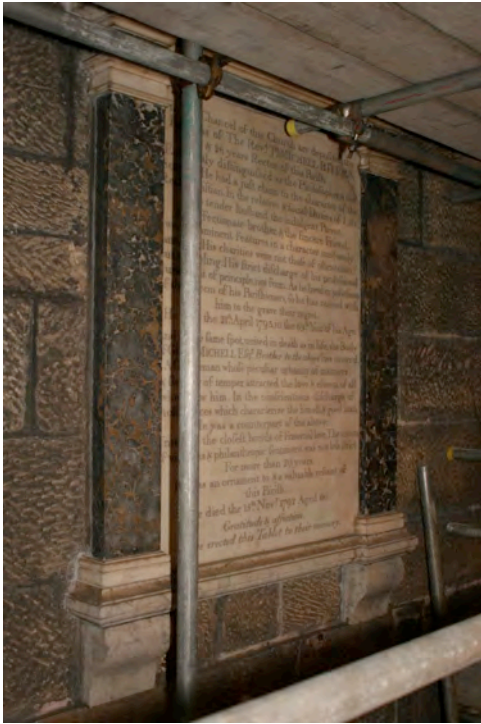
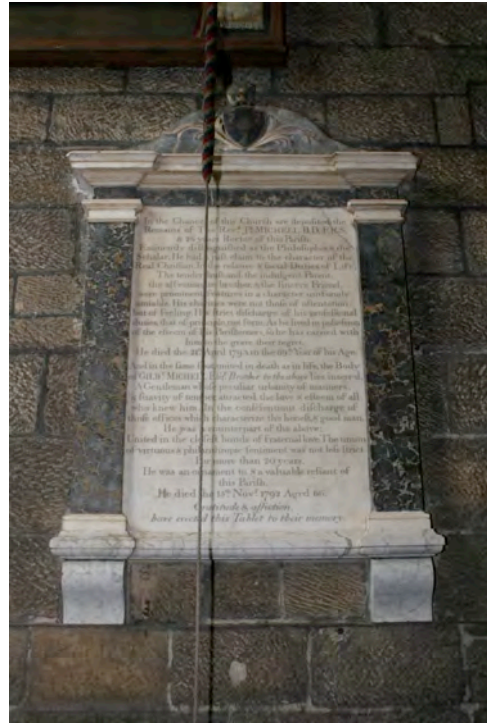
General view before and after treatment, note again the brown cast to the light coloured marble on the left-hand 'before' image and the marble looks fresher after cleaning.

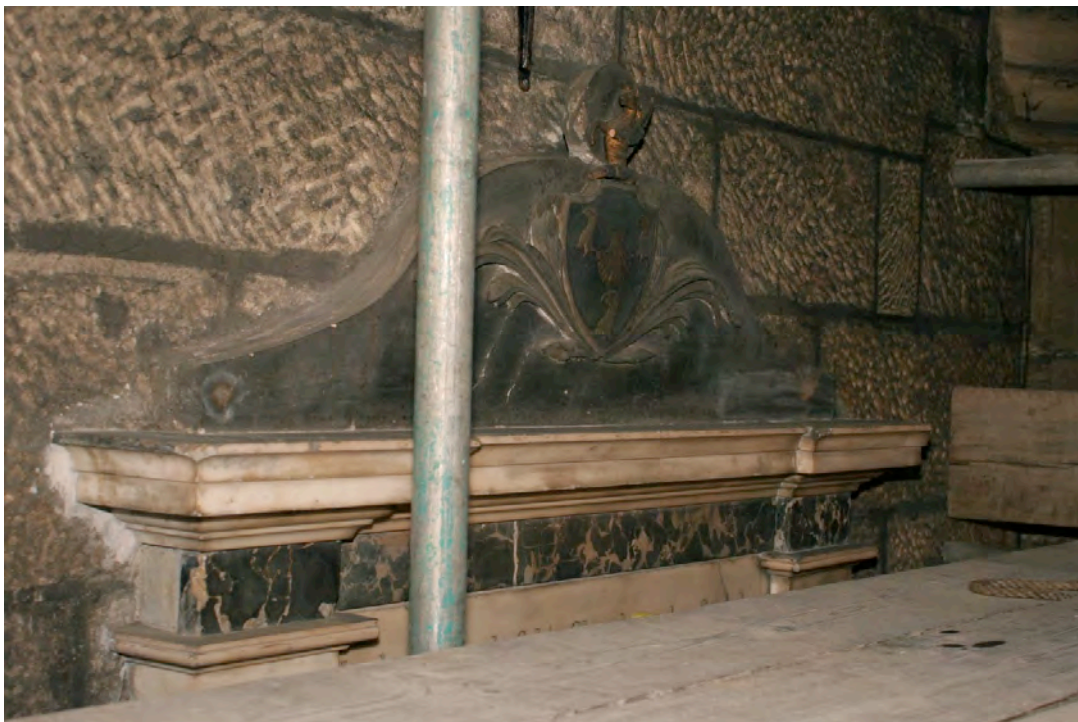
- 5.3 Despite the poor condition of the black/ochre coloured marble there were no signs of significant textural breakdown, more micro-fissuring along mineral veins. Injecting a consolidant would have done nothing to arrest this and may have been counter-productive. Efforts were made to keep moisture away from these elements as the raised areas indicate swelling, caused by repeated heating/cooling cycles over many years, possibly from a clay component in the marble.

Detail of the pediment and cornice before treatments, note the curvilinear pediment looks like a dark-grey carboniferous limestone but is in fact a heavily veined marble the same as the pilasters. Note also the heraldic representation of the horse is completely lost despite being gilded. Despite looking attractive, the frieze highlights the weak nature of this 'metamorphic' rock with a poor (large) crystalline structure having cooled quickly when formed originally.

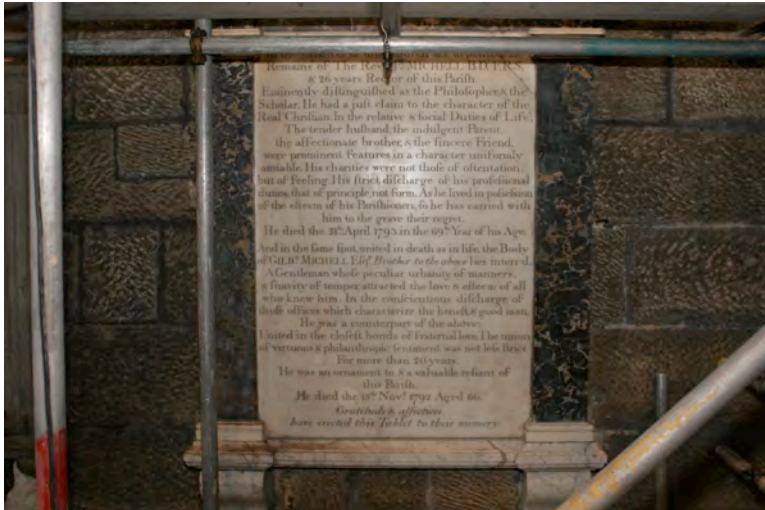
A cleaning contrast to the inscription panel, with the right-hand side having been cleaned from top to bottom.

- 4.3 The whole monument was degreased with acetone applied on cotton wool pads. The pediment, cornice and skyface of the bottom horizontal moulding were poulticed with a single application of the sepiolite clay, with a dwell time of twenty-four hours. Although out of sequence, the poultice areas were steam cleaned to remove the softened dirt. The pilaster caps and corbels were relatively clean and only required cleaning with the Solvol to achieve a comparable level of cleanliness. The incised inscription was cleaned with the V & A solution (white spirit: de-ionised water 50 : 50 with 1% Synperonic A7 applied on large cotton wool swabs to avoid affecting the paint remains in the inscription.

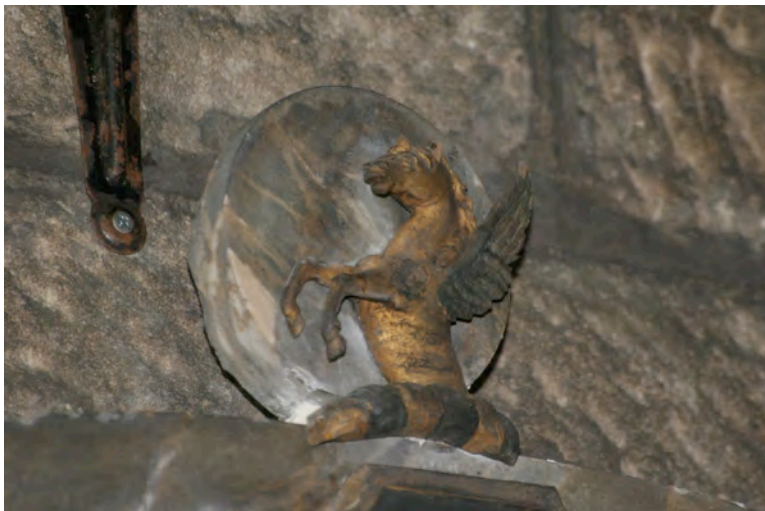
Detail of the winged horse and disc of marble behind, both having been removed, cleaned and re-secured.

- 5.1 The winged horse and background panel were re-bedded utilising the original copper dowel on a bed of casting plaster. Excess material was struck off when the material was 'green'.

- 5.2 The vulnerable left fore-leg of the prancing horse had detached and was discovered on the top bed of the cornice. It was re-attached successfully using a single brush application of a 10%w/v solution of Paraloid B72 in Acetone : I.M.S 50 : 50 on both sides of the break.

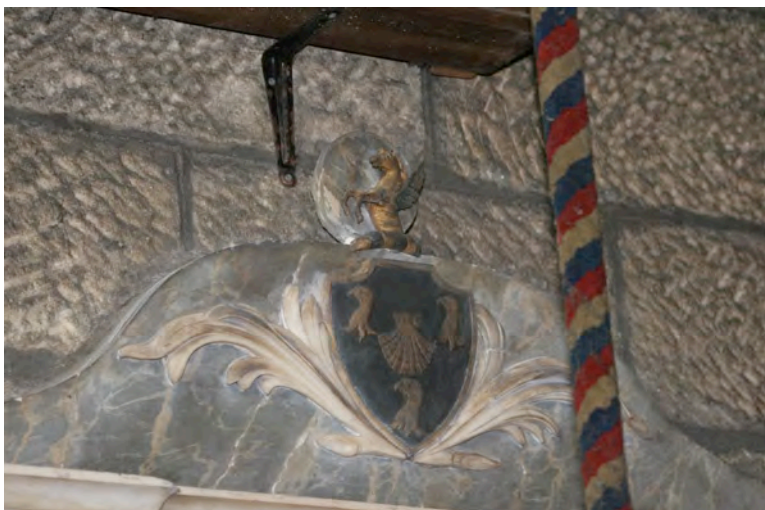
Context view of the pediment, note the veining is visible in the pediment once again, although the surface polish has long since gone, again possibly due to direct sunlight playing over the surfaces, with heating/cooling cycles setting up surface condensation over a prolonged period of time. This is a clearly a decorative marble and not that robust evidenced by the pilasters.
