Monument # 8 William Elmsall † 1817

The Works

A wall monument that is sunken beneath surrounding plaster. The monument was cleaned using a combination of solvents, Solvol Autosol, Sepiolite clay and steam.

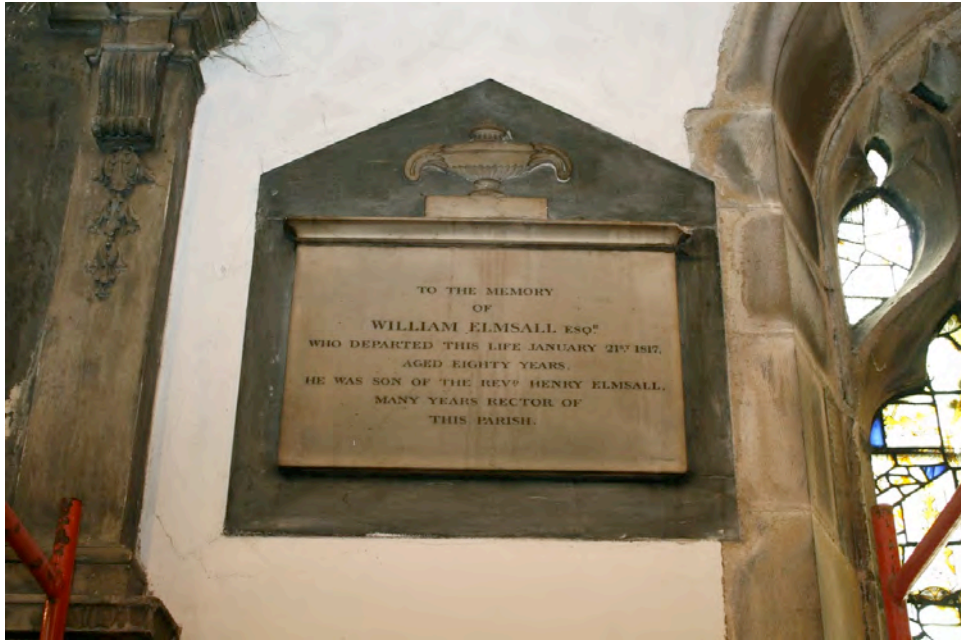
General view of the monument before treatments, note how the inscription panel in particular looks uniformly dirty.

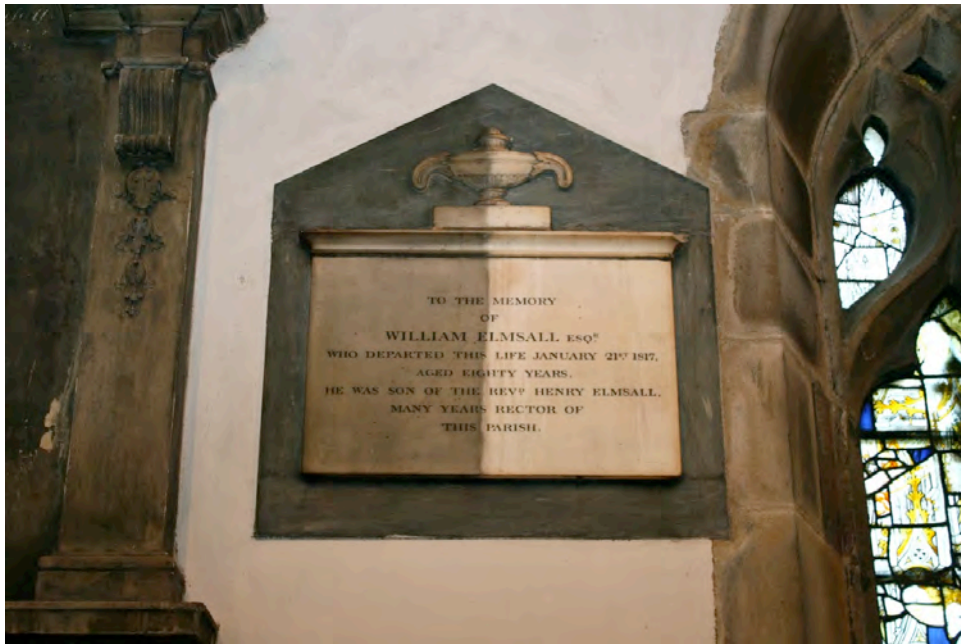
- 3.5 After cleaning, vertical marking became more apparent over the surface of the inscription panel. The inscription panel in general, and the upper arriss of the cornice in particular, display a residual brown cast that did not respond even to poulticing. This may be linked to the monuments close proximity with the old solid fuel heater which I understand was located in the recess in the south elevation of the south aisle many years ago. Airbourne contaminants from this mixed with surface condensation, would certainly produce this kind of deep-seated staining over a prolonged period.

A cleaning contrast with signs of vertical water marking visible on the cleaned part of the inscription panel now.

- 4.3 The whole monument was degreased with acetone applied on cotton wool pads. All elements were then cleaned with 'Solvol Autosol' applied by a mixture of soft stencil brushes and cotton wool pads, neutralised immediately with white spirit. Any residues in the carving was removed with the aid of a vacuum cleaner and stiff bristle brush, followed by cotton wool swabs dampened with white spirit. After preliminary cleaning, the carved urn was observed to be unacceptably dirty still, due largely to the poor finishing of the surface, having trapped dirt within the pore structure.

- 4.4 A single poultice of Sepiolite clay was applied and left for a period of twenty-four hours to soften the dirt, this allowed successful removal of residual dirt with a low-pressure steam cleaner.
