Monument # 10 William Toone (Steward to the Savile Family) † 1850

The Works

A wall mounted monument, comprising of white and light-grey marbles (and sandstone backing panel), with black paint to the inscription panel, with black and red paint to the shield. The monument was cleaned using a combination of solvents, Solvol Autosol, Sepiolite clay and steam.

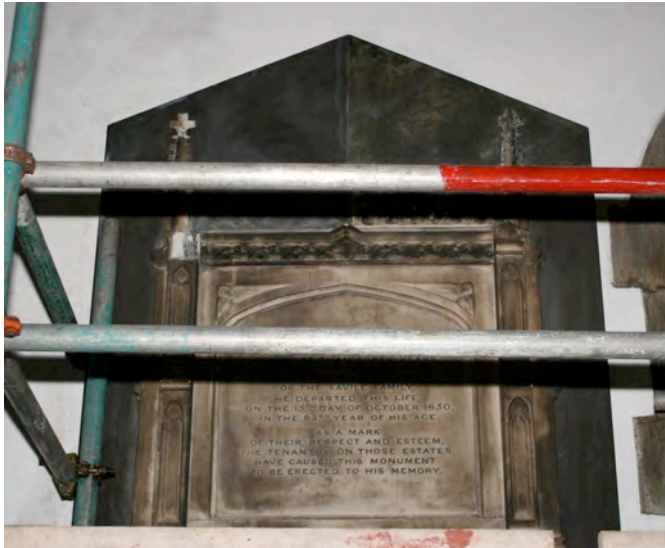
General view of the monument before any treatments. This monument is difficult to photograph in free space. Note how dirty the background marble is and appears to be a dark-grey material. Note the monument is situated immediately above the recess which is believed to have had a solid fuel stove within it historically.

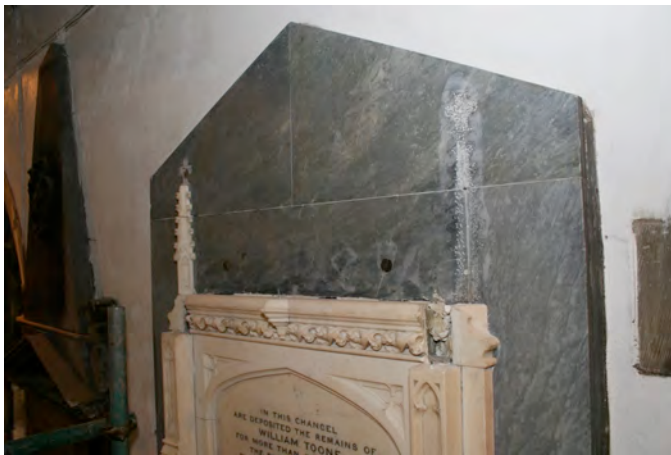
- 3.3 There is very minor resonance over the whole of the monument, except the left-hand side adjacent to the unstable 'Armiger' monument.
- 3.4 The pierced bratishing was all loose upon close inspection, albeit secured on small diameter copper dowels. Both pinnacle tops and the right-hand pilaster top were also loose. All these elements were removed and re-secured after cleaning was completed.

The background panel after cleaning with the loose pinnacle and bratishing removed for cleaning and re-attaching properly. Note the veining to the background marble is visible once again.

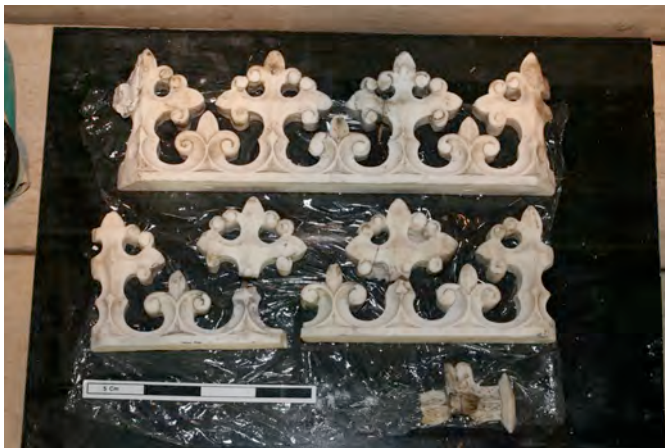
- 3.5 The delicate bratishing displayed a number of fractures and historic repairs, which had been repaired crudely in the past. Two of the terminations had fractured and been stuck back on with a combination of shellac and gypsum plaster.

The loose bratishing sections after cleaning and before re-joining broken sections, prior to re-fixing. The bratishing was re-fixed with Polyfilla.

- 5.1 The bratishing was repaired using existing holes and 3mm diameter threaded stainless-steel dowelling where possible. The aged marble was too thin to risk drilling new holes no matter how small, for fear of shattering the break edges. The areas of corresponding background marble that had been keyed to receive them previously were cleaned to remove all aged plaster and so provide a better key. The repaired elements were then re-adhered to the monument successfully, using 'Polyfilla'

- 5.2 The resulting joint lines were pointed with a mortar designed to be softer than the host material. This was a mixture of 'Tetrion' filler (a proprietary, cellulose based material) mixed with powdered, gilders whiting (calcium carbonate) in the ratio of 3 : 1. This material has the advantage of being reversible. Lime mortars employed on a non-permeable material (alabaster) often fail or do not achieve their anticipated strength due to their thin width and depth and can end up falling out in our experience.

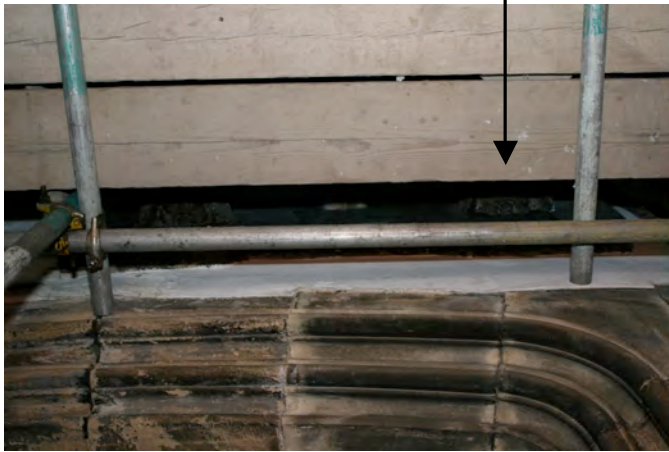
General view of the underside of the monument from floor level, before cleaning. Despite being in shadow, the foliated right-hand corbel is black. Note the levels of soiling to the moulding voussoir of the arch beneath.

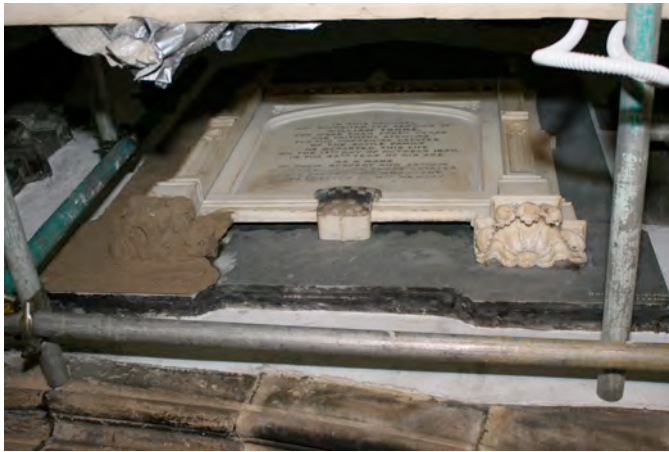
A similar view with the boards peeled back. The right corbel is clean but still displays a brown cast. The left corbel and flat background are covered with the poultice prior to removal.

- 4.3 The whole monument was degreased with acetone applied on cotton wool pads which removed much surface dirt. All elements were then poulticed (in sections) with a single application of Sepiolite clay, left for a dwell time of twenty-four hours. This softened a distinct layer of dirt and made its removal relatively easy with the steam cleaner. Once dry all areas were cleaned further with 'Solvol Autosol' applied by a mixture of stencil brushes and cotton wool pads, neutralised immediately with white spirit. This was successful in returning some lustre back to the grey marble. The loose bratishing was all carefully removed to allow ease of poulticing and the same process applied, before re-fixing.

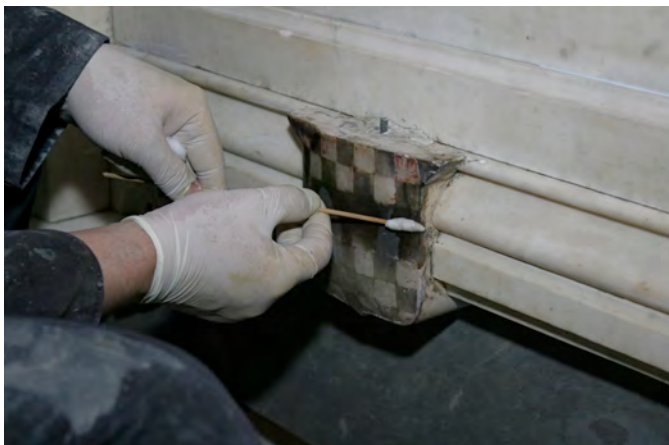
Cleaning the shield at the bottom of the monument, without disrupting the paint beneath.

- 4.4 The painted surfaces of the heraldic shield were cleaned using cotton wool swabs dampened with de-ionised water, which were rolled over the surface to pick up dirt. This avoided disrupting the paint layer, which was not fugative, and negating the need for surface consolidation.
