**St Michael & All Angels Church, Thornhill.  
Conservation report on the internal monuments**

**The basis of the report and an analysis of the general  
environmental conditions of the church.**

**Prepared for:  
Thornhill Parish Church Council  
June 2010**

**By  
MARTIN HOLDEN  
SCULPTURE AND ARCHITECTURAL CONSERVATION SERVICES  
Dalshangan  
Carsphairn  
Dalry  
DG7 3SZ**

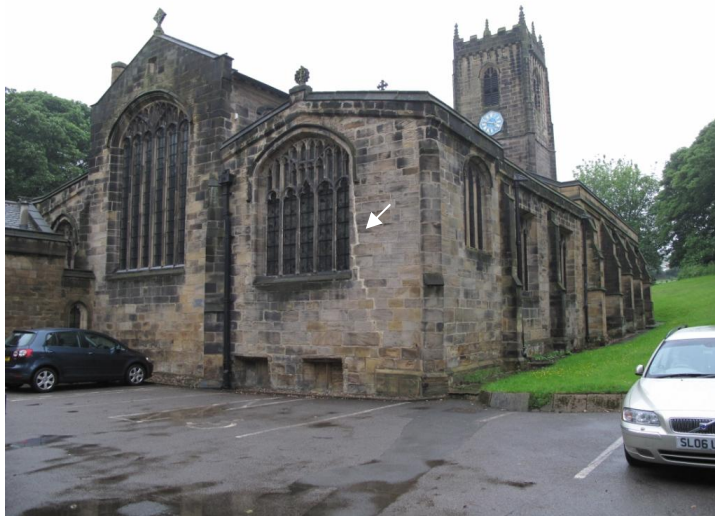
09/329

*North east corner of the church.*

In this view it can be seen that there has been movement in the wall: Indicated by the fresh lime pointing in the settlement joint running vertically adjacent to the north jamb of the east window of the Savile chapel (white arrow).

It is not known when the pointing was carried out but there was no sign of further movement within this joint.

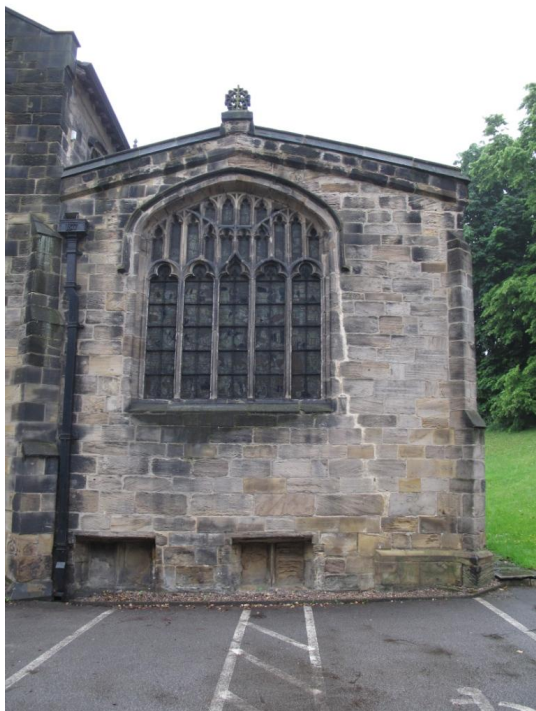
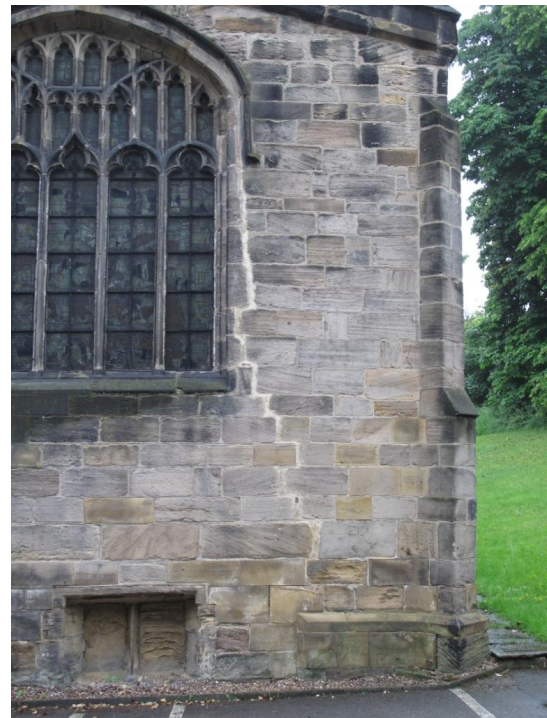
There is evidence of the settlement also on the north elevation of the Savile chapel wall.

Brief discussion with the church structural engineer indicates that the settlement is not considered to be an ongoing major concern. This comment will need to be reviewed following issue of the engineer's full report.

The blocked up windows would indicate that previously there existed a crypt to the Savile Chapel.

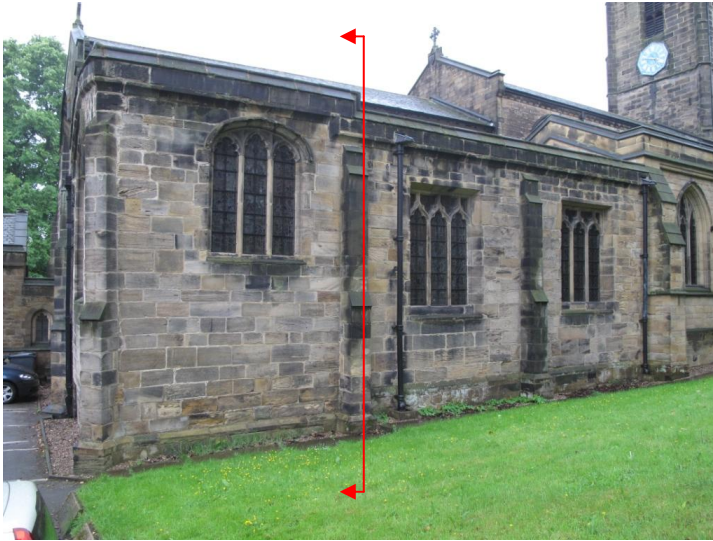
09/330

*North elevation of the Savile chapel.*

The eastern bay (indicated by the arrows), is an addition dating from about 1490, while the two western bays, (corresponding to the two square headed windows), date from about 1445.

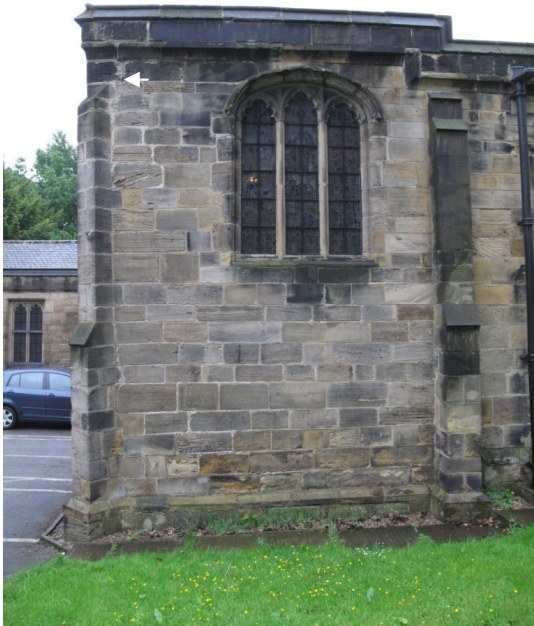
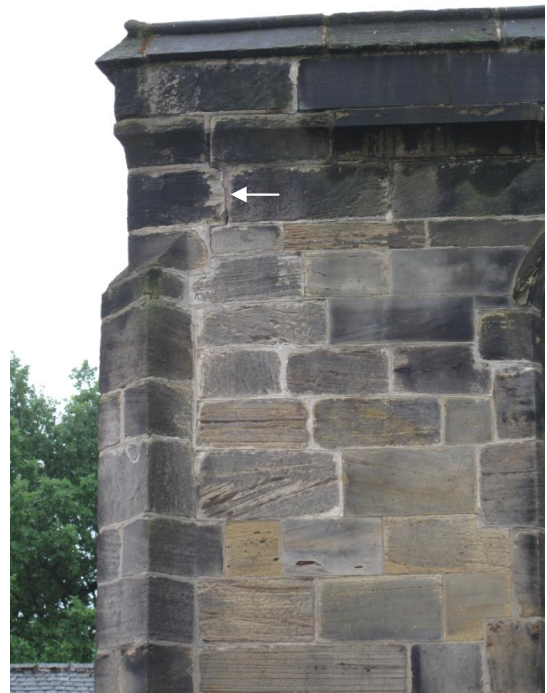
It appears that some relatively recent pointing has been carried out on this elevation but the upper east section has either subsequently moved or was not properly repaired as there are open joints as indicated by the white arrows.

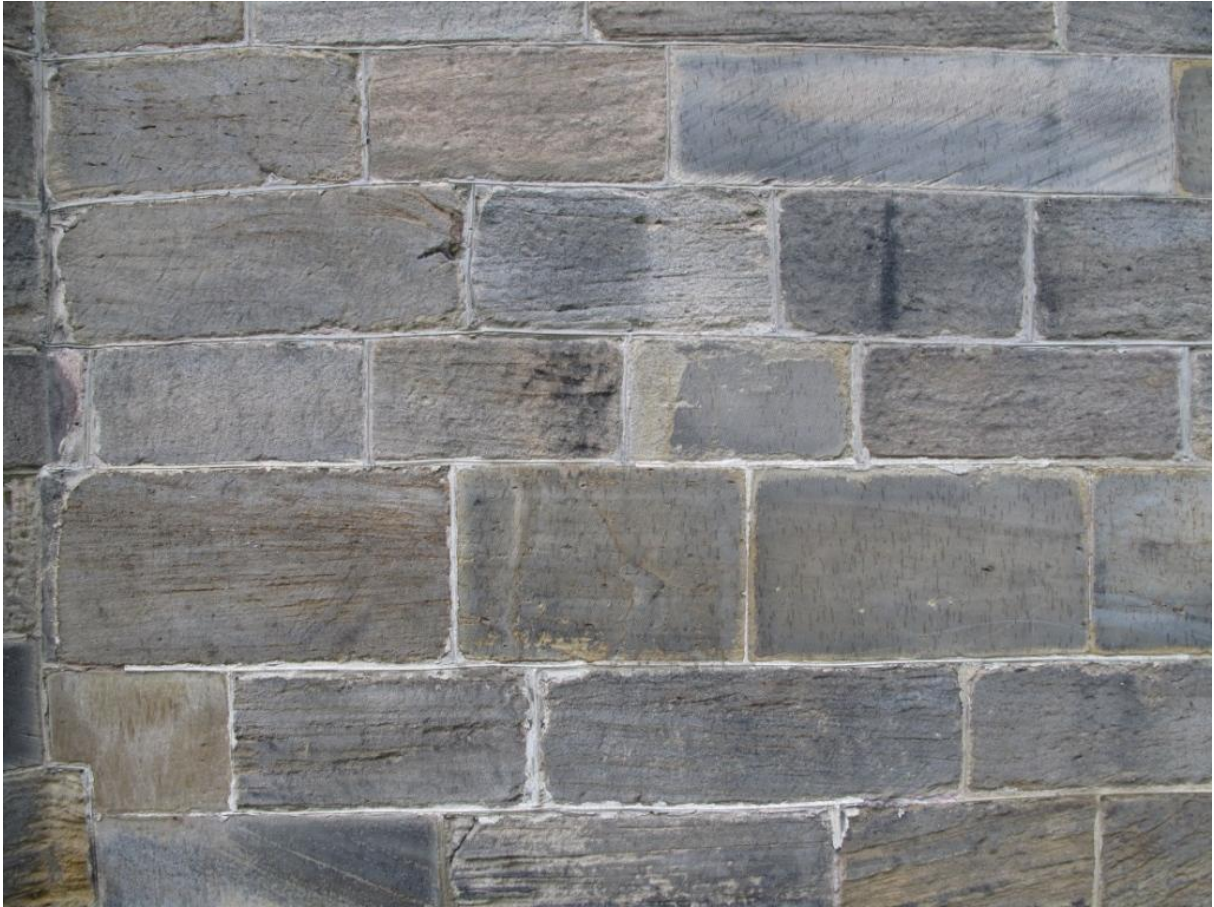
09/345

It would appear that there has been more than one re-pointing on this elevation and it is of mixed quality. Overall the pointing is in fair condition but some may be a little too hard. It would be of benefit to detail the mortar joints and ascertain if there would be any benefit to reducing moisture in the walls further by replacing some of the mortar where it is missing, defective or inappropriate.

The pointing is in fair condition and the stone work itself generally fit for purpose. As referred to above it would be worth undertaking a detailed survey of the pointing to ascertain if the mortar is both suitable (not too hard) and in good condition.

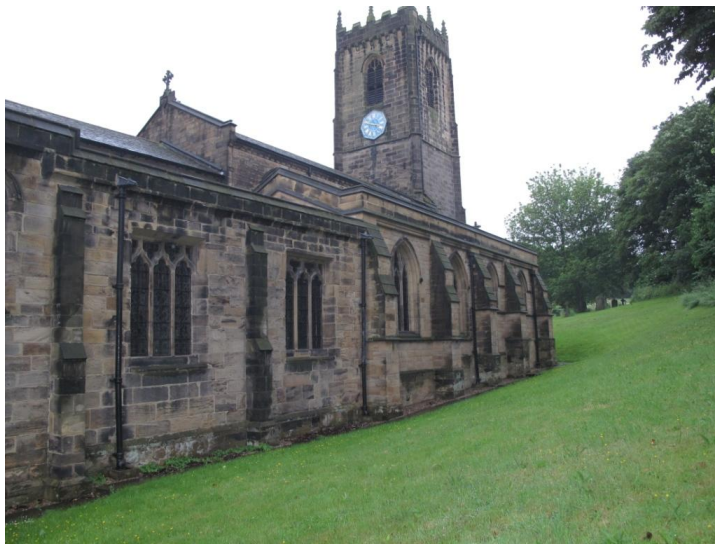
09/331

General view of the north elevation of the church showing the ground rising higher to the west.

It is understood that there has been a history of dampness in the church as a consequence of the location; it is believed water has a tendency to run along the line of bedrock under the foundation of the building. Various steps have been taken to mitigate the impact of this on the interior of the building and previous works have been carried out including re-laying some floors and adjusting levels between the Savile chapel and the north aisle and the nave.

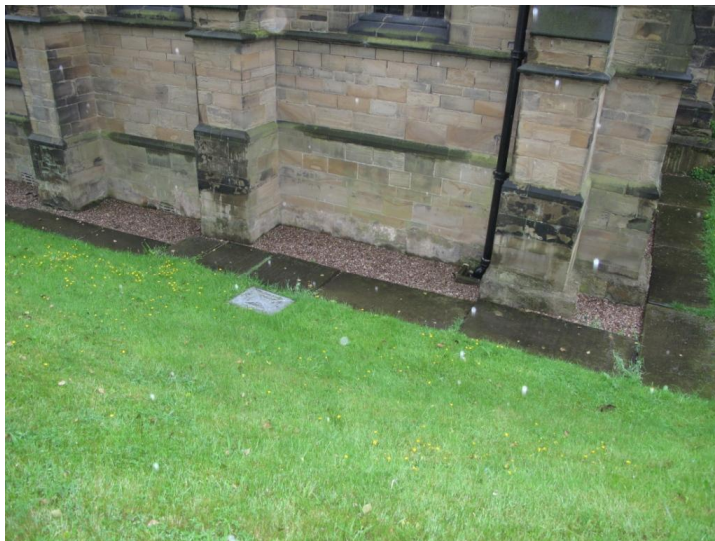
09/343

Along the north elevation a French drain has been installed recently and it appears to be in good order.

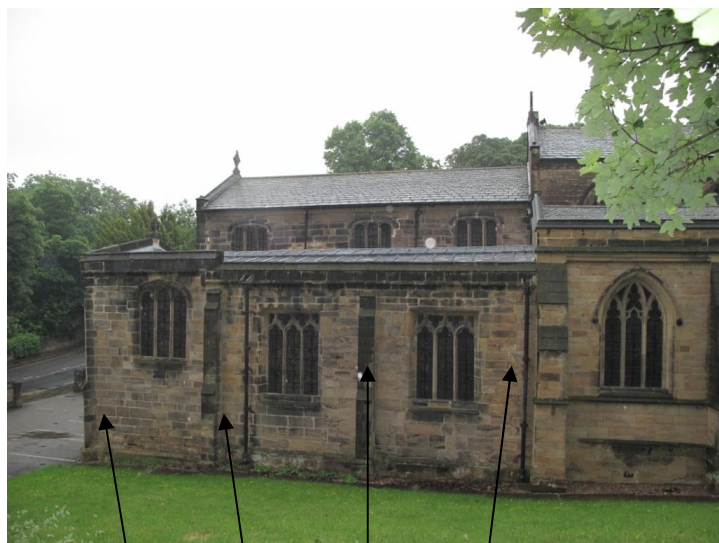
09/344

North elevation of the Savile chapel showing the roof to be lead with a shallow pitch.

No inspection was made of the roof but it is known to have been replaced relatively recently following theft of the lead covering and it is assumed to be in good order.

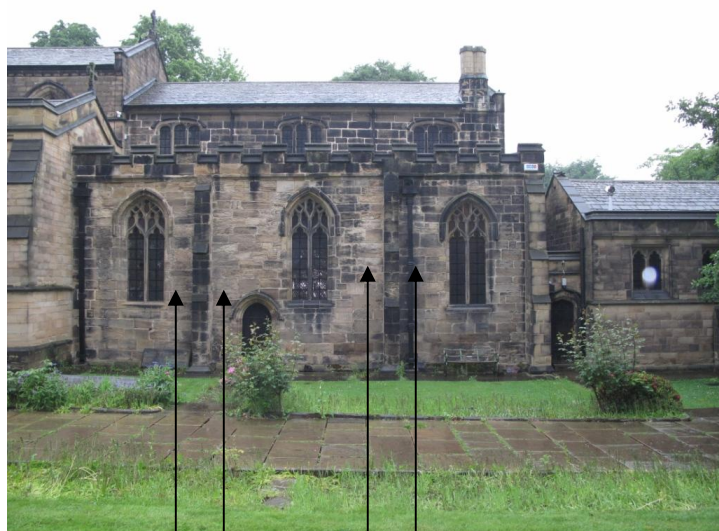
09/336

General view of the external elevation of the south chapel.

Note the ground level is high effectively setting the church in a valley with the ground rising on the south, west and north elevations. On the east side of the church the ground slopes away very steeply.

In general steps have been taken to reduce moisture within the building fabric by maintaining the roofs, gutters, down pipes and drains in particular by introducing the French drain on the north elevation. It might be worth considering introducing a French drain on the south elevation, at least in the area corresponding to the south chapel as there is an issue of dampness in the wall on the interior as will be shown later in this report.

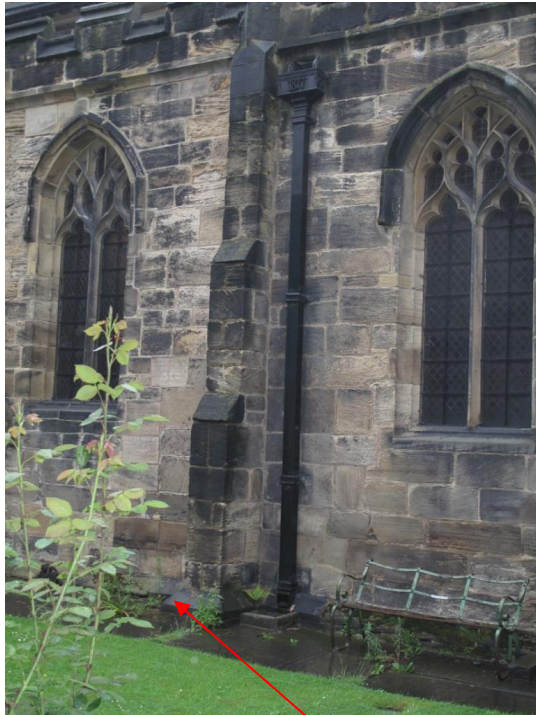
09/337

Detail of the eastern buttress on the south chapel wall

Note the area adjacent to the walls is paved and the level of plant growth would indicate a moderately high level of moisture. Moisture will easily penetrate the paved areas through the joints and it is not known how the general soil will drain. There is a risk that this will increase the levels of moisture in the fabric of the church walls.

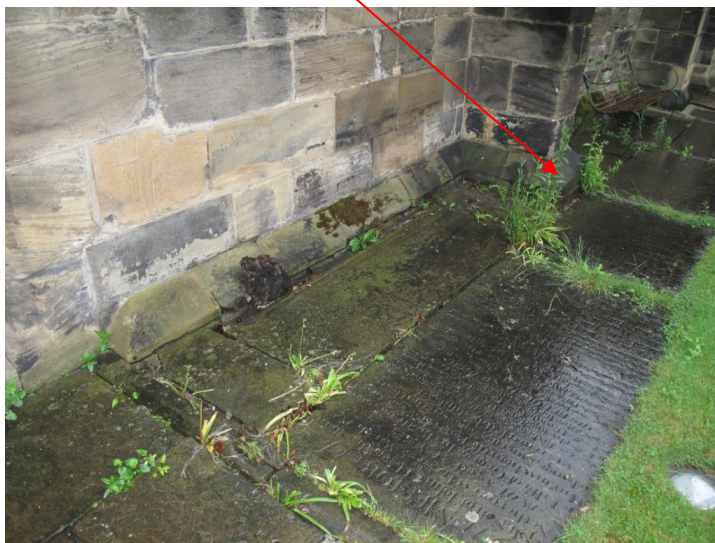
09/338

The arrow indicates the same location in the two photographs viewed from different angles.

At the time of the survey it was raining and the drains appeared to function well with the exception of one that appeared to be superficially blocked by leaf matter.

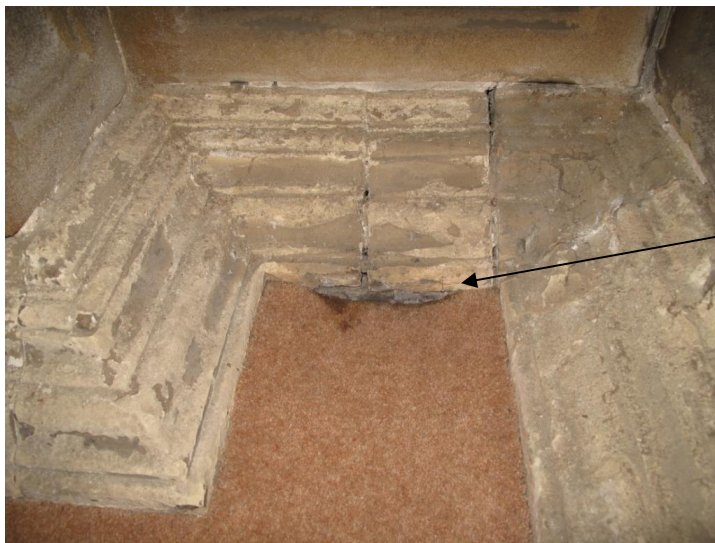
08/013

The area of floor between the main monument and the base of the western pilaster base.

Note the damp stains on the carpet.

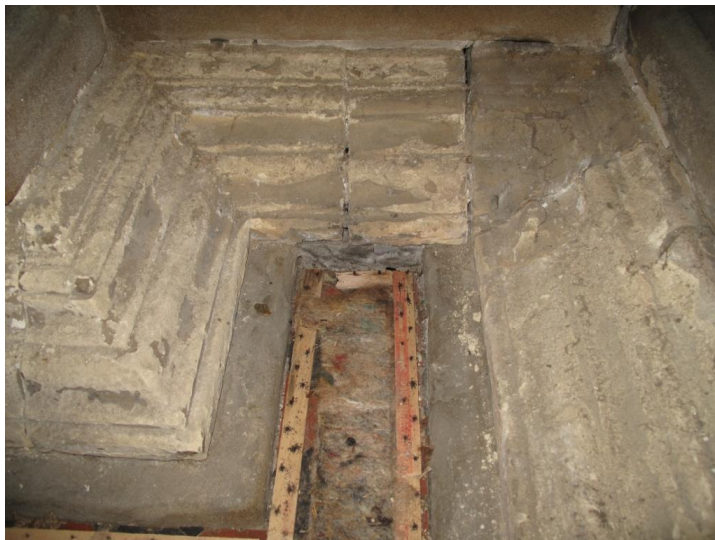
08/014

Lifting the carpet reveals the underlay to be retaining very high levels of moisture.

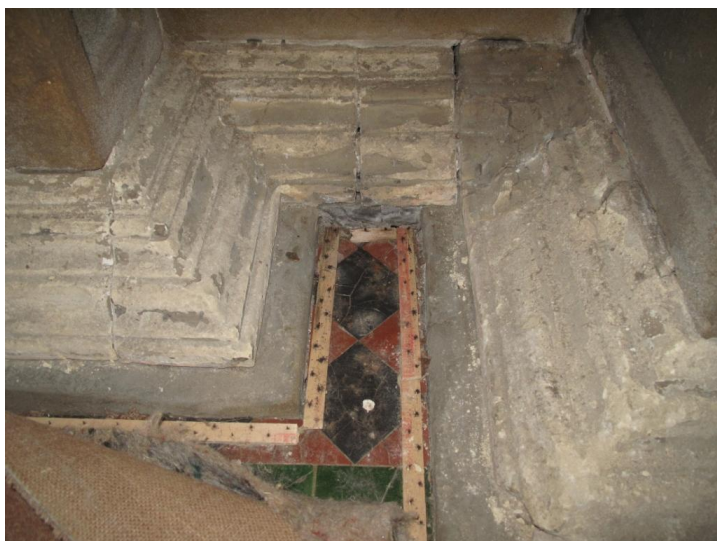
08/015

The floor under the carpet and the underlay is glazed tiles. There was considerable dampness on the surface of the tiles and it was noticeably greater at the margin adjacent to the base of the tomb. Note the extent of the corrosion occurring on the metal component of the gripper rods.

These observations indicate that the monument itself may be wicking moisture from the sub floor more easily than the tiled floor area thus causing the migration of water and soluble salts through the stone of the monument. Testing by touch only the moisture level appeared to reduce further from the monument.

It would appear that the carpet is a relatively recent addition. Consideration needs to be given to whether it has changed the ambient conditions in the adjacent monument in a detrimental way.

Moisture mapping of the area around the monument might further indicate the source of moisture.

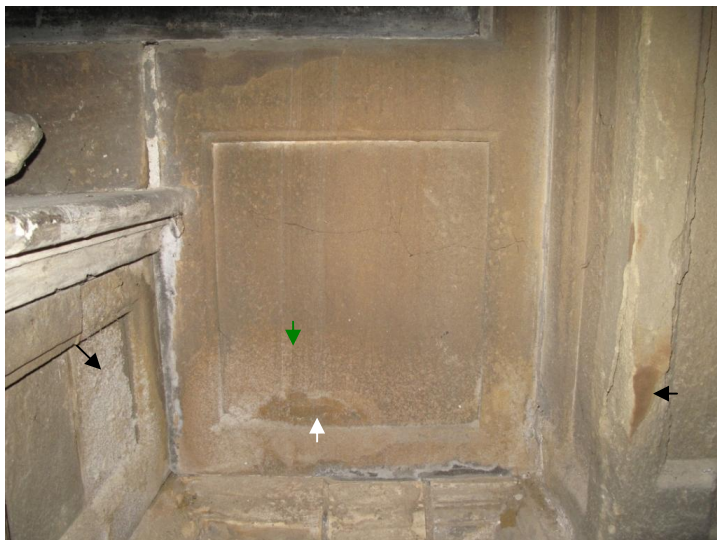
08/020

At the corresponding location on the east side of the monument can be seen strong evidence of soluble salt efflorescence on the surface of the stone (black arrow).

The general pock marking (green arrow) as a consequence of salt efflorescence and mineral discolouration (white arrow) also indicate ongoing moisture and salt movements.

The indications are strongest at low level and decrease with height up the monument therefore indicating the ground as the most likely source of both the salts and the moisture.

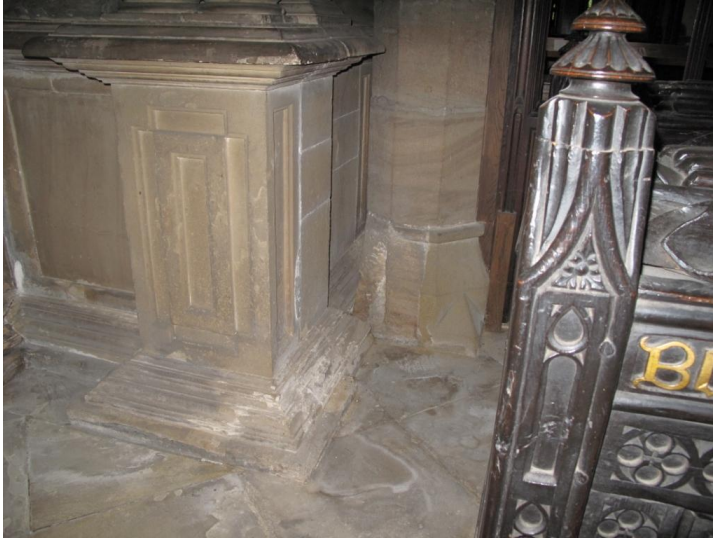
08/150

A general view of the western end of the Sir George and Lady Anne monument from within the Savile chapel.

The stone floor has many marks consistent with moisture penetration through the stone over a long period of time.

There is mineral discolouration and salt efflorescence generally on all the stone floor surfaces as

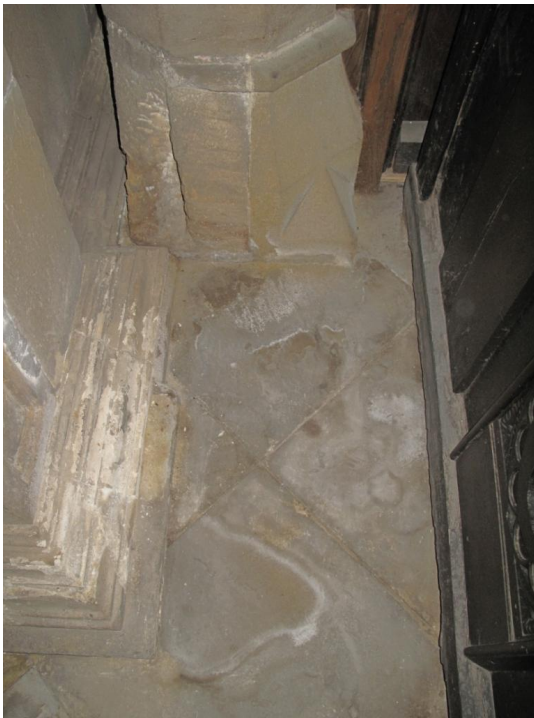
08/151

The floor in the chapel appears to breathe more generally thus avoiding the concentrations of moisture as observed in the margins of the floor within the chancel.

There is evidence of salt efflorescence within the stone of the monument but perhaps not as severe as in the south elevation.

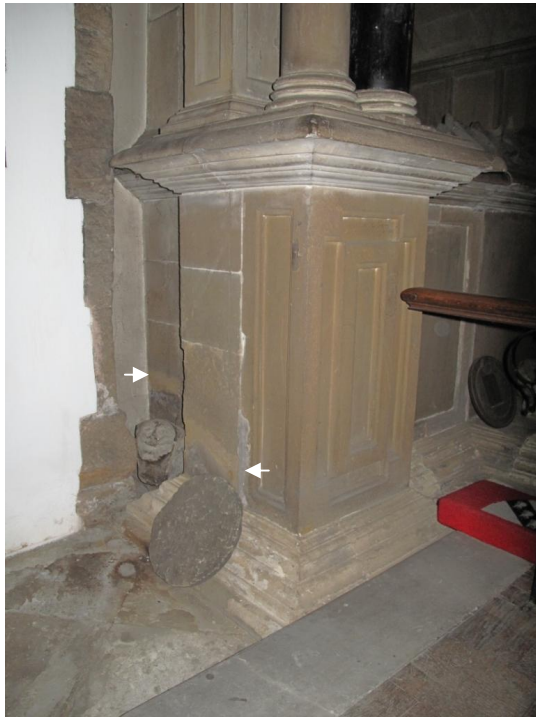
08/155

The eastern end of the Sir George and Lady Anne monument.

The floor in this area carries the signs of penetrating moisture as discussed above and there is a strong indication of an ambient moisture evaporation level line as indicated by the white arrows.

This feature is typical of damage caused when moisture reaches a natural evaporation level within stone causing salts to be deposited where they sub-florescence and/or effloresce causing damage to the stone surface.

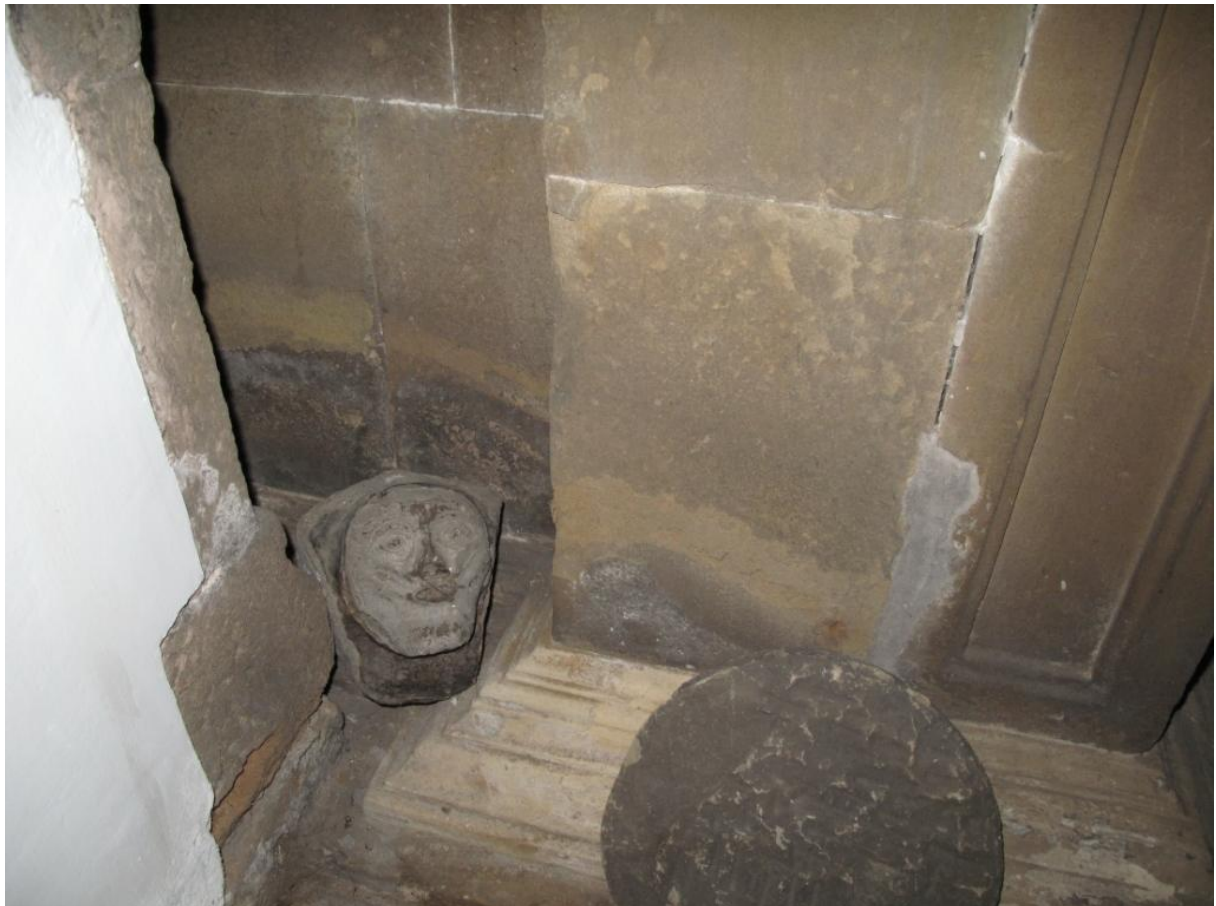
08/157

As can be seen below the salts are present generally within the stone but a dominant

feature has formed.

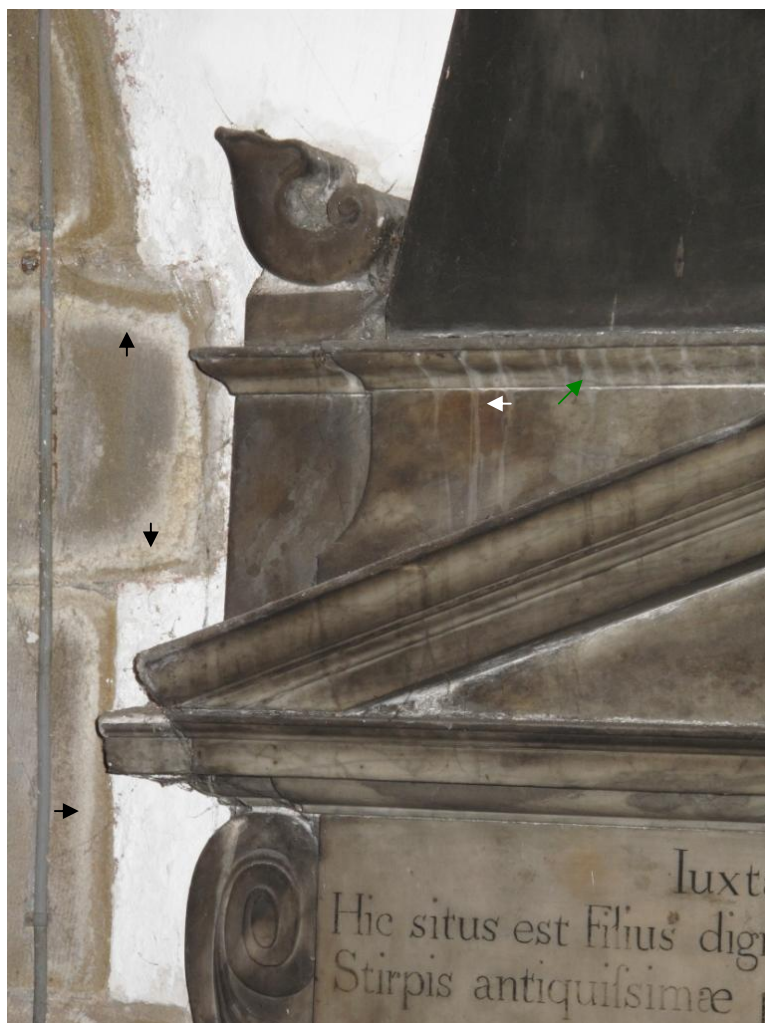
09/262

Detail of monument number 11, eastern end of the south chapel.

There are indications of humidity and moisture affecting this area of the church.

Note the salt efflorescence in the stones surrounding the adjacent window; (black arrow).

The internal cramps are corroding with rust stains evident on the surface of the monument (white arrow).

The water marks across the surface may be condensation over a period of time of from water leaks in the roof above; (green arrow)

This monument is relatively high on the wall but moisture

is able to rise, most likely from the ground outside, to this level within the fabric and the wall memorial.

It might be worth undertaking analysis on the various salts apparent within the building to ascertain a possible source and to establish if they are deliquescent as this would exacerbate the situation. There is a possibility that such salts once disturbed will continue to move within the stone under the influence of ambient humidity within the atmosphere of the building. This might mean that previous rising dampness could have transported salts to a point in the stone where ambient humidity is sufficient for a cycle of dissolution and efflorescence to occur. Removal or reduction of such salts from the ambient zone in the stone could reduce the problem. However the evidence of moisture in the floor on this side of the monument and generally elsewhere as noted above and in the following detailed reports indicates that there is likely to be a continuing issue about ground moisture affecting the monuments, walls and floors and therefore the identification of the salts is of interest but may not affect the outcome for recommended treatments.
