Thornhill St Michael and All Angels
(Anglican Diocese of Leeds)

Condition Report
on windows sIV and sV
with recommendations and
outline method statement

Jonathan and Ruth Cooke
June 2020

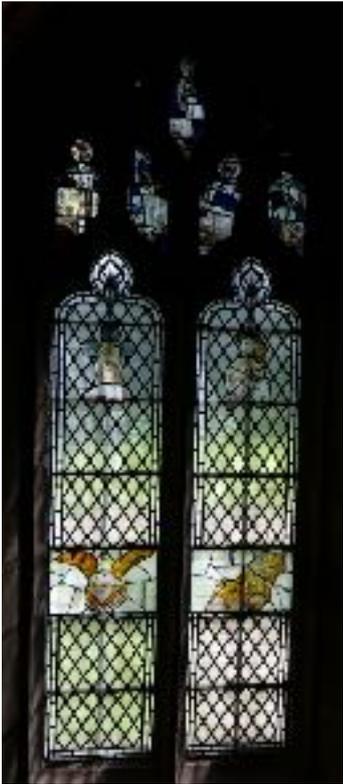
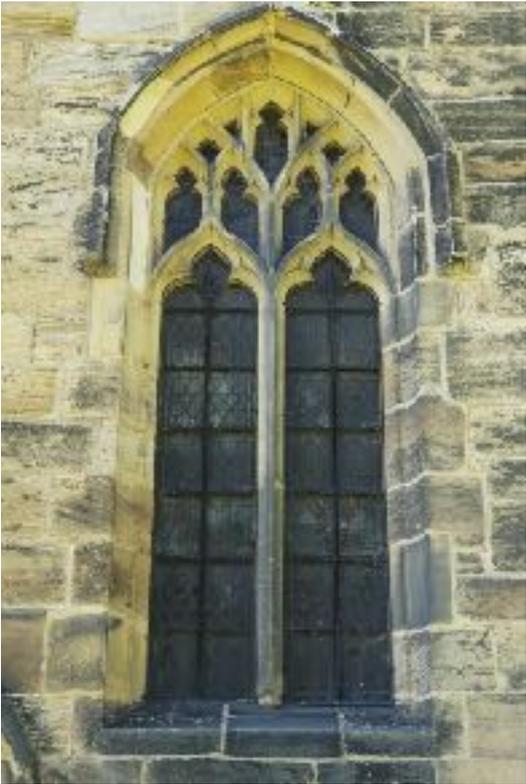
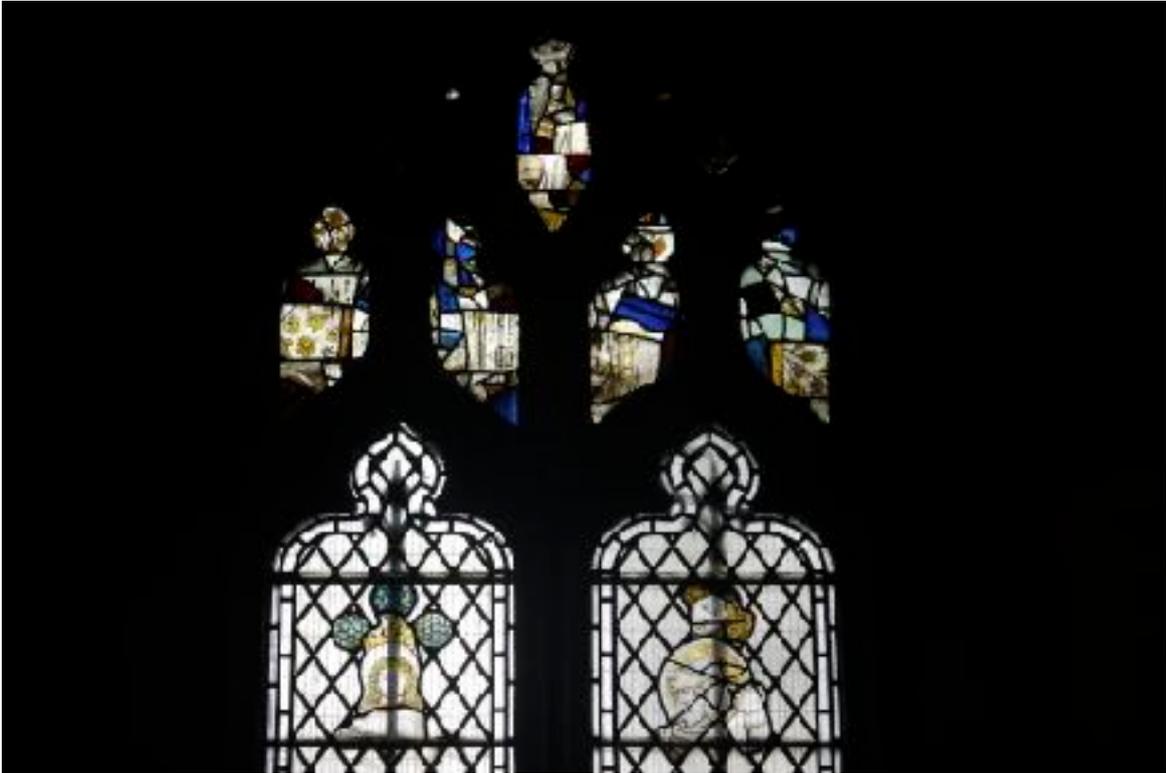
sIV internal, external and tracery detail

Lead matrix all C19; no later interventions were noted other than *in situ* repairs in cathedral glass to unpainted quarries. Leaded breaks to angel wing date to Burlison and Grylls restoration. Structurally in reasonable condition, given age of leads and supports, with some movement on slight pressure. Leaded light cement reasonably sound, with no significant leaching. The tracery lights are distorted and bowing, probably due to lack of support and daily and seasonal significant variations in temperature at the glass surface in a sheltered "hot spot" on the south wall; all pieces appear secure within the lead comes at present.

The c15 painted surface decoration varies in stability; in some pieces only trace lines remain; there is also some loss of trace line in places where the paint has been applied more thickly. As with north side windows, there is no detectable pattern to the paint loss within pieces. Elsewhere, the paintwork appears intact though it should be assumed unstable throughout.

The recommendation for both windows is for conservation of the c15 glass and installation into an internally ventilated protective environment; the reversed pieces in sV provide supplementary reason for protection.

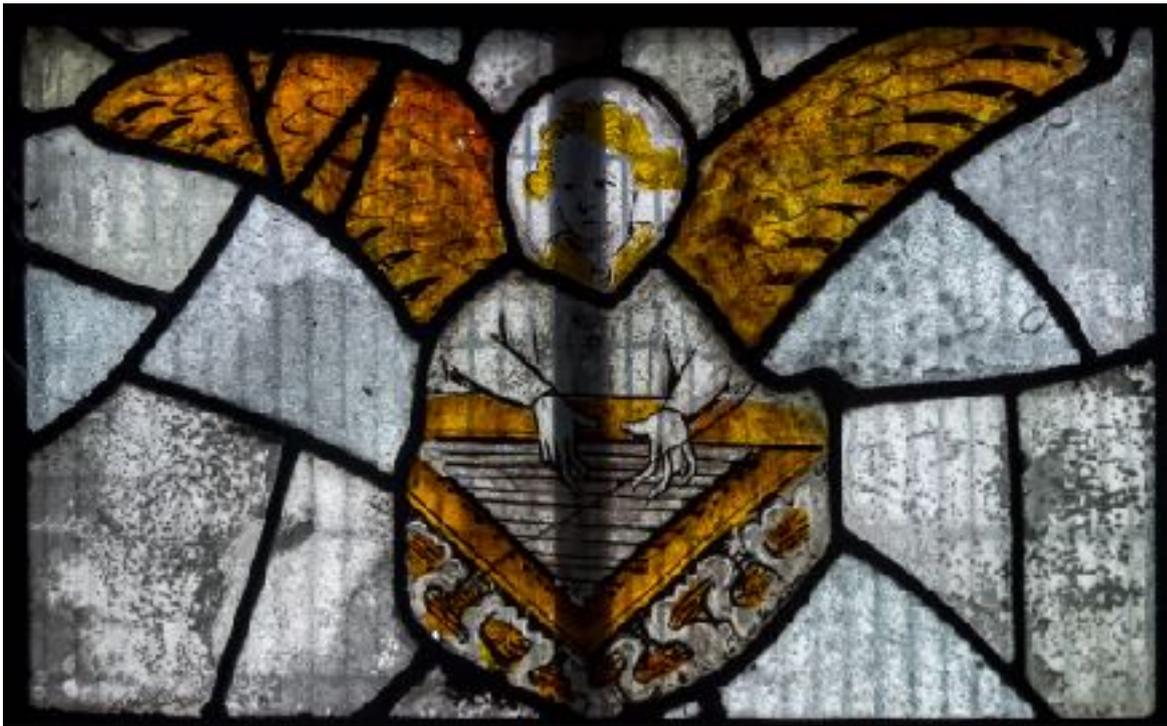
sIV 1a detail

The c15 white glass, some of which is original to the north elevation, is generally in better condition than that of nII and other Savile Chapel glazing. There is an unleaded fracture across the psaltery due to pressure, and it is possible that there are further fractures in the tracery lights which were not accessed closely. Small internal fractures such as characterise the glass of the Savile Chapel, are visible to

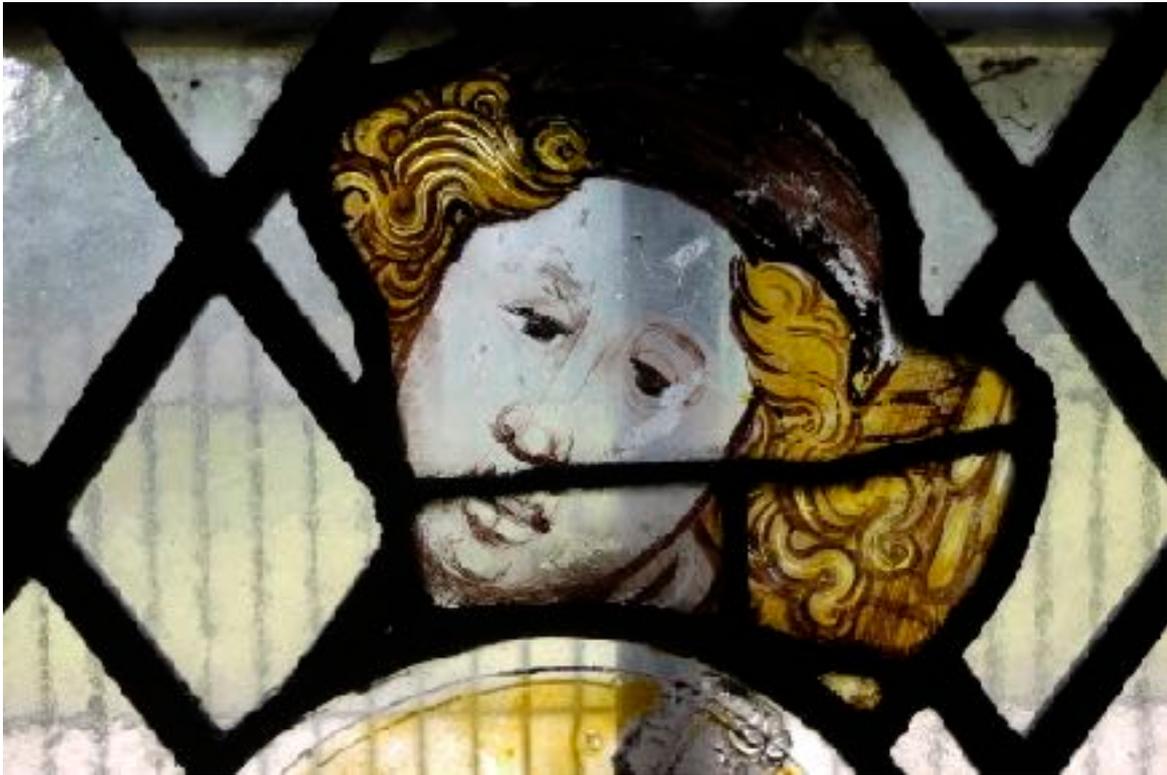
sIV 2b detail: internal fracturing visible to face of angel

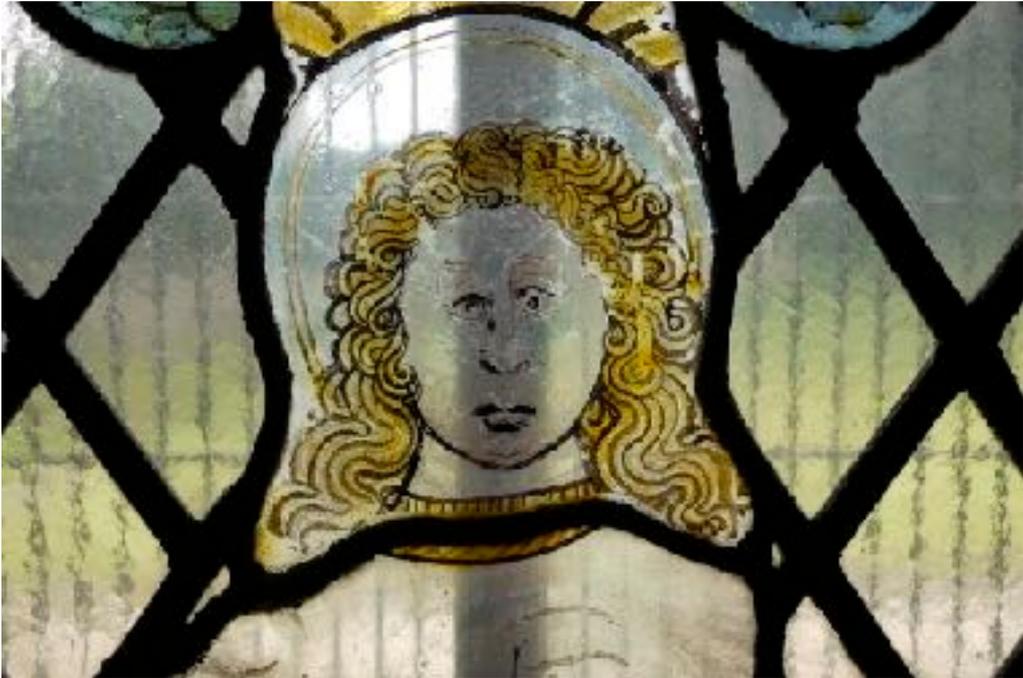
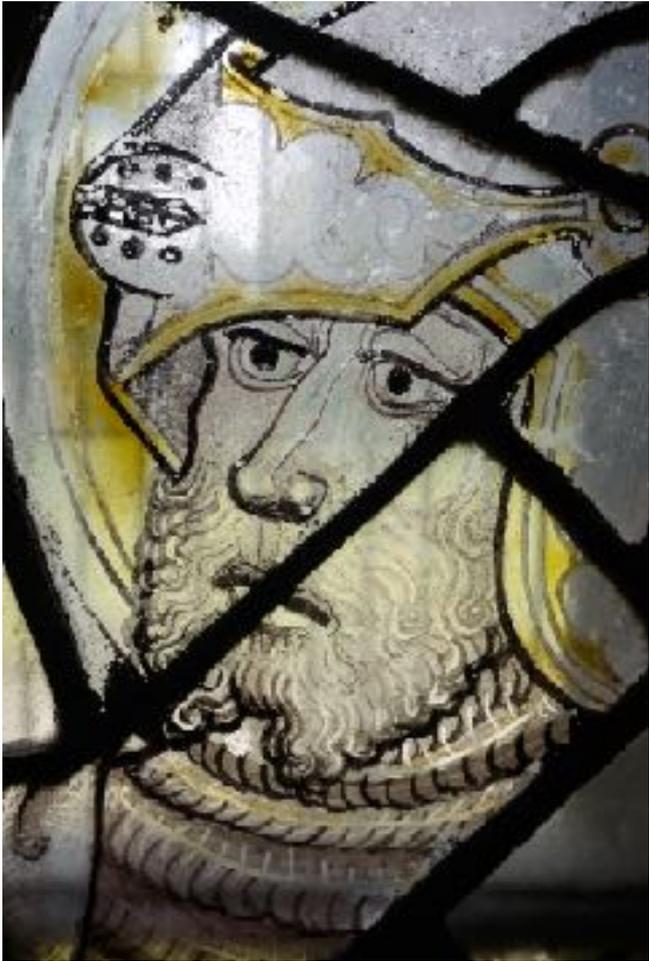
the naked eye, as noted above, though the process of deterioration is less advanced. There are some small areas of visible corrosion in the form of micro pitting to the internal surface, resulting in paint loss in these areas. No impact damage was noted.

sIV details 2a and 2b: pigment loss to trace lines and internal corrosion

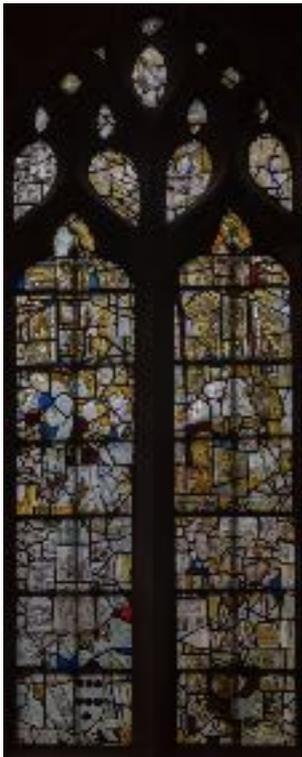
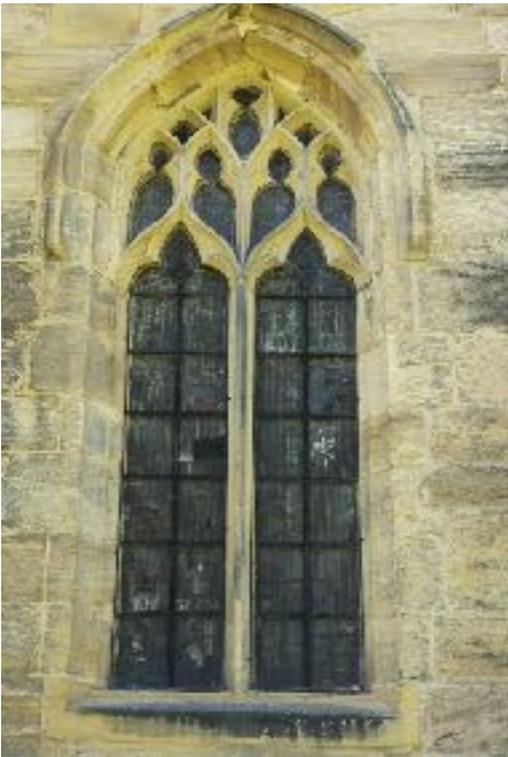
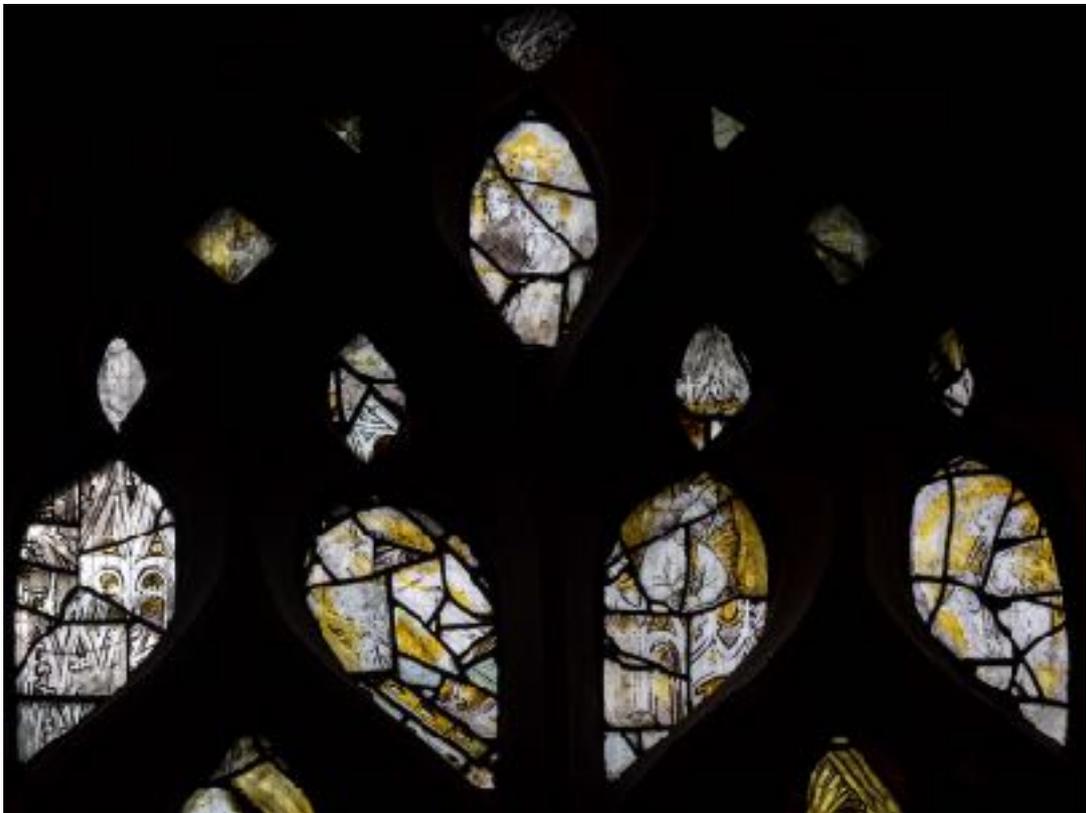
sV internal, external and tracery detail

Lead matrix all C19; Structurally in reasonable condition, given age of leads and supports, with some movement on slight pressure. Leaded light cement reasonable, no significant leaching. As sIV, the tracery lights are distorted and bowing, for reasons given above; as sIV, all pieces appear secure within the lead comes at present.

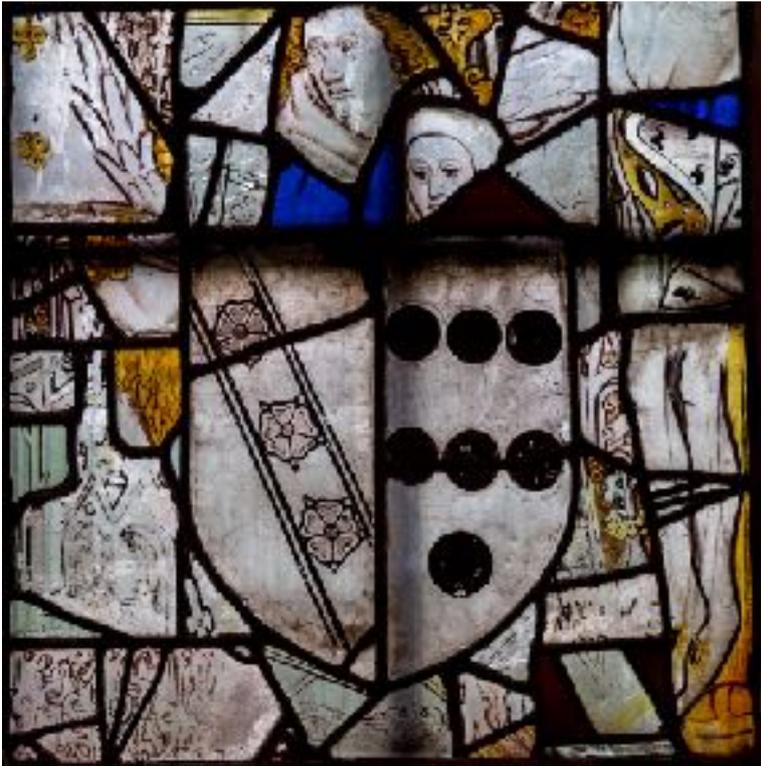
An unsecured multi-fractured piece of white glass was noted, damage due to impact prior to installation of guards. Further single fractures due to pressure were also noted in the main lights. As with sIV, it is possible that there are further breaks in the tracery lights which were not closely accessed. There are several reversed pieces throughout; the leaded panel with musician angel occupying tracery A3 is entirely reversed.

sV 1a detail: impact damage

Edge bonding of cracked pieces with Araldite 20:20 or other appropriate conservation grade epoxy resin/silicone. [the use of moulded external plates for mechanical support is not anticipated]

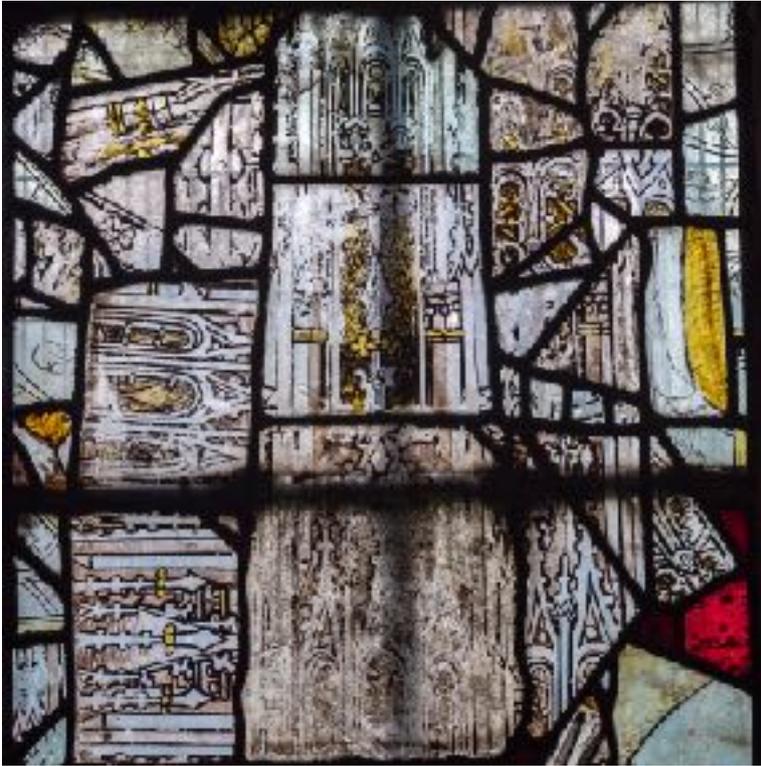
sV 1a detail: pressure fractures

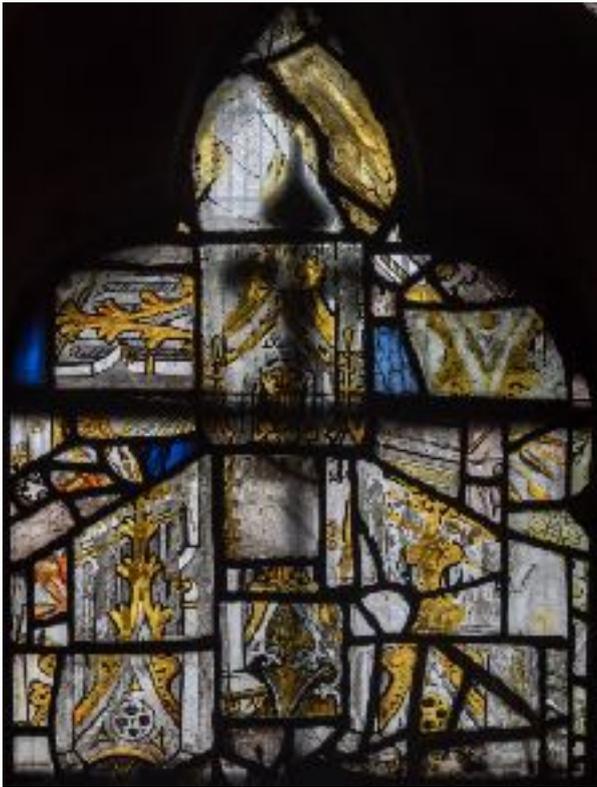
sV 2a detail

There are two areas of *in situ* repairs in 2a, and a further single *in situ* painted insertion, all probably carried out by YGT c1980.

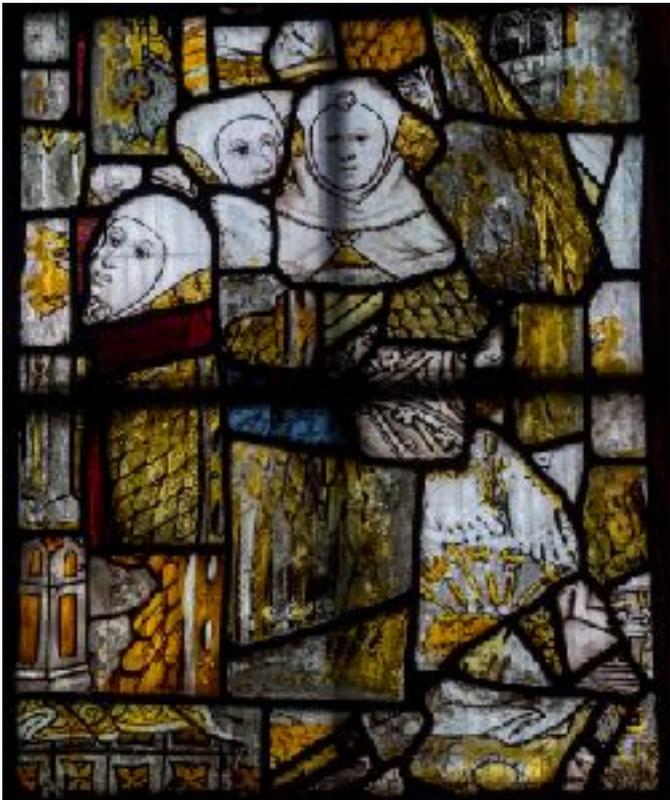
sV 2b detail: *in situ* repair to canopy and part of wing in orange stain at lower left
