Thornhill St Michael and All Angels
(Anglican Diocese of Leeds)

**Condition Report
on stained & painted glass
and leaded glazing**

sII, sIII, sIV, sV, sVI, sVII, sVIII sIX, sX, sXI
wI
nVI, [nVII], nVIII, nIX, nX
SII-SVIII & NII-NVIII
with outline recommendations

©J&R Cooke
August 2019

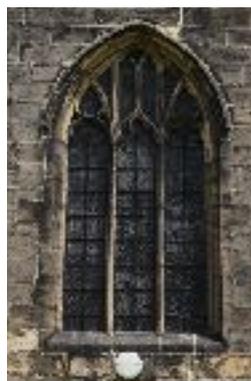
w1 tower west wall

Many *in situ* unpainted repairs to the collection of fragments and to the quarry glazing alike. Otherwise the structural condition is sound. All ties visible appear to be in place. Leaded light cement appears sound in lower accessed parts of the window. There is at least one piece double plated with a small collection of early glass within. There is a significant amount of corrosion on the internal face of much of the stained glass, and microbial growths which could be active.

Despite the high number of replacement pieces, environmental protection could be considered for the panels containing vulnerable medieval glass.

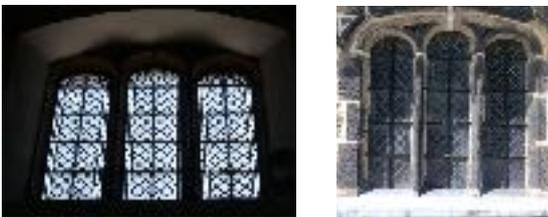
SII chancel south first from east

The lead matrix is original to the glazing; perimeter leads and borders are being pulled apart on a light, mullion side, and leaded light cement is becoming powdery. Ties are holding at present. There are two *in situ* repairs in a light in clear textured glass.

Reinspect within the quinquennium, for indication of further movement or fracturing of leads, and specifically in the areas mentioned above

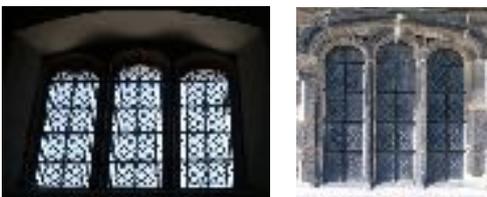
SIII chancel south second from east

All sizes etc. as SII. The condition of the leaded border in a and b light, mullion side, is rather worse than in SII above. No later interventions noted.

Recommendations as SII

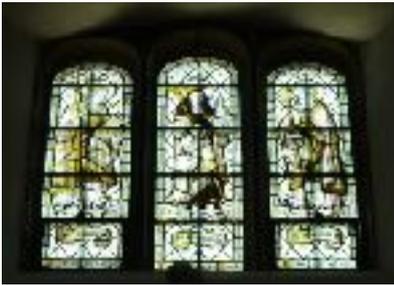
SIV chancel south third from east

The lead matrix is original to the glazing; reasonable condition. All ties holding and leaded light cement condition better than that in adjacent SII and SIII above. However, the mortar is failing in places, notably, but not limited to, around the hopper in base of a light, and at the bar socket above the hopper in c light on jamb. The hoppers are corroded, and almost certainly inoperable. Several inferior painted repairs in a light at border, mullion side.

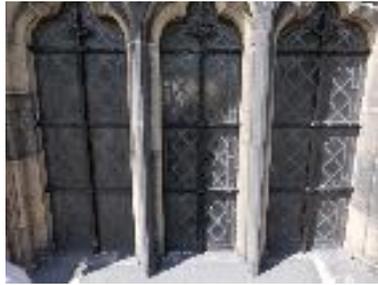
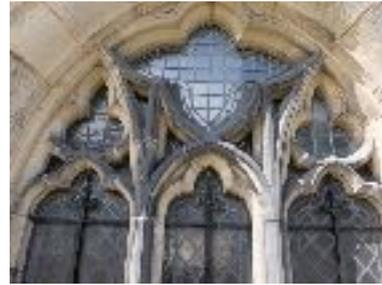
SV nave south first from east

The large tracery has been releaded in 3/8" flat leads within the last 50 or so years, elsewhere lead matrix original to the glazing; no later interventions were noted. Ties are all holding; leaded light cement becoming powdery, as SII. There is some stretching of the leads at base of a light, jamb and mullion sides, also mullion side of c light; this is perhaps due to stone movement in combination with strong cementitious mortar. Beyond the scope of this report, masonry movement appears to be the cause of mortar loss from stone joints.

Reinspect within the quinquennium, for indication of further movement or fracturing of leads, and specifically in the areas mentioned above

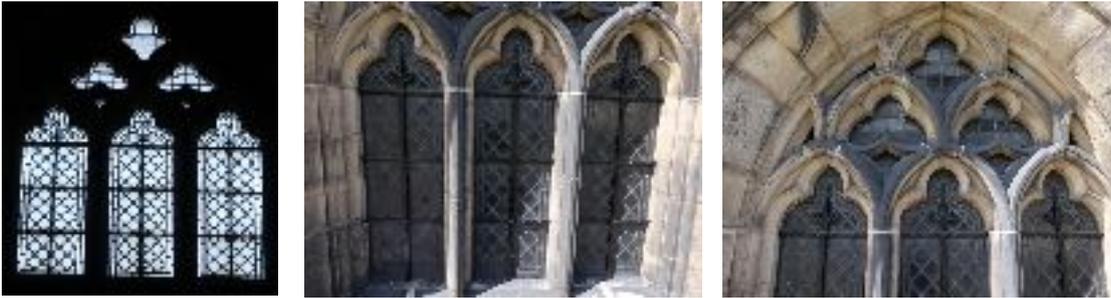
SVI nave south second from east

Lead matrix is original to glazing; no later interventions were noted. Ties are all holding. There is some mortar failure due to stone movement, notably in the head of c light, and leads are stretched at base of a on both jamb and mullion side, and at base of c light, mullion side; less pronounced than on SV C2 mouchette tracery is folding along a vertical line of weakness.

Reinspect within the quinquennium, for indication of further movement or any fracturing of leads, specifically in the areas mentioned above

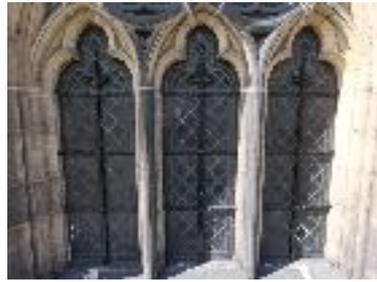
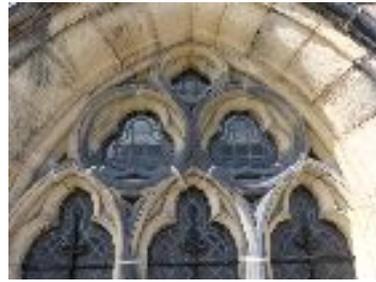
SVII nave south third from east

Lead matrix is original to glazing; two in situ repairs, one in each of a and c lights. Ties are all holding. There is some movement in the stone, and recent mortar repair work to joints, most noticeable in heads of main lights. Leaded light cement becoming powdery. Leads are stretching, as in SV and SVI mainly at jamb side of c light.

Reinspect within the quinquennium, for indication of further movement or fracturing of leads, and specifically in the areas mentioned above

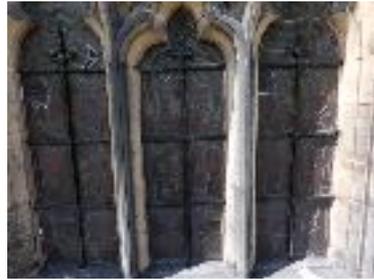
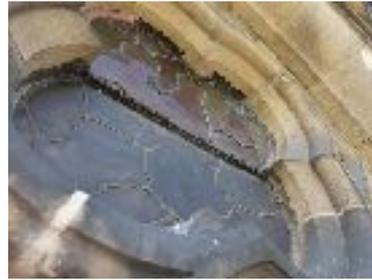
SVIII nave south fourth from east

Three light window with large quatrefoil principal tracery light. a and c lights 16" x 63", b light 16" x 49", each in two panels with division at 39" from cill. Quatrefoil tracery 28" max. width, in two panels, with horizontal external glazing bar 3/8" square section mild steel at division. Lead matrix is original to glazing, predominantly 3/16" flat. Each light is tied to external *ferramenta*, comprising single stanchion as SV and three horizontals.

a light: standing figure of St Jude, facing half left, with open book in right hand, unidentified attribute in left: tiled floor, ruby dorsal curtain, seaweed diaper with jewelled border: beneath is name scroll "St Jude" in gothic script. Above the figure is a scroll *Earnestly contend for the faith which was once delivered unto the saints*⁹ All on a ground of white glass, silver stain; repeat painted quarries.

A1 tracery contains three kneeling angels on a ground of flowers holding scroll as above *The glorious Company of the Apostles praise thee*. All white glass, silver stained.

The lead matrix is original to the glazing; three *in situ* painted repairs were noted; one in a light, and two in c light. Main lights are in reasonable condition. All ties holding. Tracery is bowed to the interior; ties here on central horizontal bar are still holding at present

Monitor tracery, specifically for the appearance of any fractured ties

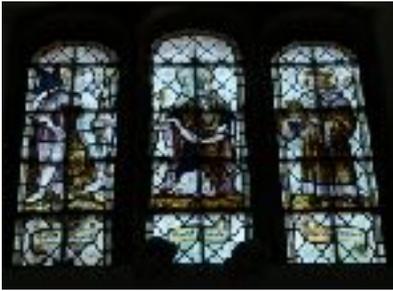
NII north chancel first from east

The lead matrix is original to the glazing; no later interventions were noted; reasonable condition. All ties holding: leaded light cement 'frilly' in places and lost in small areas. Beyond the scope of this report, there is much patch pointing externally to the hood moulding around this window. The *ferramenta* appear corroded; there is also much patch pointing around the bar sockets which conceals any underlying problem. There is some paint loss, particularly to inscriptions at base of window, indicating past condensation action on possibly underfired paint

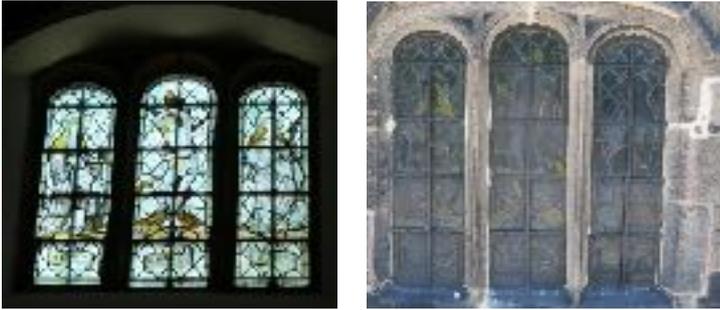
NIII north chancel second from east

Three light window, shallow arched tops.

Leaded light cement becoming frilly throughout, and lost in places, as NII. The hopper is corroded and probably inoperable. *Ferramenta* also corroded. There is an unconsolidated multi fractured piece of drapery of a light, jamb side. Pigment loss is particularly evident in the commemorative inscription at base

Consolidation of fractured piece *in situ* to prevent further loss.

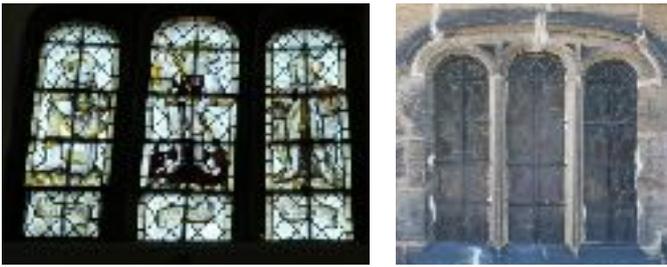
NIV north chancel third from east

Three light window, shallow arched tops.

Leaded light cement beginning to fail. The hopper is corroded and probably inoperable. *Ferramenta* also corroded; appears to be cause of damage to mullion at lowest bar socket, eastern side of b light. Much patch repair to masonry in hood mould in ?lime mortar, and around bar sockets of various dates and materials indicative of ongoing movement. There appears to be some movement of the mullion between b and c lights which could be linked to some ongoing mortar failure. One tie has failed. Stretching of leads at base of c light, mullion side, and daylight can be seen between perimeter lead and masonry. Pigment loss is particularly evident in the commemorative inscription at base

Reinspect within the quinquennium, for indication of further movement and fracturing leads

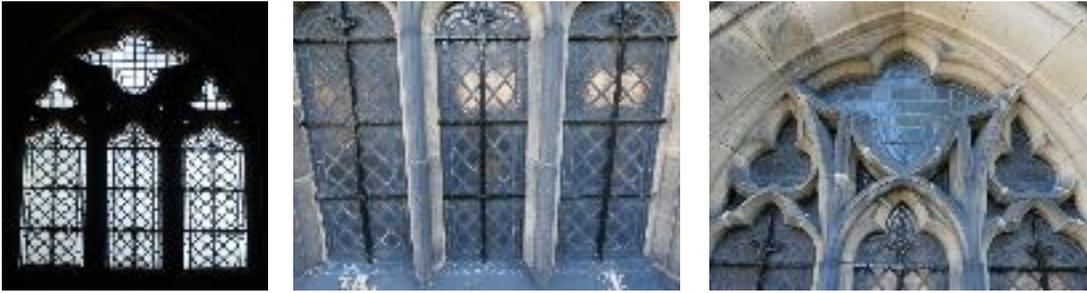
NV north nave first from east

The large tracery has been releaded in 3/8" flat leads within the last 50 or so years, and probably at the same time as that in SV. Elsewhere lead matrix is original to the glazing; no later interventions were noted. Leads are more oxidised than those of SV on south side of the church. Ties are all holding; the mortar is fractured in places.

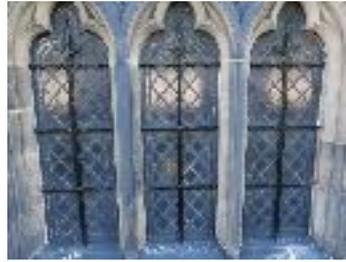
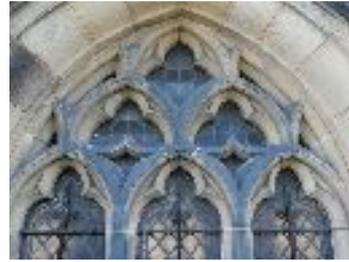
NVI north nave first from east

A pair with SVI: three light window, main lights single-cusped, three principal traceries and further eyelets. Each main light 16" x 51" with division at 39" from cill. Tinted cathedral diamond quarry glazing with double border; rectangular quarries in the tracery lights. Leads 3/8" flat. Main lights tied to external *ferramenta*, comprising single stanchion as SV and three horizontal in each main light.

lead matrix original to glazing; no later interventions were noted, other than in situ repairs. There are three broken quarries at base of c light, and the leads are stretched in places. Ties are all holding. The three principal tracery lights are distorted, and bowing along lines of weakness.

Reinspect within the quinquennium, for indication of further movement or fracturing of leads, and specifically in the areas mentioned above
