**Thornhill St Michael and all Angels**

**Great East Window  
Tree of Jesse**

**Condition Report**

**J&R Cooke  
July 1998**

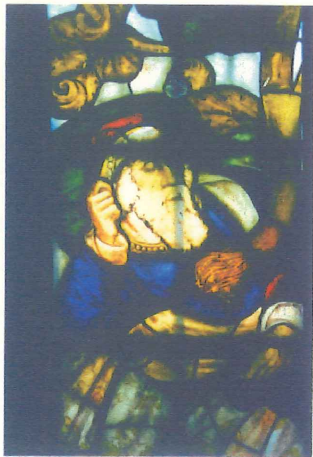
Photograph 21 1c Jesse - detail

vi) As noted in 4b iv), runs throughout the window which have removed the paint are characteristic of the action of condensation on underfired pigment. This can be seen in photographs 21, p.31 and 9, p 21, of Jesse's right hand, and David's face respectively. The writers have found loss in the form of runs in other Burlison and Grylls windows of similar and later date. While this may have been a problem peculiar to this building, it may also be associated with the practices of the studio fluxes and firing temperatures.

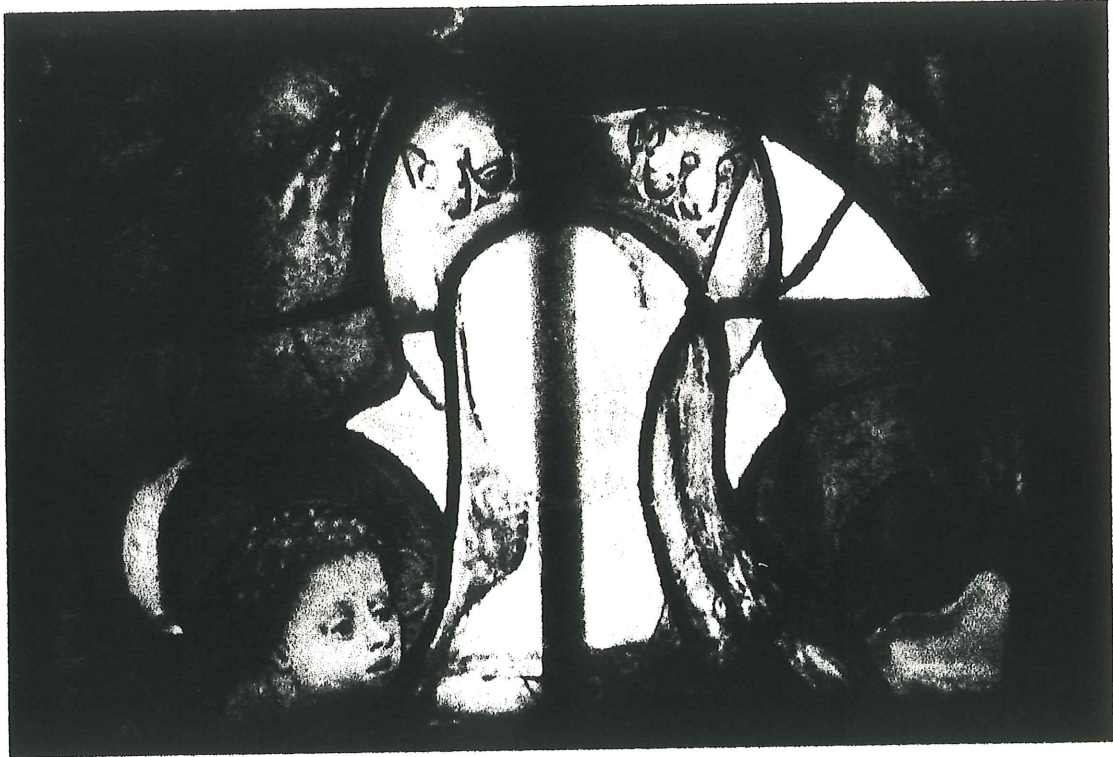
Photograph 10 3c Virgin and Child - detail  
Thornhill Tracing 3C -detail

iii) A comparison of the glass itself with the painted detail of 1877 as shown by the Thornhill Tracing indicates that since 1877 there has been considerable further pigment loss throughout the window. Photograph 10, p.22 and tracing 3C show the head of the Virgin in panel 3c; the tracing shows faint details of the main features. There are now residual traces only to the eyes, nose and mouth, not visible from floor

level to the naked eye. TT shows complete traceline to the vertical line forming the LH edge (as viewed) of the crown. This is now lost in places. Comparison of Manasseh in panel 4e (Photograph 17, p 27) with the tracing of this panel [2E], indicates a considerable amount of pigment loss since 1877 as does a similar comparison of the detailing on the crown of Ahab in 3f (Photo 19, p.29) and tracing 3F) and the face and crown of Rehoboam in panel 3d where the pigment loss noted in 1877 is now more severe and there is additional loss of painted detail to face, which was apparently almost intact in 1877 ( photograph 13, p 24 and tracing 3D). iv) There has been further damage to the painted glass of the window, probably caused by water in the form of condensation standing on the glass and running down. The repeated action of running condensation has removed the paint from the glass. this more particularly applies to the c19 but was noted on some of the ancient glass. Photograph 13, p.24 of Rehoboam's inscription in 3d shows this type of damage to c15 pigment.

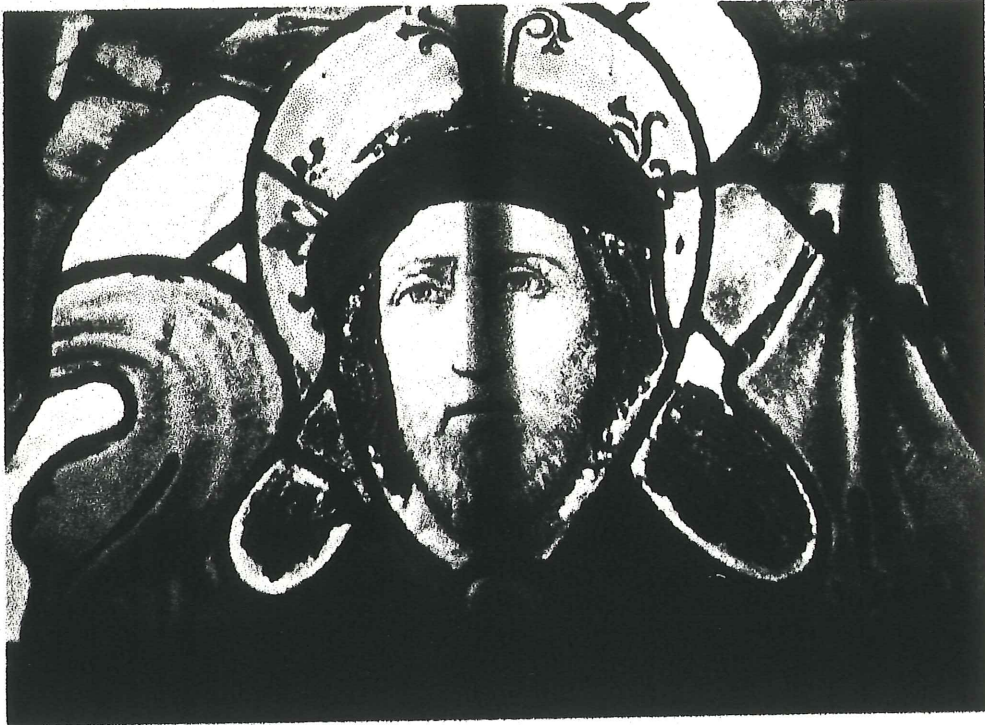
Photograph 11: 4c Christ in Majesty - detail

Christ in Majesty seated front facing; cross-nimbed and holding orb in left hand. Green crown of thorns and loose purple robe. *Stigmata* visible on r hand and foot. With the exception of the face and several pieces adjacent to the figure this panel is shown to be nearly complete in Thornhill Tracing. The face of Christ has the incongruous appearance of a portrait. See photo 11, p.23

ii) There is pigment loss on many pieces in a band 2mm-6mm approx. around the present lead lines. These damaged areas correspond to the heavier leading of the previous restoration shown on the TT. Photograph 11 shows a clear area of pigment loss around the hair of the Christ figure which is c15, and the c19 face of Christ which has been deliberately distressed around the edges to emulate paint loss in the original pieces. Note that the painted hair above the crown of thorns shows in tracing to be in a similar state in 1877.

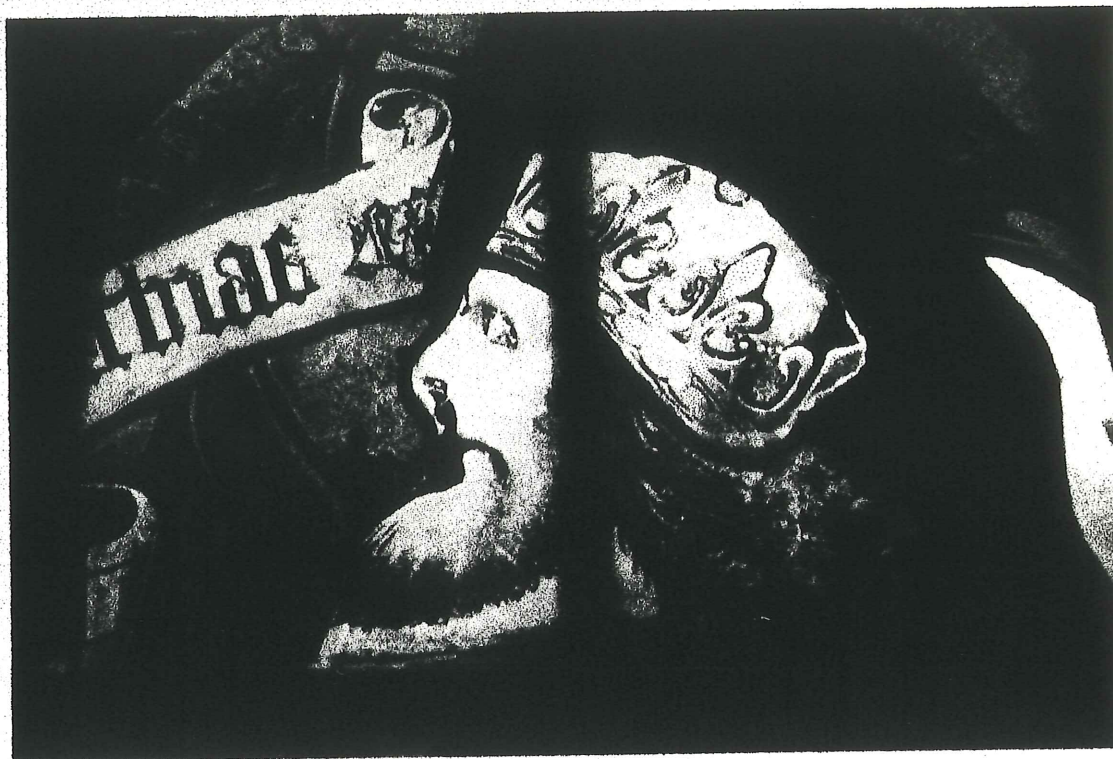
Photograph 14.4d Hezekiah -detail

iii) A comparison of the present condition of the painted work with the TT demonstrates that the TT differentiate, by means of intensity /thickness of lines, the condition of the pigment in 1877 and also where pigment had been entirely lost at that date: the areas indicated as unstable in 1877, correspond well to the evidence of the glass. This holds good throughout the window, but can easily be seen by examining inscriptions. For example, the tracing [2A] of the Daniel panel indicates loss of pigment to the left eye area and the inscription on his scroll corresponds in intensity to the glass as seen; Photo 5, p.19. The same is true for Manasseh in panel 4e, where the tracing [2E] shows pigment loss throughout the inscription which corresponds relatively to the glass, (photograph 17, p.27) though the loss is now greater, and for the inscription "Ahab" in 3f. (compare photograph 19, p.29 and tracing 3F). The tracing of Hezekiah [2D] shows the loss of detail to his left eye, comparable to its present condition - photograph 14, p.25.

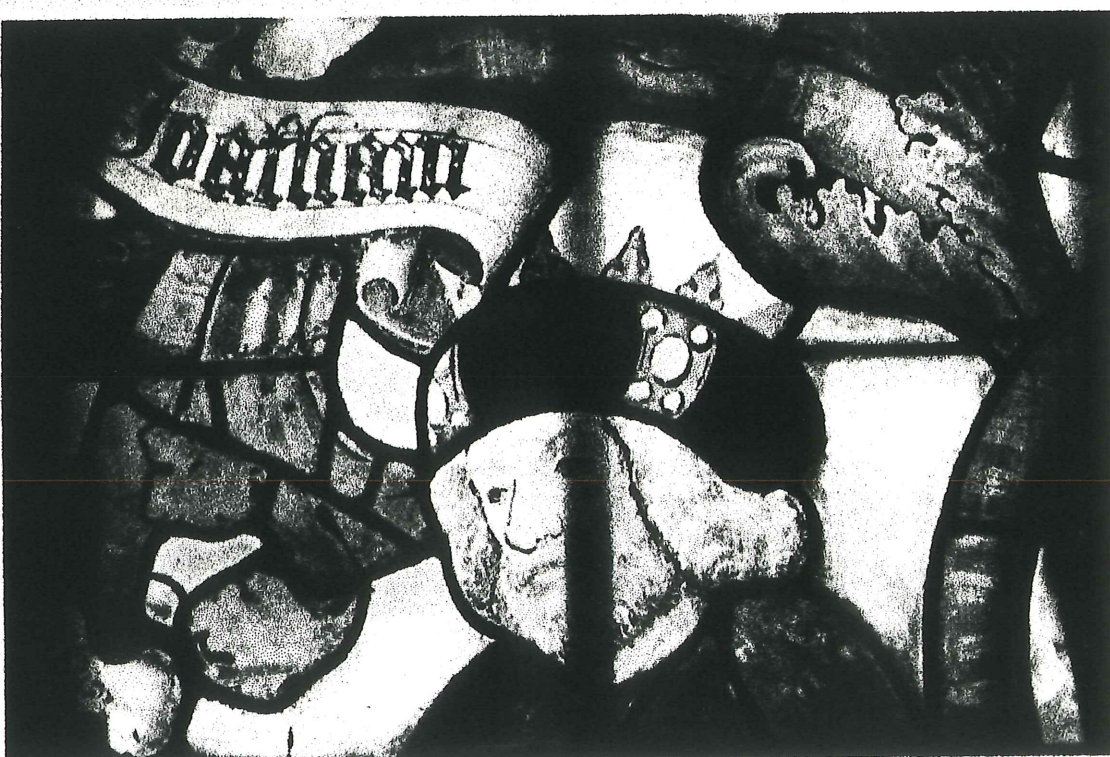
Photograph 16: 3e Jotham - detail

**c19 pigment v)** this has been 'antiqued' and distressed in places to match what would have been the condition of the original glass at that time. Photograph 16, p 26 shows the deliberate nature of the erasure of pigment by stickwork prior to firing in Jotham's inscription in 3e. The face of Christ (photograph 11, p. 23) has been mentioned above. Photograph 15, p 26 shows the detailing to right eye of Asa in 2e which appears to have been deliberately erased. It is a reverse image of upper part of c 15 figure of Ahaz (See note 5) ) which has suffered pigment loss to his right eye. Further antiquing appears to have been achieved by means of erasing pigment with a stiff brush. Photograph 28, p.35 of the Arms of Savile and Paston in 1b shows removal of paint prior to firing. These techniques make it more difficult to determine from an in situ inspection the degree of paint deterioration suffered by the c19 glass. The back painting to the c19 glass comprises a stippling or spattering to tone in with ancient glass (photograph 33, p 38)

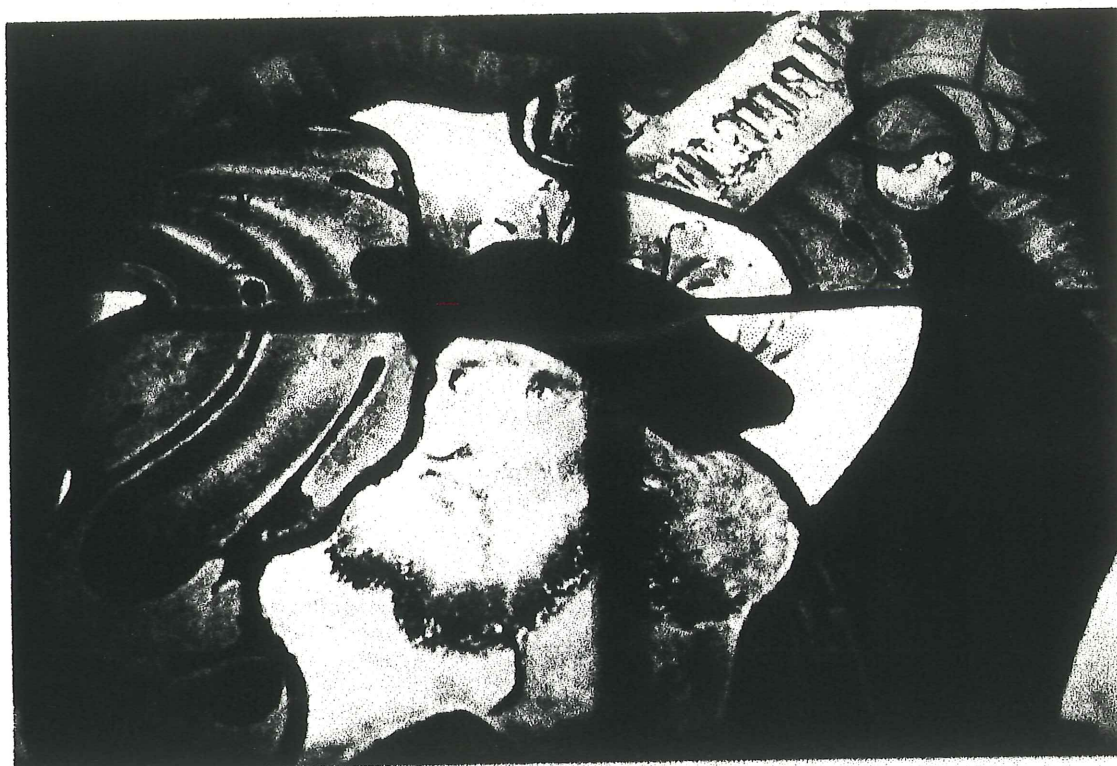
Photograph 17: 4e Manasseh -detail

In individual pieces of both pot metal and white glasses throughout the window, there is isolated pitting, with pits < 1 mm diameter on the external surface and to a lesser extent the internal surface. The frequency of small pits is greatest at the lower edge of such pieces both internally and externally: i.e. where water collects and is most noticeable in the ochre glasses of vine stem and leaves, but found to some extent in all colours. Pitting of this sort can be detected in photo 17, around lower edges)

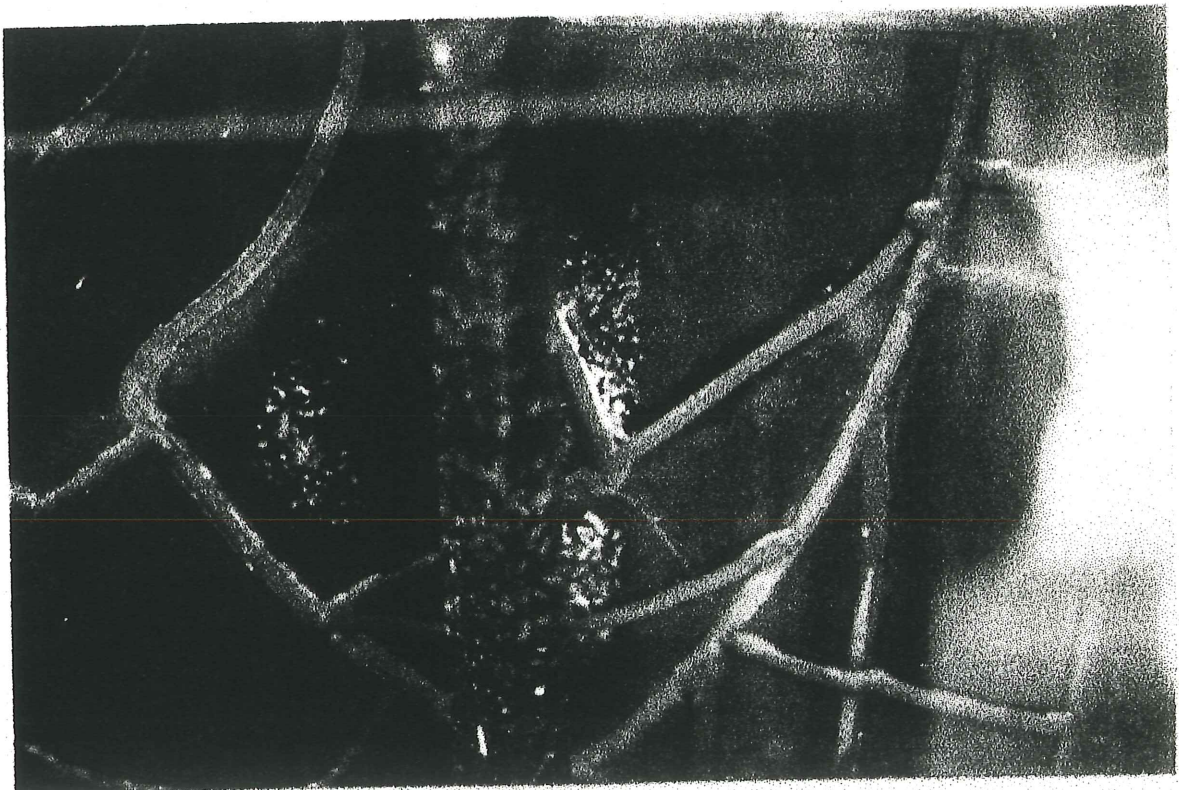
Photographs 22 & 23: Panel 2b internal and external of same detail - c15 murrey glass

ii) The deterioration of the c15 pink/purple "murrey" glasses is much more advanced than other glasses, and examples were noted in at least nine panels. (3a, 2b, 4b, 3c, 4c, 2d, 3d, 4e, 4f) The most deteriorated examples have lost both their original surfaces. They have a heavily pitted or crusted external surface (Ezekiel's hat in panel 4f has a light coloured crust) with an irregular internal surface, partially covered with a hard crust of a brown appearance. Additionally, the majority of these pieces are surface fractured. These glasses no longer transmit light efficiently or at all, and have a black appearance. Photograph 24, p 33 of piece from panel 2b ( Abijah) shows fracturing and crusting to internal face.

There are some pieces of murrey glass which, although surface-fractured, and with internal crusting to some extent, are only micropitted on the external surface. (See photo 23, p.32)

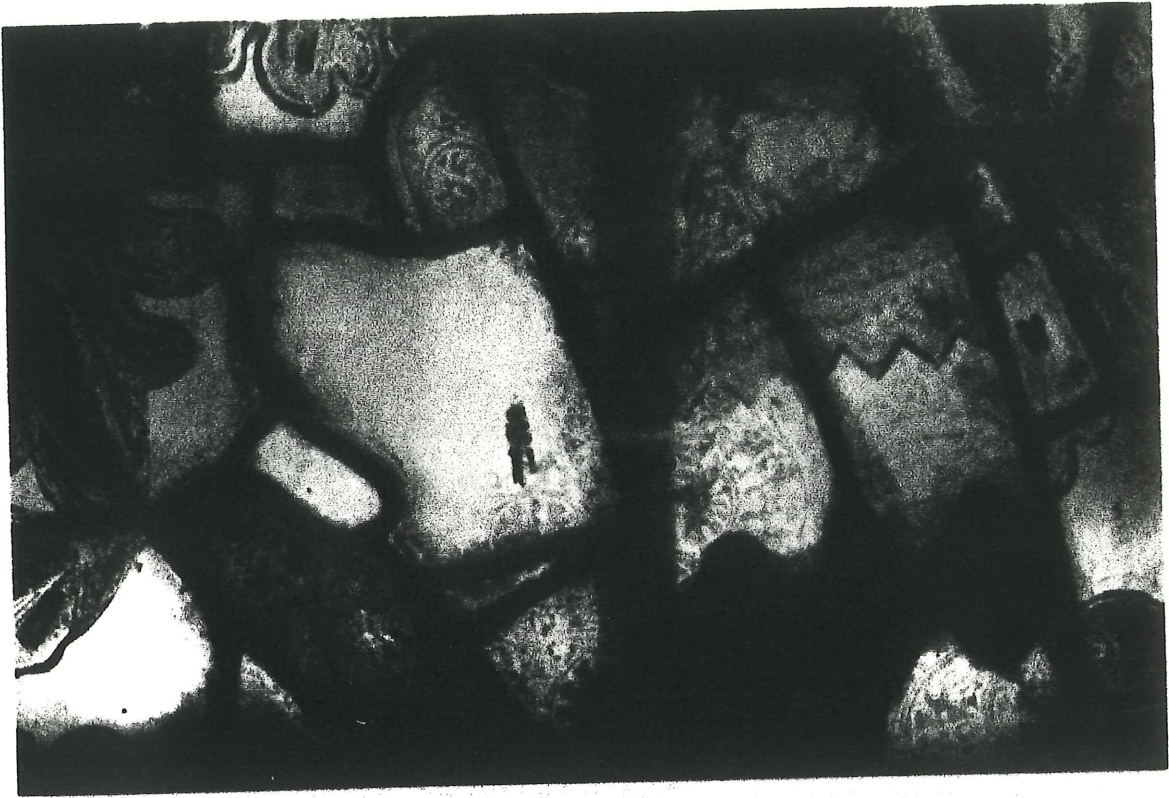
Photograph 28: 1b Savile/Paston armorial: intentional distressing of pigment prior to firing and pigment loss

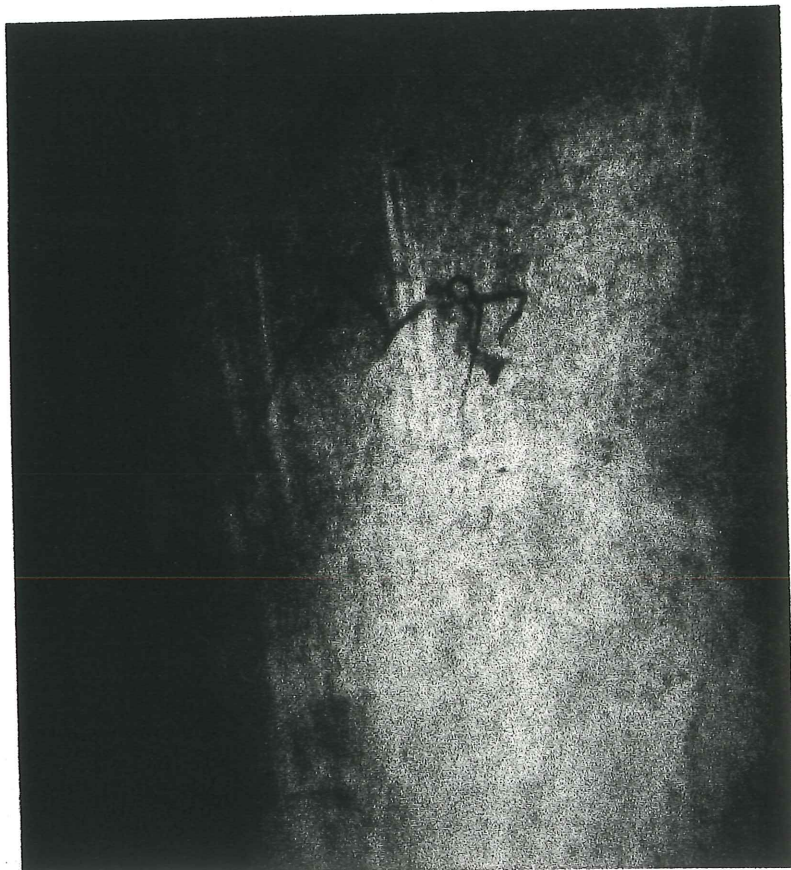
Photograph 29: 2b - ?glazier's mark on reverse

Abijah, standing three quarters right, wearing cap and crown, with purple robe; chain over left shoulder and under right arm. The Thornhill tracing<sup>9</sup> shows only the top half of this figure above waist. This, though somewhat scrambled, reads quite well. Photo 22, p.32 There is a glazier's mark in white glass above figure. See photo 29, p.35. Scroll, 'Abias', is c15. The glass is approximately 50% c15

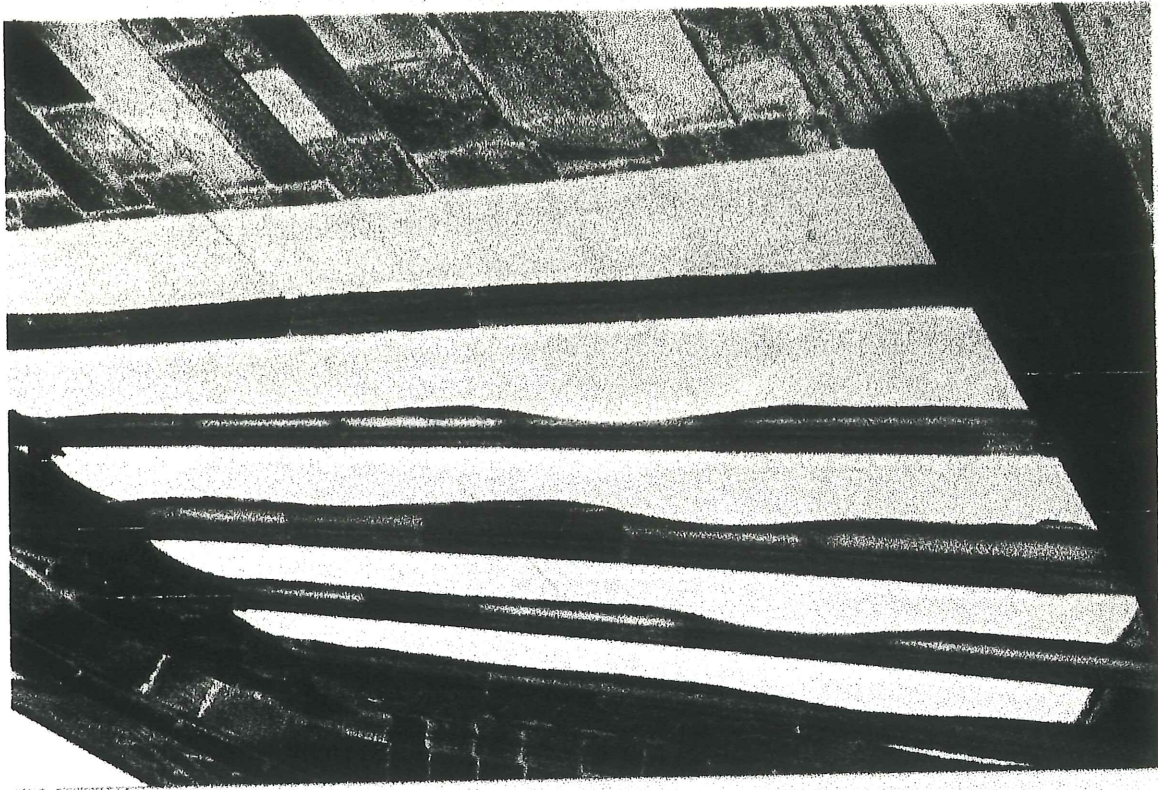
1. The thickness of material is not adequate for this application and there is too much flexing. Moreover, the fixing method, which does not allow for the degree of expansion needed for polycarbonate (as much as 1/8" expansion per linear foot~5 ), has caused bowing and distortion.

Photograph 31: full window (external) showing distortion of polycarbonate sheet  
Photograph 32: If jamb side(external), fixing method and debris in interspace

Isothermal glazing is internationally recognised as the best means in principle of retarding deterioration to glass, and to pigment. Given that the lead matrix is structurally sound, and would in any case no longer need to fulfil the function of weatherproofing the building, the panels could be mounted into frames with a minimal amount of intervention. A maintenance and monitoring programme could be considered. Suitable protection against impact damage should also be retained.

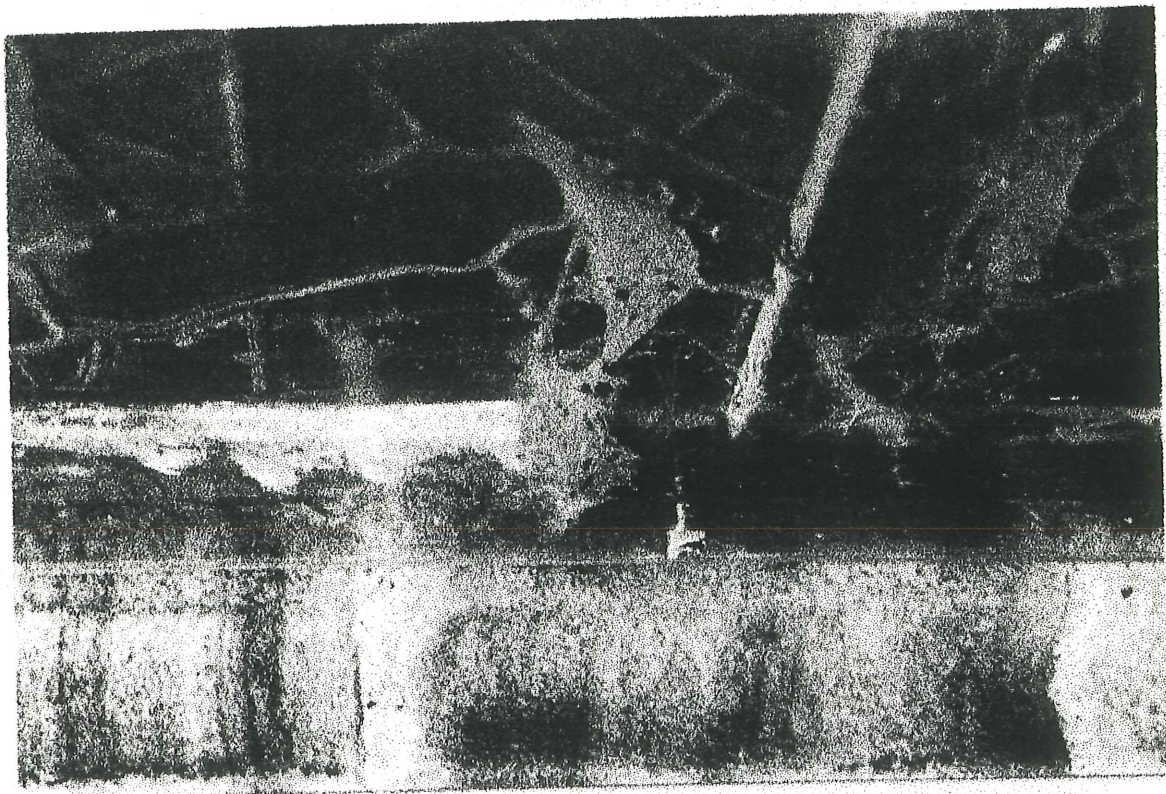
2. While the fixing method for the main lights is theoretically reversible, allowing access to the glass, that of the tracery is not, and damage to stonework could result from removal.

3. As noted above, the window appears not to have been cleaned prior to installation of the protective sheeting and the stone dust generated by drilling holes for the fixings of the wooden frame has not been removed. Protected in the interspace, this debris favours the collection of further deposits which may be damaging to the glass.

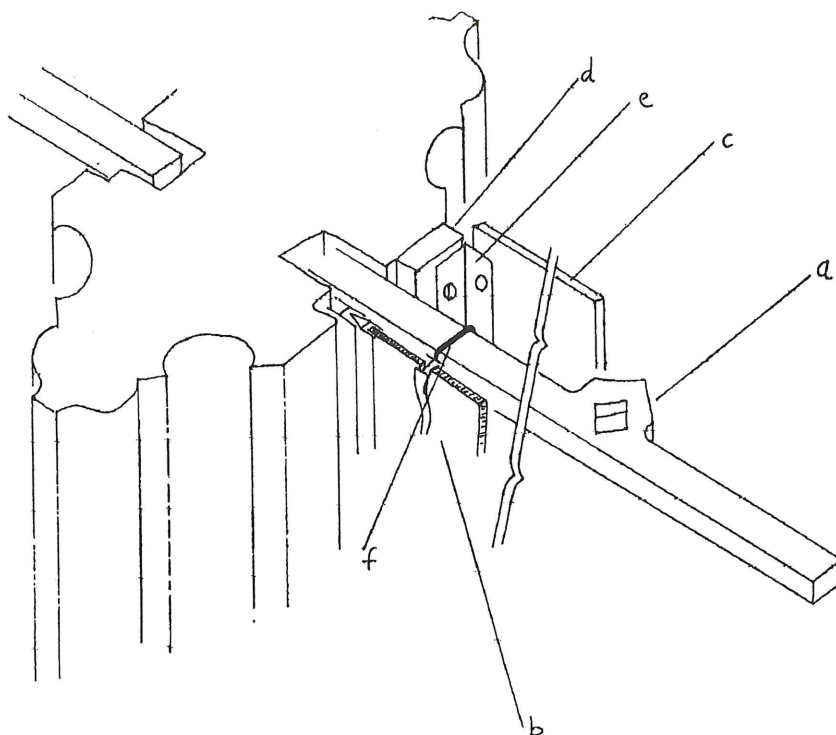
**Diagram 3**

Axonometric view showing installation method of polycarbonate sheeting.

- a. lugbar
- b. stained glass
- c. polycarbonate sheet
- d. soft wood frame
- e. bracket
- f. copper tie
