Thornhill St Michael & All Angels: east window
Conservation undertaken January -May 2000 J&R Cooke

**Thornhill St Michael & All Angels: east window
Conservation undertaken January- May 2000 J&R Cooke**

Thornhill St Michael and All Angels: Great East window: panel 1a

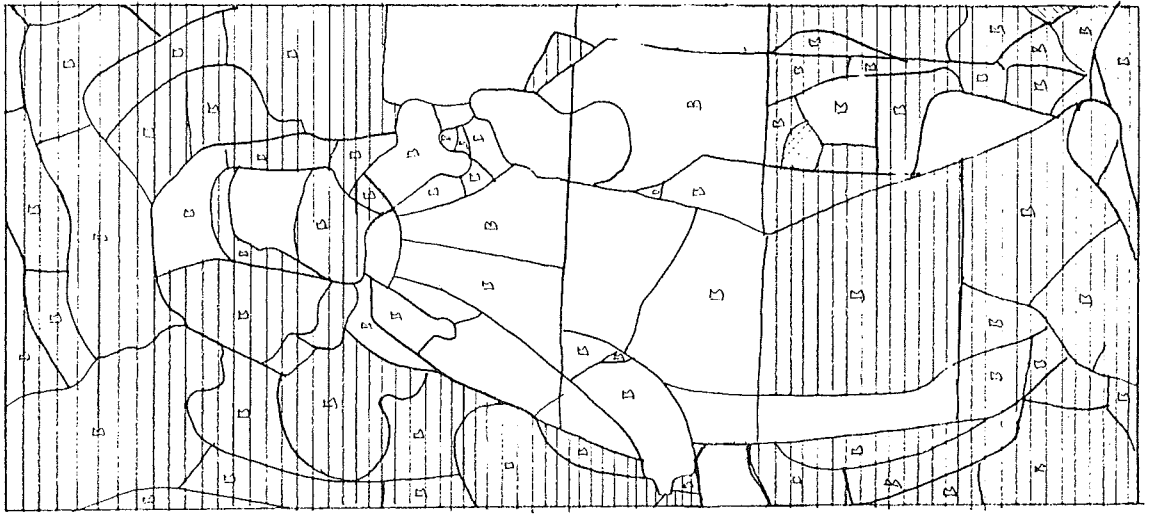
Restoration diagram

J&R Cooke for Barley Studios 2000
Thornhill St Michael and All Angels: Great East window: panel 2a

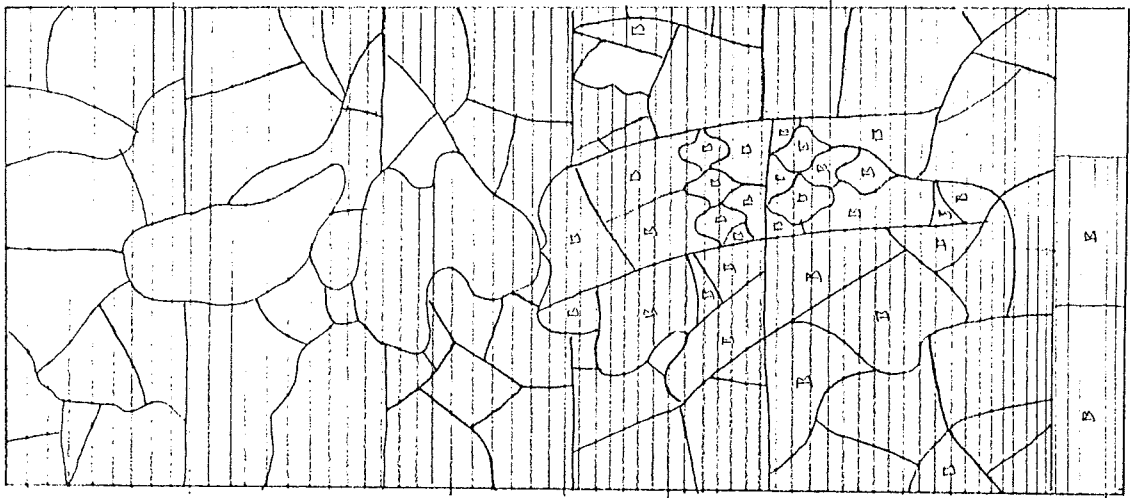
Restoration diagram

J&R Cooke for Barley Studios 2000
Thornhill St Michael and All Angels: Great East window: panel 1b

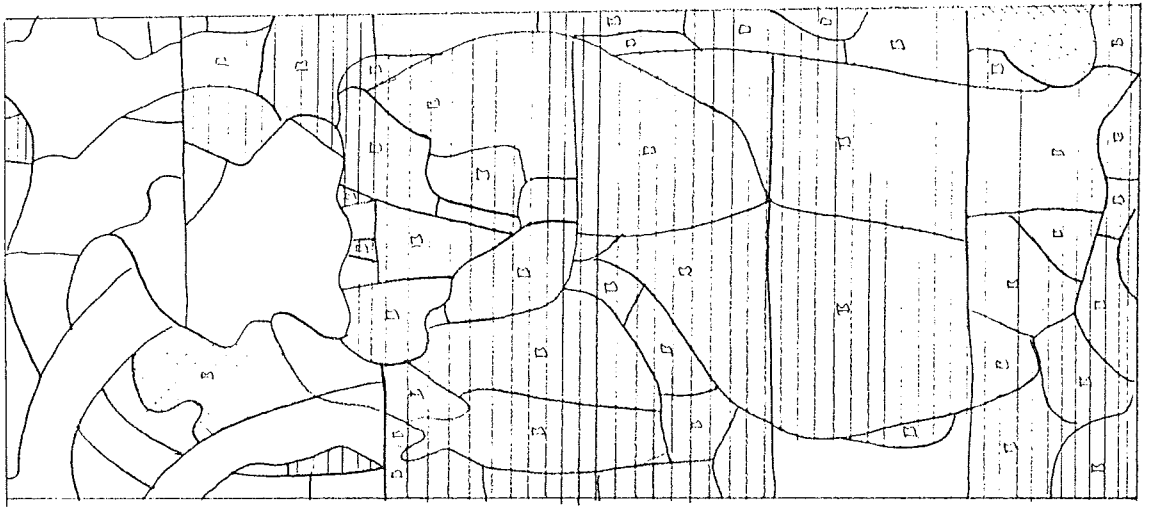
Restoration diagram

J&R Cooke for Barley Studios 2000
Thornhill St Michael and All Angels: Great East window: panel 3b

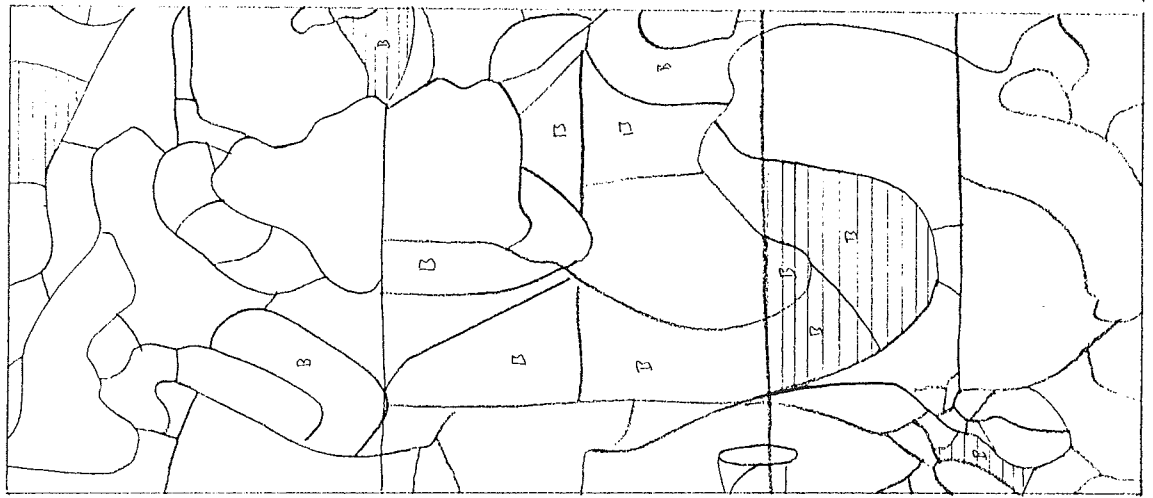
Restoration diagram

J&R Cooke for Barley Studios 2000
Thornhill St Michael and All Angels: Great East window: panel 4b

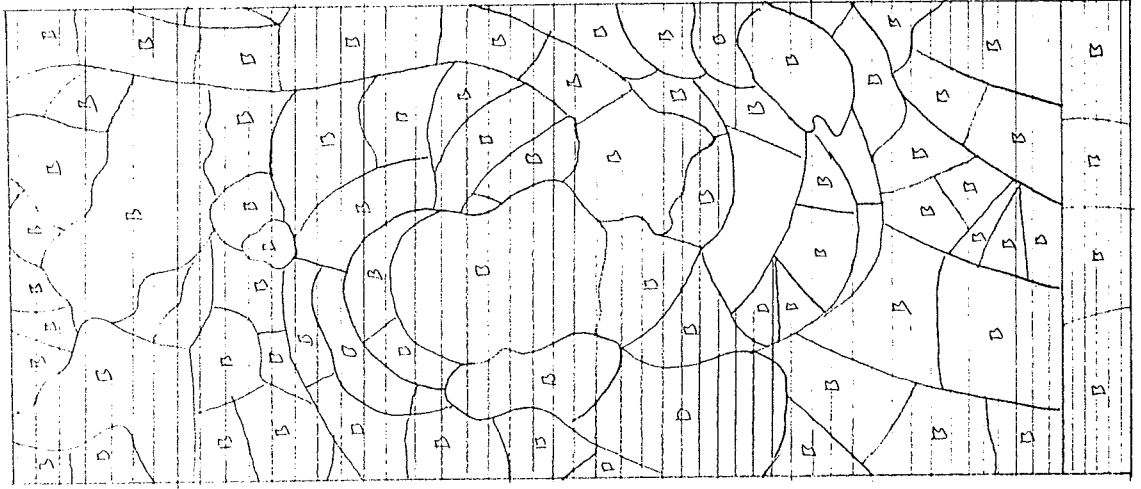
Restoration diagram

J&R Cooke for Barley Studios 2000
Thornhill St Michael and All Angels: Great East window: panel 1c

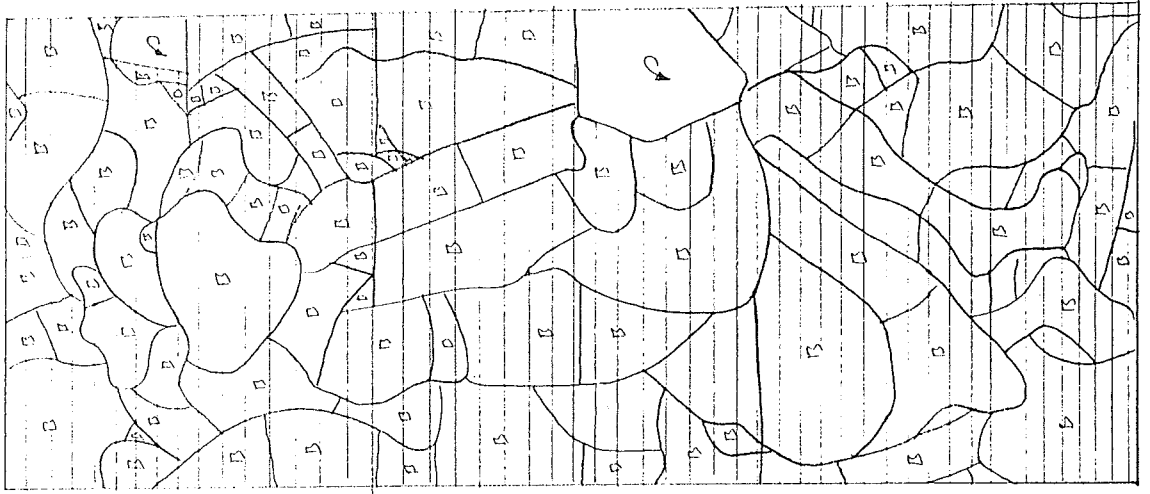
Restoration diagram

J&R Cooke for Barley Studios 2000
Thornhill St Michael and All Angels: Great East window: panel 2c

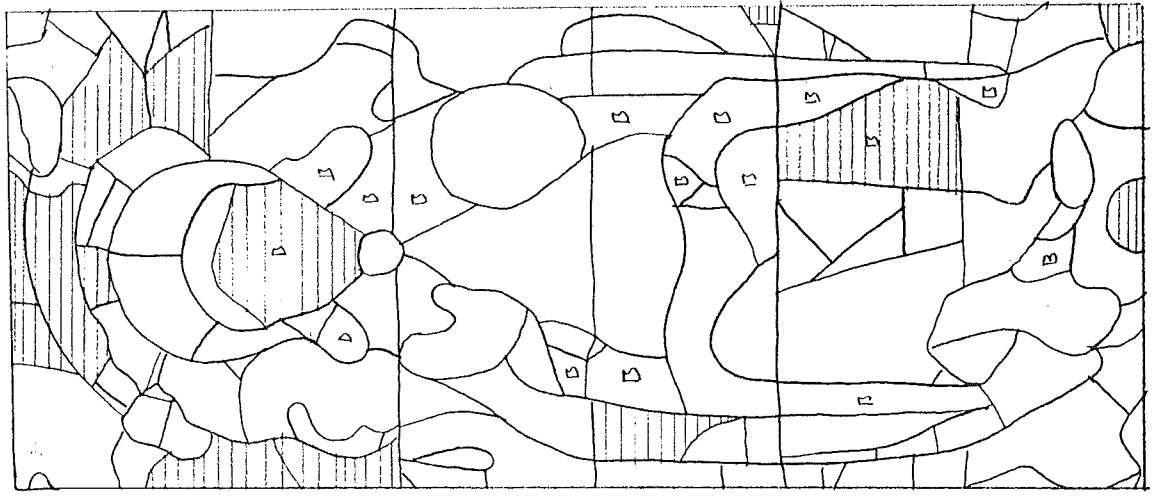
Restoration diagram

J&R Cooke for Barley Studios 2000
Thornhill St Michael and All Angels: Great East window: panel 4c

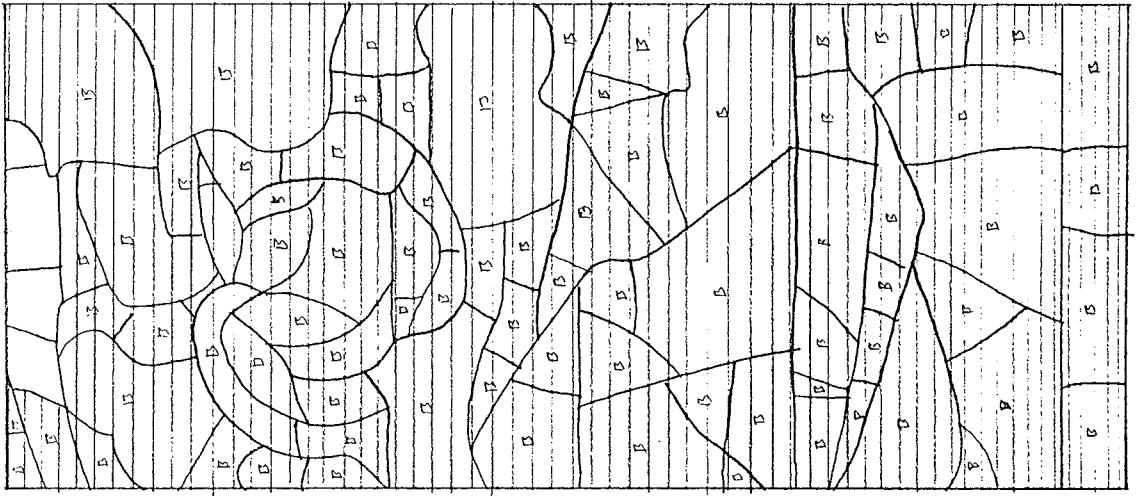
Restoration diagram

J&R Cooke for Barley Studios 2000
Thornhill St Michael and All Angels: Great East window: panel 1d

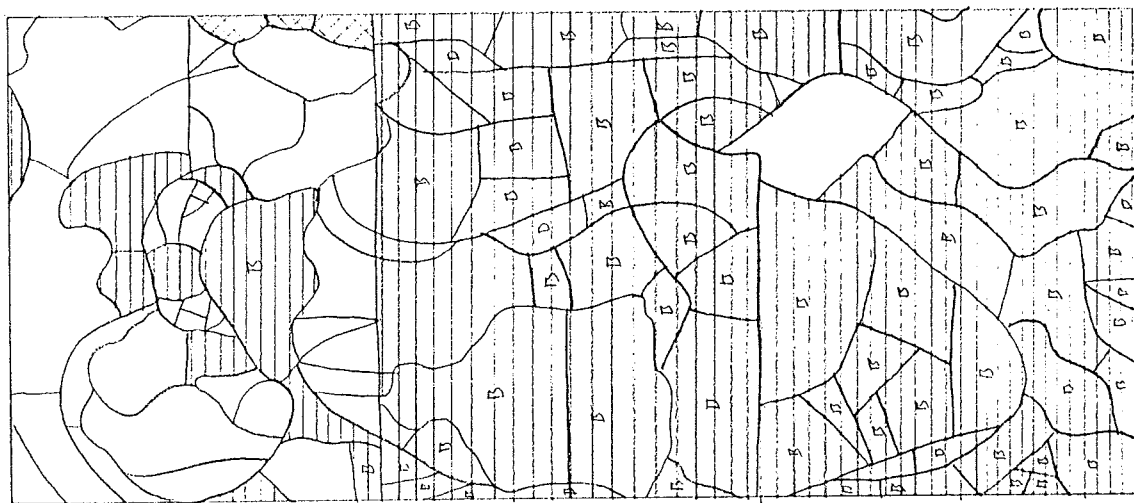
Restoration diagram

J&R Cooke for Barley Studios, 2000
Thornhill St Michael and All Angels: Great East window: panel 2d

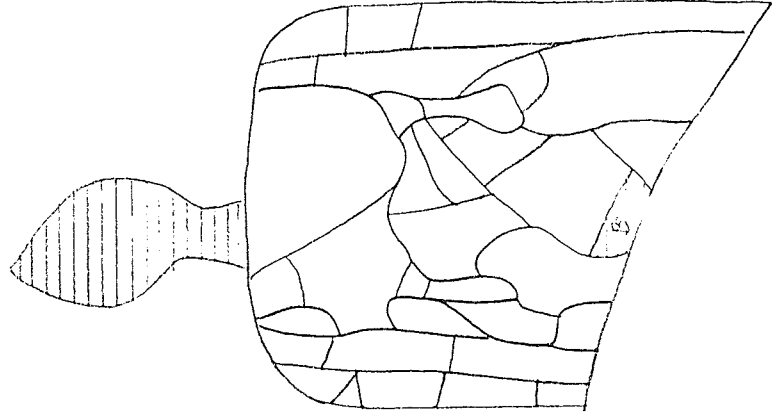
Restoration diagram

J&R Cooke for Barley Studios 2000
Thornhill St Michael and All Angels: Great East window: panel A1
