Monument # 3 Anne Savile † 1878 & Henri Savile † 1881

The Works

The wall mounted monument, comprising of alabaster and brass with inlaid paint, was cleaned using solvent and mechanical means to reduce accumulated dirt and disrupted paint. A protective, conservation-grade wax was then applied and dusted with purified talc.

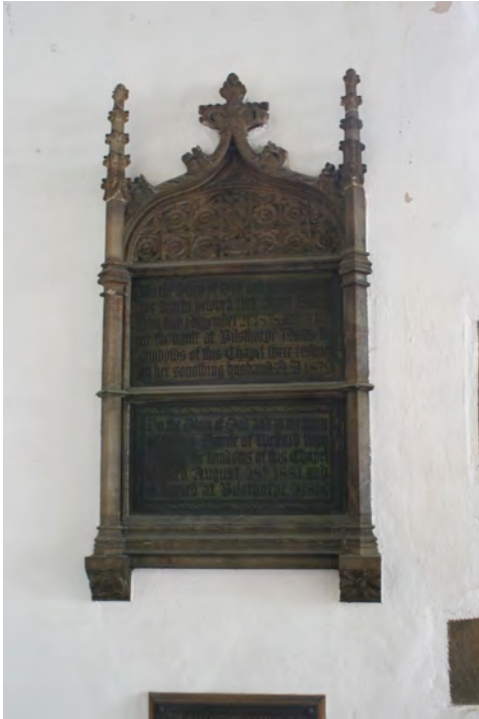
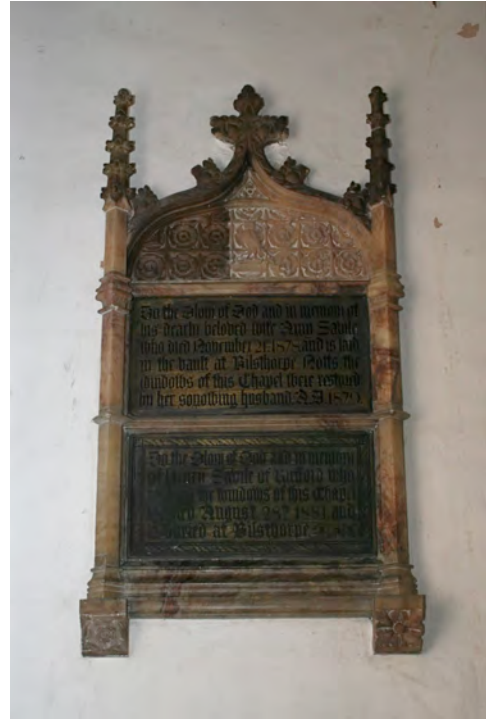
General view of the monument before and during treatment, with a cleaning contrast clearly visible to the upper elements. Note how the carved detail to the panel within the ogee arch, are completely lost due to the heavy uniform soiling.

- 4.3 All alabaster elements were cleaned with 'Solvol Autosol' applied by soft bristle brush and neutralised immediately with white spirit. Any residues in undercutting of the carving was removed with the aid of a vacuum cleaner and stiff bristle brush, followed by cotton wool swabs dampened with white spirit.

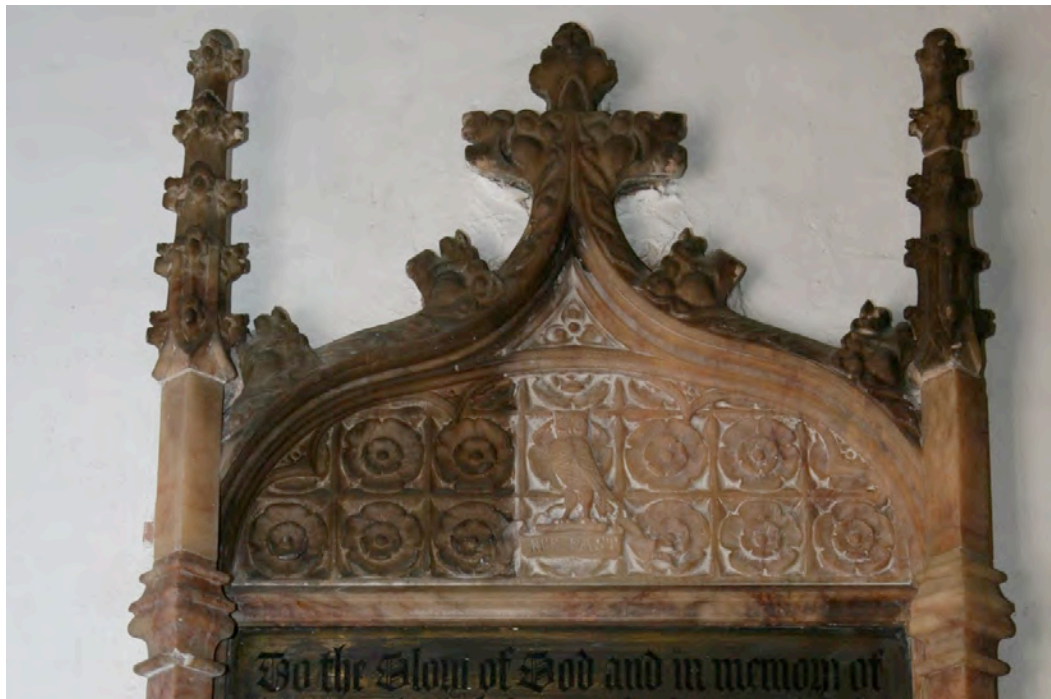
Detail of the repeat foliage decoration incorporating the Savile family motto, note how the rich veining within the alabaster has been restored visually.

- 5.1 Once cleaned the alabaster was given a single brush application of 'Renaissance' micro-crystalline wax, this was dusted with purified talc such that the inevitable airborne dirt sits on the coating and not the cleaned alabaster.
