Monument # 4 Sir George Savile 8th Bart † 1784

The Works

A wall mounted monument, comprising of white marble, dark-grey carboniferous limestone, grey decorative marble and black paint within the inscription. The monument was cleaned using a combination of solvents, Solvol Autosol, Sepiolite clay and steam.

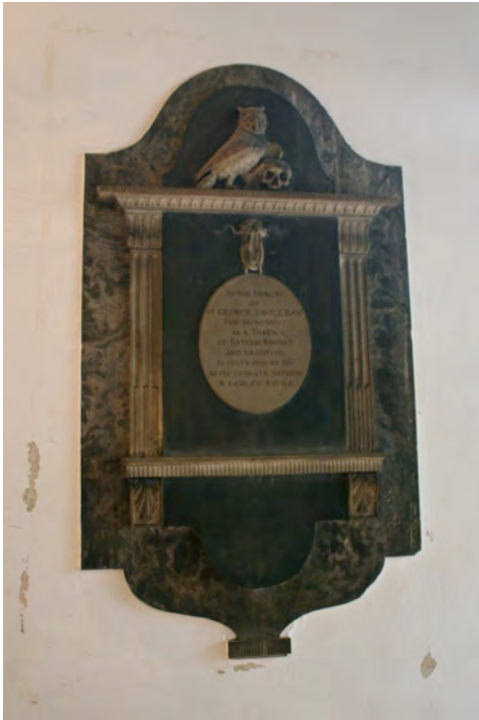
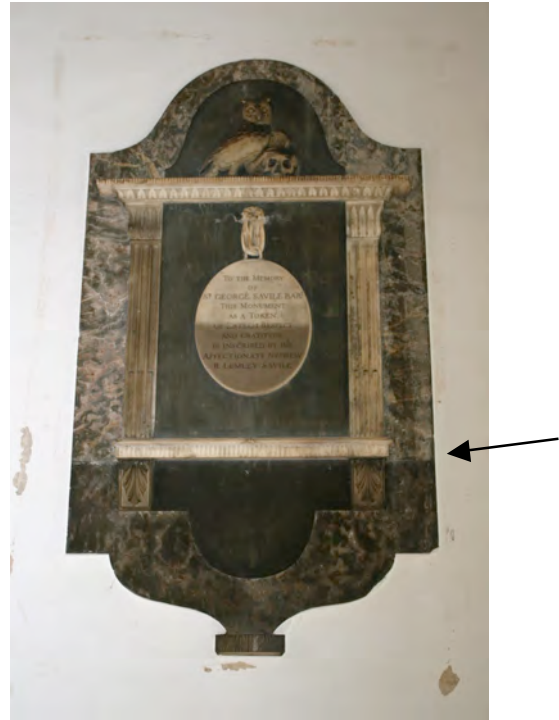
General views before and during cleaning. The image on the right shows the light-grey background has been cleaned down to surbase level (indicated) the lighter areas above are where all original surface polish has been lost, the darker grey (cleaned) areas are where original polish remains, the lower sections and the owl are still to be cleaned.

- 4.3 The whole monument was degreased with acetone applied on cotton wool pads. All elements were then cleaned with 'Solvof Autosol' applied by a mixture of soft stencil brushes and cotton wool pads, and neutralised immediately with white spirit. Any residues in the carving was removed with the aid of a vacuum cleaner and stiff bristle brush, followed by cotton wool swabs dampened with white spirit. After preliminary cleaning, the owl was observed to be unacceptably dirty still, due largely to the poor finishing of the surface, having trapped dirt within the pore structure.

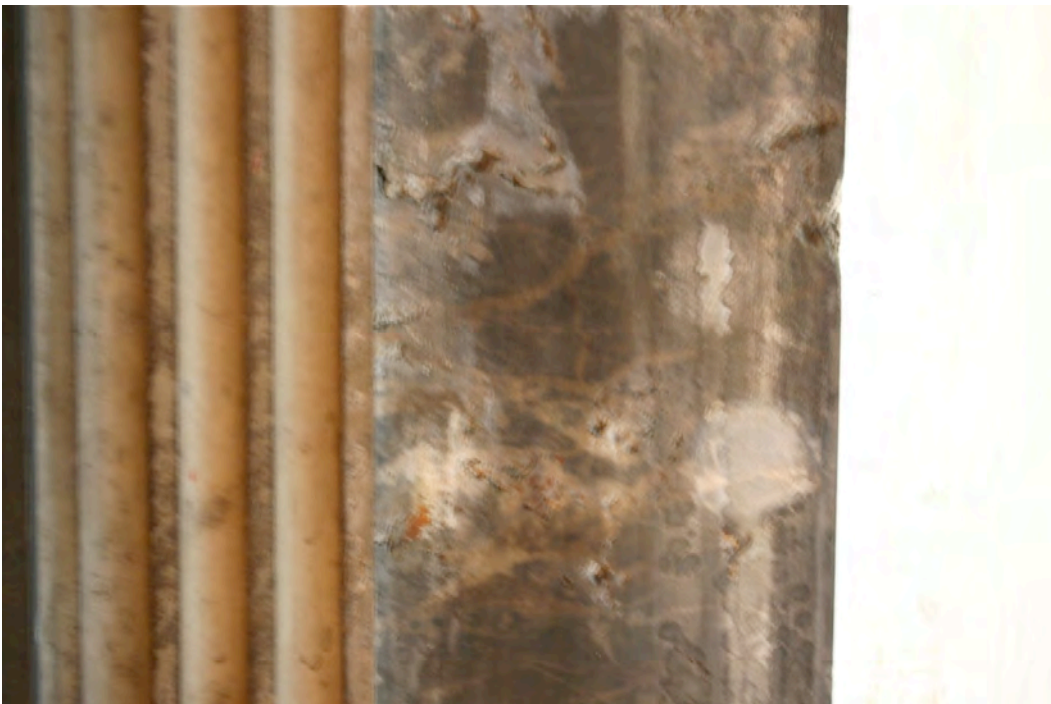
Detailed view of the poor (geological) quality of the light-grey decorative marble, with historic loss of material to the unusually weak calcite component. This is across the whole surface area of the slab and is not isolated to this area. Despite its dramatic appearance deterioration is not accelerated or progressive and these areas still remain solid. The deterioration may even be due to the original polishing process.

- 3.4 The light-grey decorative marble (not a building material) has survived poorly due to the inherently weak geological nature of this particular marble. Fissuring can be seen at random over the surface although these areas are still solid. Vertical water marking can be clearly seen on the viewers' right-hand side, with the lighter grey areas where all surface polish has been lost. The darker areas are where some surface polish remains. The fluting to the lower, right pilaster is sucrose at random, in small areas and as such was not up to low-pressure steam cleaning.

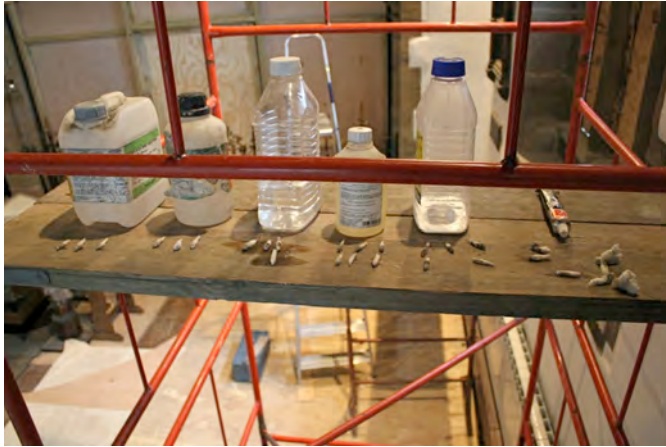
Context view of cleaning trials in progress when the range of solvents/materials known to work on the different materials present are trialled and then evaluated to determine the safest most effective technique/material.

- 4.2 A series of cleaning and solubility trials were conducted on representative areas of the marbles (which responded well) and the coating to the brass panels.

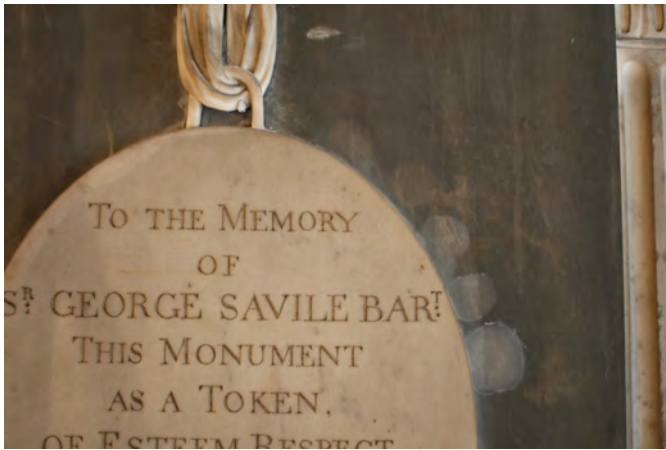
Cleaning trials in progress around the perimeter of the elliptical inscription panel, note how heavily soiled the dark-grey background panel was prior to wholesale cleaning.

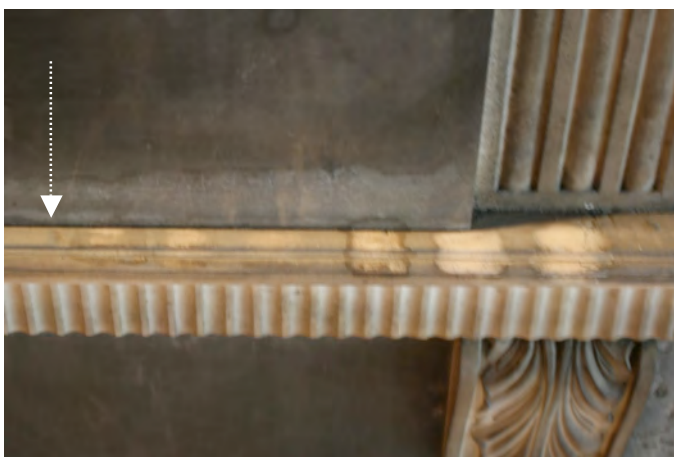
More cleaning trials to a discrete, heavily soiled area of the white marble, with trials starting at the far left-hand side (indicated) with more gentle, volatile materials, gradually increasing in strength to the abrasive paste at the far right-hand side.
