## St Michael and All Angels' Church, Thornhill East Window of the Savile Chapel

19<sup>th</sup> October 2008

David Martlew

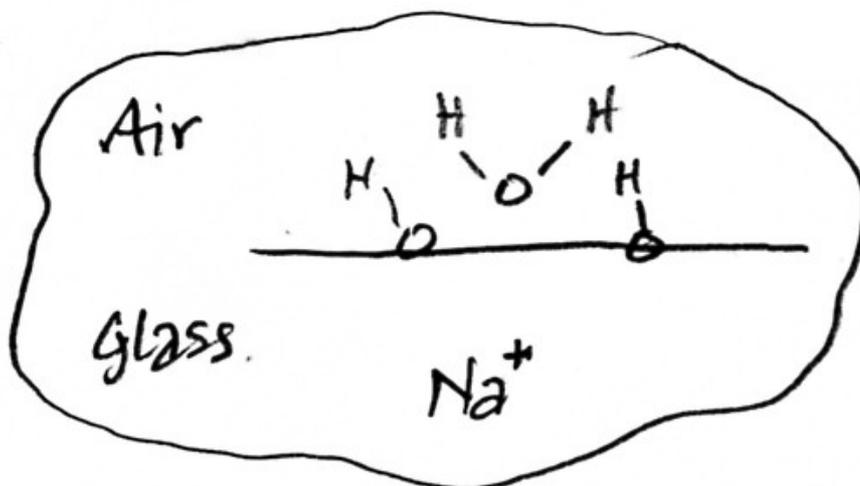
*Sketch 1: the glass surface, showing an adsorbed water molecule and, within the glass, a sodium ion*

Water molecules occasionally break apart, H<sub>2</sub>O becoming H<sup>+</sup> and OH<sup>-</sup> for a while. H<sup>+</sup> is very aggressive, instantly commandeering another water molecule to become H<sub>3</sub>O<sup>+</sup> which is capable of burrowing into the glass, thereby allowing a sodium ion Na<sup>+</sup> to escape from the glass and come to the surface. The two ions swap over as indicated in Sketch 2 below.

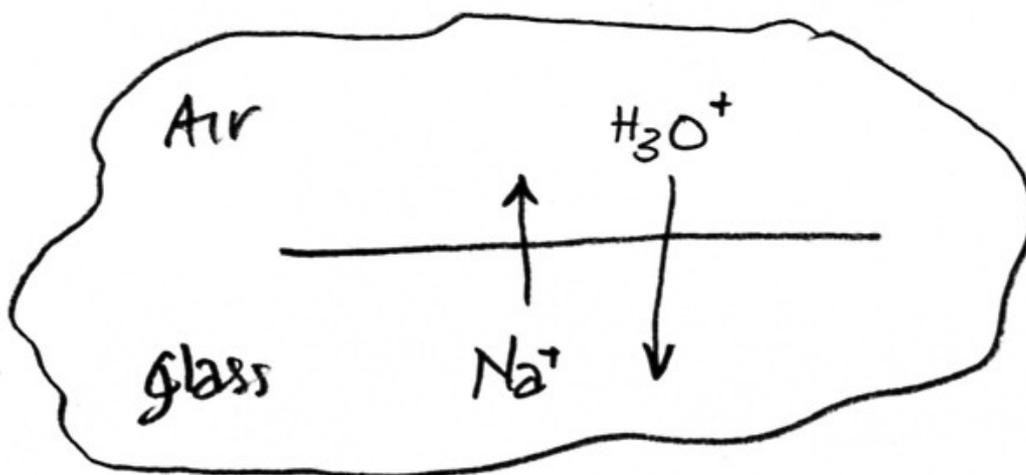
*Sketch 2: the exchange of sodium in the glass with water at the surface*

Dr Fearn's measurements indicate that for every hydrogen atom which remains in the glass, three sodium atoms are lost at the surface. An explanation of this is that the  $\text{H}_3\text{O}^+$  ion in the glass reacts with the network of silicon and oxygen atoms which makes up the molecular framework of the glass, creating  $\text{OH}^-$  ions. These negative ions can balance the positive sodium ions if they move along with them, so pairs of  $\text{Na}^+$  and  $\text{OH}^-$  ions can diffuse up to the surface and are lost from the glass structure.

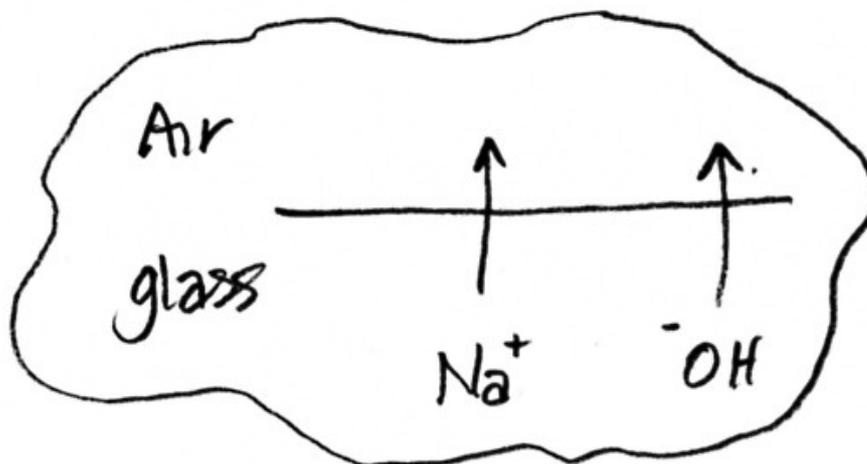
*Sketch 3: co-diffusion of positive sodium ions and negative hydroxyl ions to the glass surface*

Two things then happen. The sodium hydroxide which accumulates at the glass surface serves as a focal point which attracts water - ultimately in the form of visible droplets of moisture. Certain sensitive glass artefacts in museum cases exhibit this phenomenon, known to curators as "weeping" glass disease. In all probability the same thing happens in context of architectural glass, but that is much less easily seen.

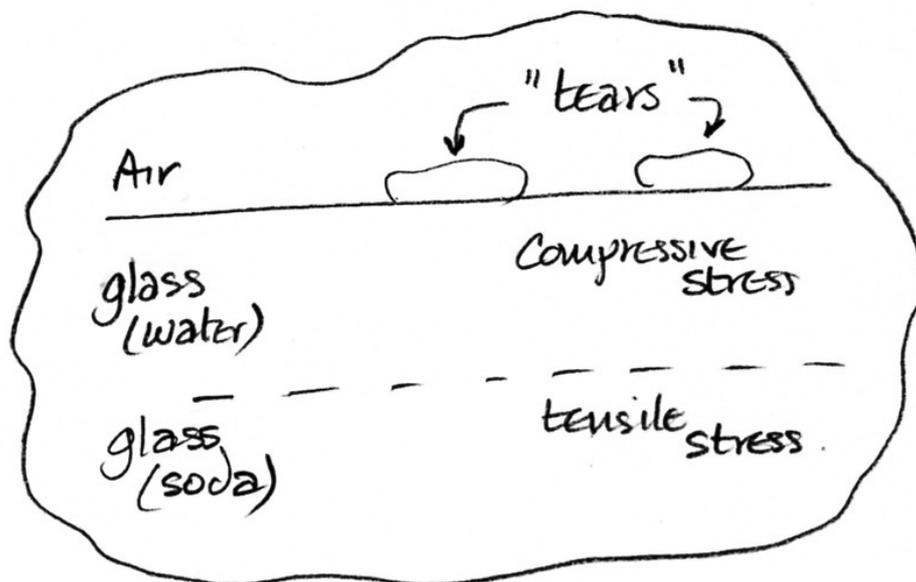
*Sketch 4: development of tears on the surface and stress within the layers of the glass*

As a result, the surface layer has a compressive stress set up in it, and there is a balancing tensile stress in the unchanged layer beneath. This stress distribution is rather like that in thermally tempered glass: the compressive stress at the surface helps prevent cracking occurring.

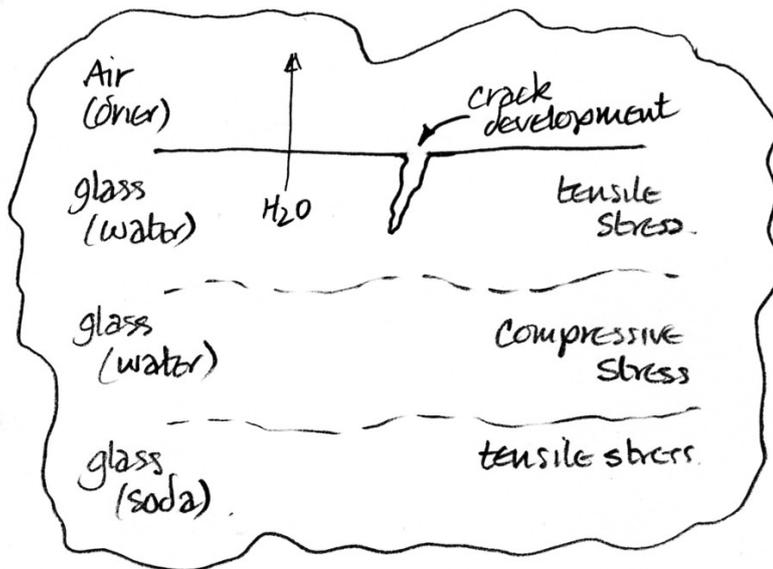
Whilst the moisture content of the atmosphere remains constant, all is well. The dangerous moment is when the surrounding air dries out. The surface layer of glass loses water to the air above, and as it does so it starts to shrink. Again, the layers of glass are anchored to one another, so the surface of the glass starts to experience a tensile stress. In that circumstance microscopic flaws start to open up, turning into small cracks which grow sideways along the surface and downwards into the glass. Sketch 5 depicts this in a schematic fashion.

In a museum context, this becomes visible as a very fine network of cracks extending over the surface of the artefact – known as “crazzling”. I believe that the Thornhill glass must have passed through this stage in the past.

Sketch 5: loss of water from the hydrated layer causes tensile stress in the surface which encourages cracks to grow

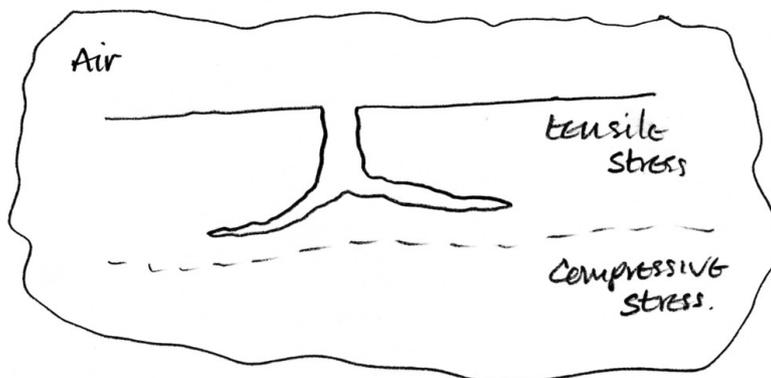
Beneath the surface layer there is still a layer lower down which has not lost water and which is still under compression. As the growing cracks extend downwards they respond to this changing stress condition and are deflected, bifurcating and starting to run parallel with the surfaces. Sketch 6 attempts to illustrate this.

Sketch 6: developing cracks being deflected by the prevailing stress fields in the glass

Inevitably as these sideways extensions to the cracks develop, some will meet up. In the end, fragments of surface glass will become completely separated from the bulk, falling off as little shell-shaped pieces. This process is known as "shelling" or "spalling", and it results in complete and irreversible loss of the surface glass, leaving behind scoop-shaped fractures known as "conchoidal" fractures.

Visually the badly affected pieces of glass in the Savile Chapel East Window show this appearance over most of their interior-facing surfaces. One would expect that this process would leave a jagged surface with sharp ridges between the hollows, but careful examination of the panes with a hand lens show that these ridges are rounded off at the tops. The most likely explanation of that is that the attack by atmospheric moisture has been continuing for many years and so the original shape features have become blunted.
