**St Michael & All Angels Church, Thornhill.  
Conservation report on the internal monuments**

**The basis of the report and an analysis of the general  
environmental conditions of the church.**

**Prepared for:  
Thornhill Parish Church Council  
June 2010**

**By  
MARTIN HOLDEN  
SCULPTURE AND ARCHITECTURAL CONSERVATION SERVICES  
Dalshangan  
Carsphairn  
Dalry  
DG7 3SZ**

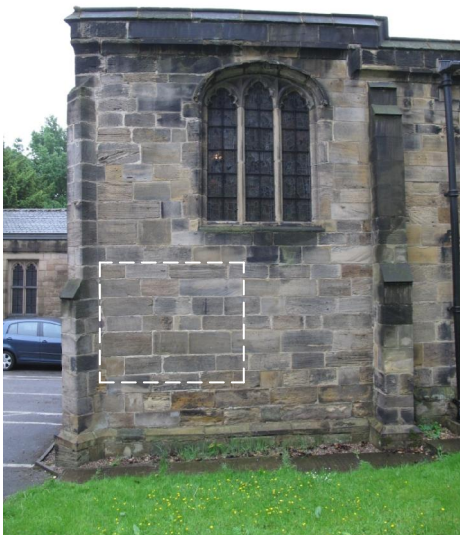
09/332

It would appear that there has been more than one re-pointing on this elevation and it is of mixed quality. Overall the pointing is in fair condition but some may be a little too hard. It would be of benefit to detail the mortar joints and ascertain if there would be any benefit to reducing moisture in the walls further by replacing some of the mortar where it is missing, defective or inappropriate.

*Location of the detailed photograph above.*

The pointing is in fair condition and the stone work itself generally fit for purpose. As referred to above it would be worth undertaking a detailed survey of the pointing to ascertain if the mortar is both suitable (not too hard) and in good condition.
