Thornhill St Michael and All Angels
(Anglican Diocese of Leeds)

Condition Report
on windows sIV and sV
with recommendations and
outline method statement

Jonathan and Ruth Cooke
June 2020

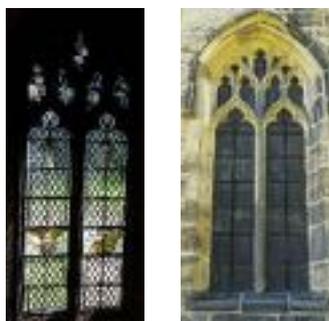
sIV south aisle south wall second from east

twin light window, five principal, four further small tracery lights, perpendicular fenestration c.1490. Masonry, ashlar, mainly c19, though some of the hood moulding and parts of external cill could be medieval. Stainless steel guards, set within sight size apertures; apparently non-ferrous fixings.

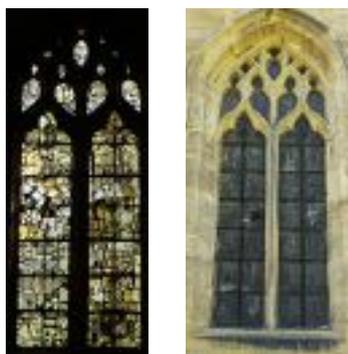
sV south aisle south wall third from east

Twin light window, five principal, seven smaller tracery lights, perpendicular fenestration c. 1490. Masonry, ashlar, reveals and hood moulds probably c15, elsewhere, c19.
