SIXTEENTH – CENTURY MONUMENT

Church of St Michael & All Angels

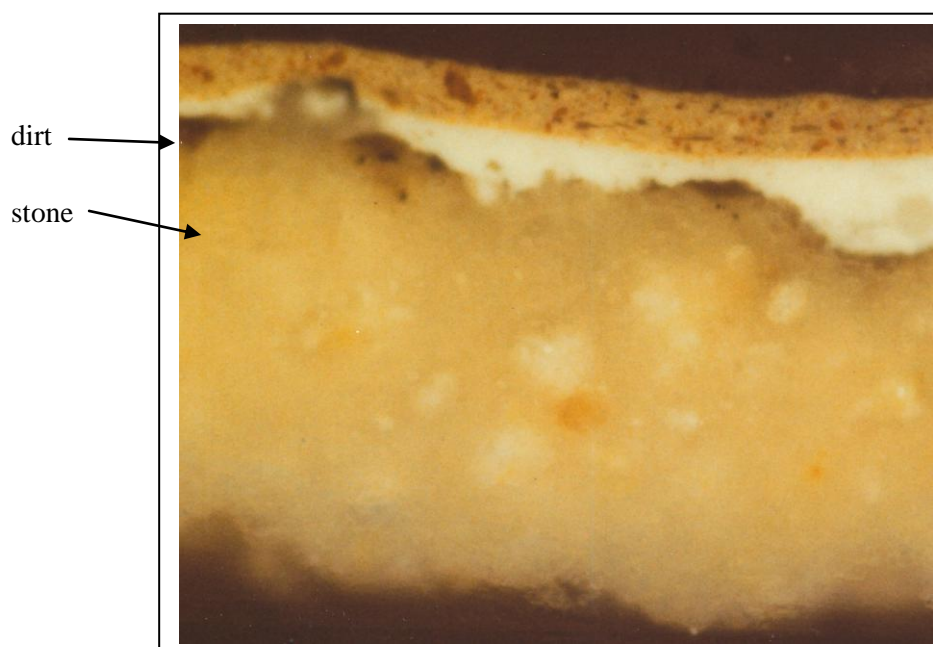
The sections show a dirt-stained stone surface, followed but a single paint scheme, consisting of a white undercoat and a light brown, or stone-coloured, top coat.

The main pigment in the paint is lithopone, which is a combination of zinc sulphide and barium sulphate. Lithopone was widely used in house paints in the middle decades of the twentieth century. It was largely displaced by titanium white in the 1950s/60s, but it is still occasionally used.

For certain identification of the medium, instrumental organic analysis would have to be carried out, but the pigments point to it being a type of oil paint. There is some extender present, in the form of chalk, but the ratio of lithopone to chalk is high which suggests the paint is unlikely to be an emulsion paint or a water-based paint.
