**St Michael & All Angels Church, Thornhill.  
Conservation report on the internal monuments**

**General description and Detailed condition survey of the  
monument to Sir George and Lady Anne Savile – south  
elevation**

**Prepared for:  
Thornhill Parish Church Council  
June 2010**

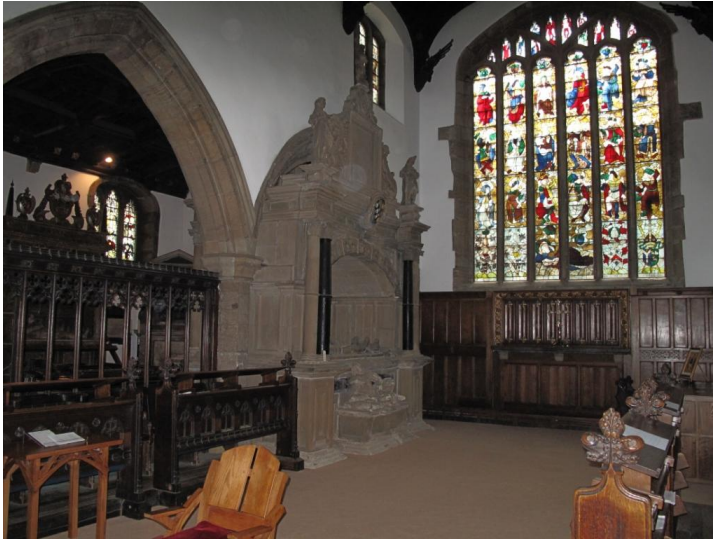
08/001

General view of the monument located within the chancel.

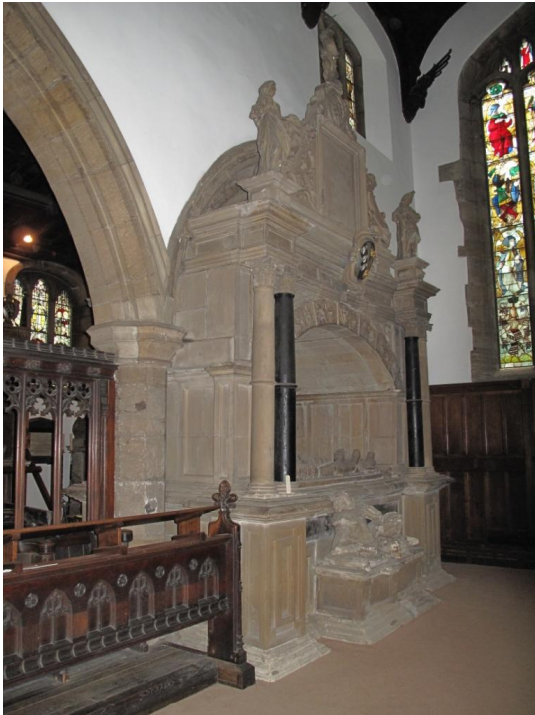
08/003

General view of the west elevation.

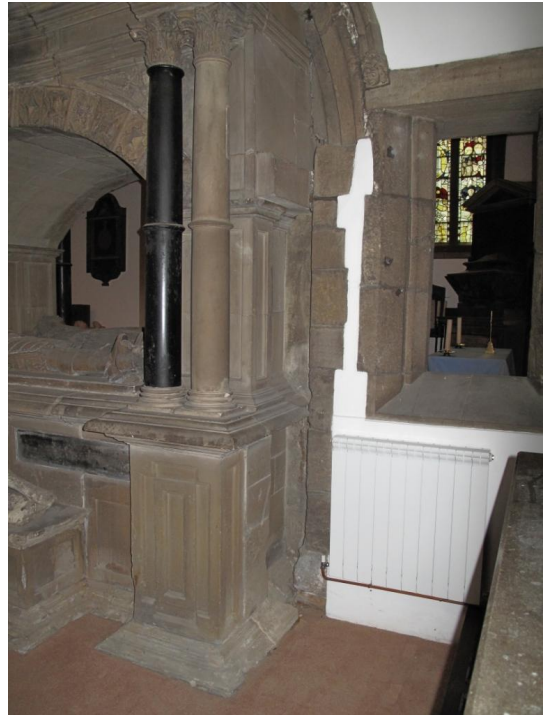
08/004

General view of the lower section of the east elevation.

The monument has a heavy covering of dust and dirt; some being superficial and would be easily removed by vacuum and some being much more ingrained and not easily removed. This is responsible for the general grey surface appearance.

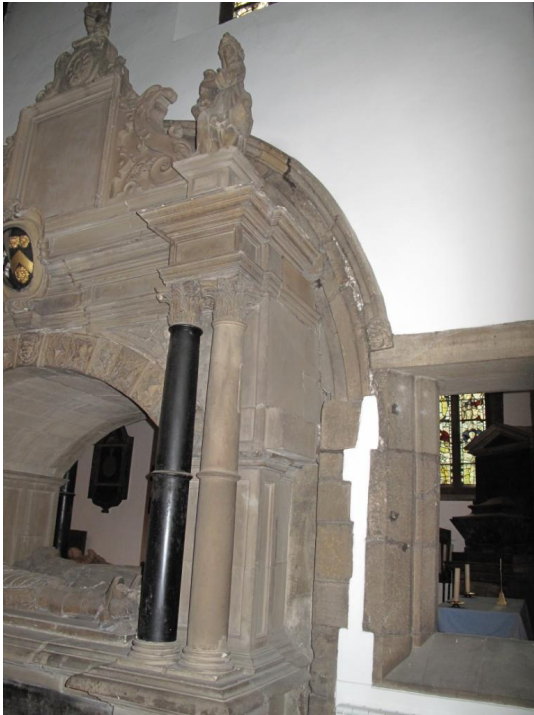
08/005

General view of the upper section of the east elevation.

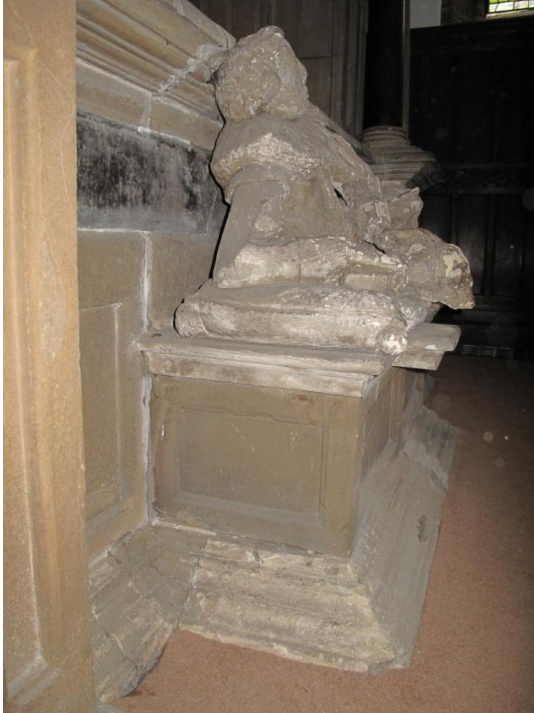
08/016

Western elevation of the son's effigy.

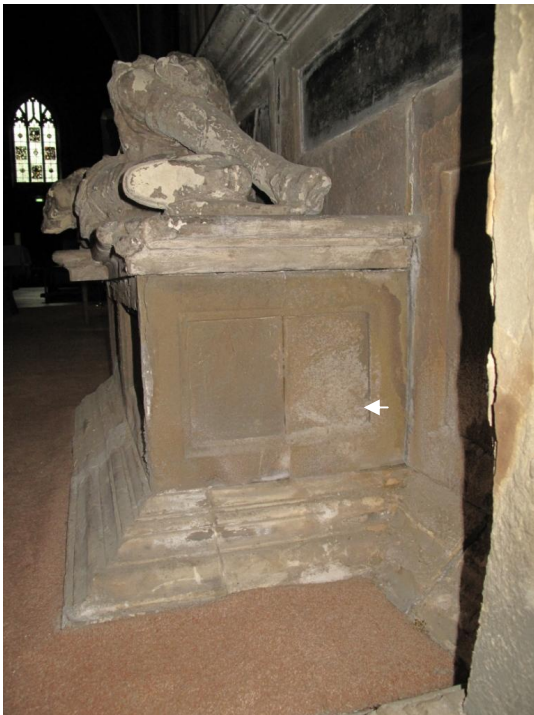
08/019

Eastern elevation of the son's effigy.

The sole of the foot is actively eroding leaving the white tone of the stone in contrast to the darker surface coating.

Note the salt efflorescence on the end panel of the son's chest (white arrow) which is shown in greater detail in the following page.

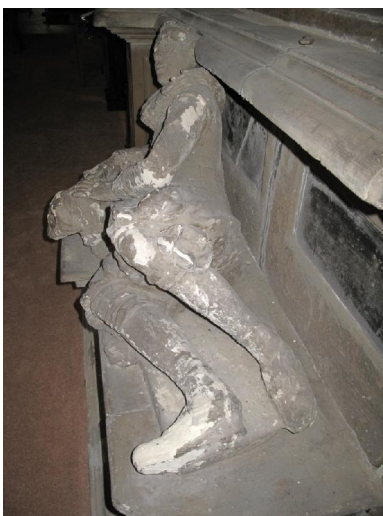
08/029

Left: The effigy viewed from the eastern side.

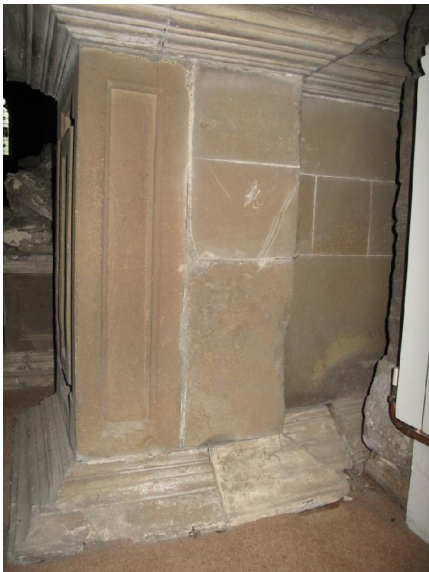
08/025

For comparison the eastern elevation is shown here again.

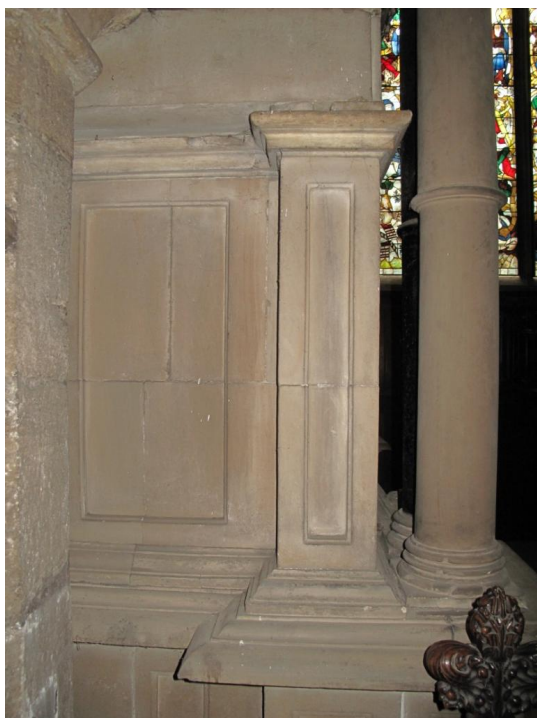
08/033

Western elevation of the return at the spring of the arch.

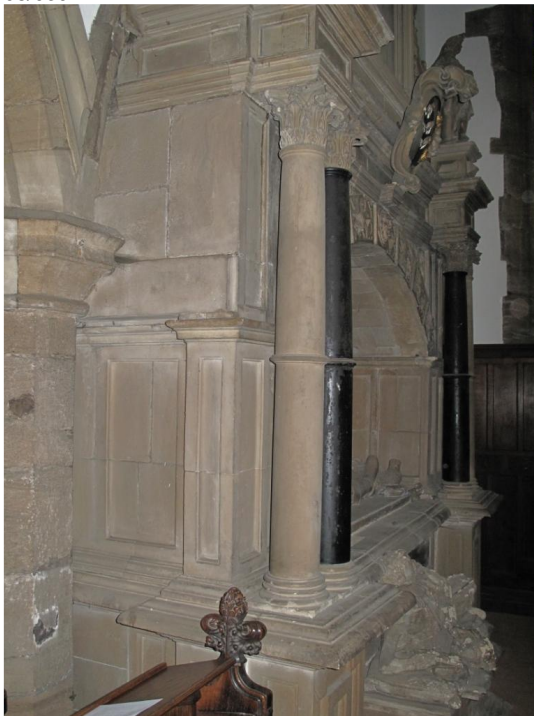
08/039

Western elevation of the west columns

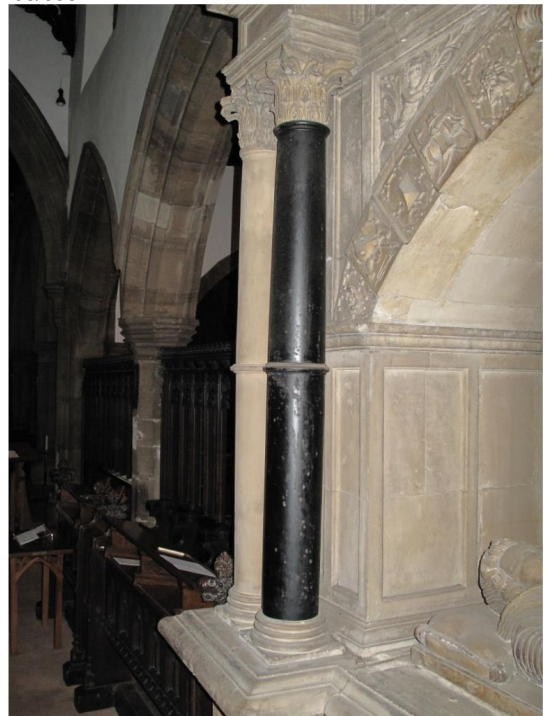
08/038

Eastern elevation of the west columns

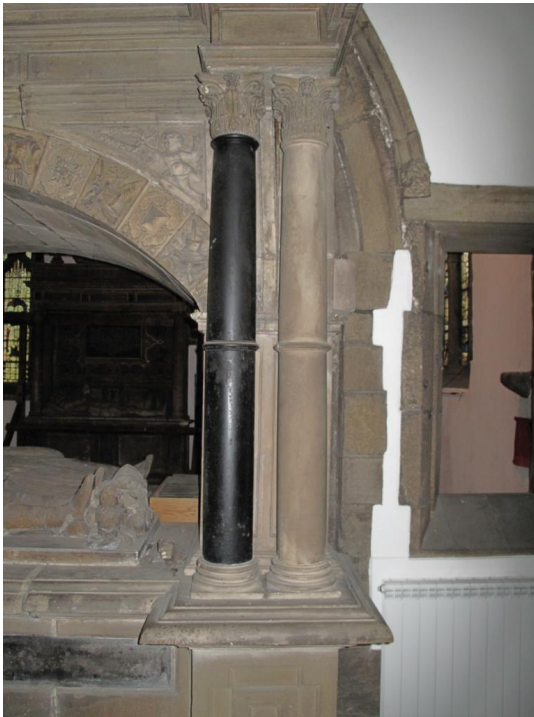
08/041

Front elevation of the eastern columns.

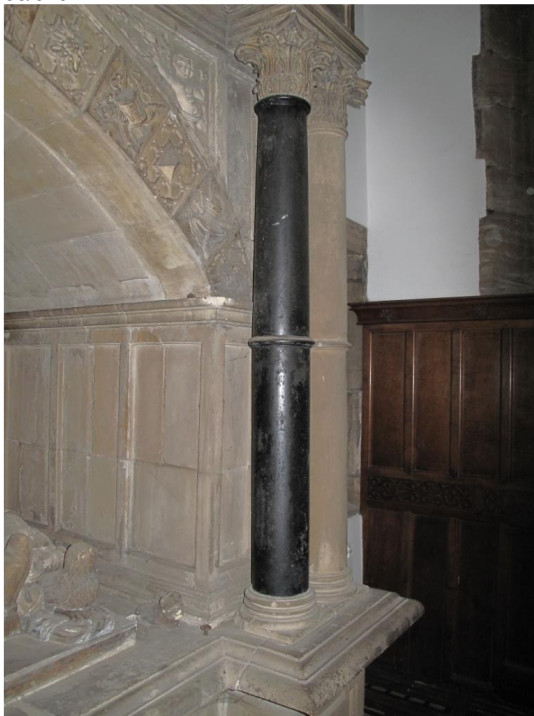
08/040

West elevation of the east columns

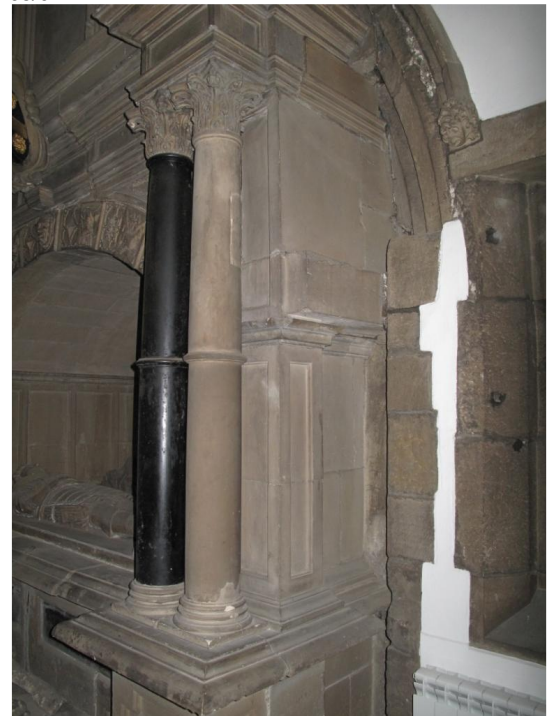
08/042

East elevation of the east columns

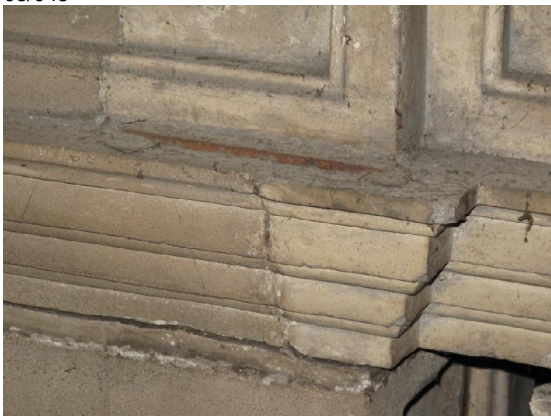
08/048

Detail of the cramp on the left in the above photograph.

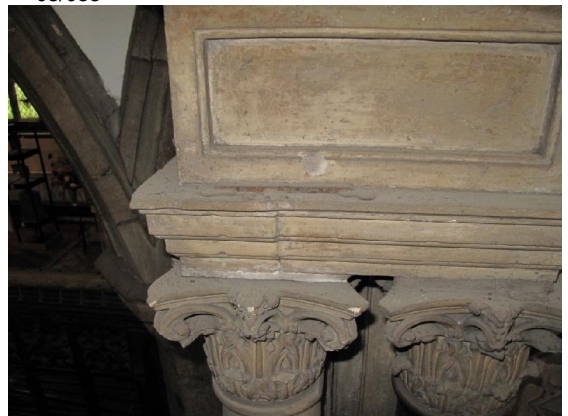
08/053

Detail of the cramp on the right in the above photo

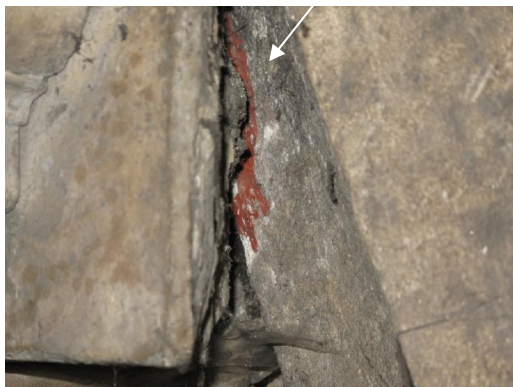
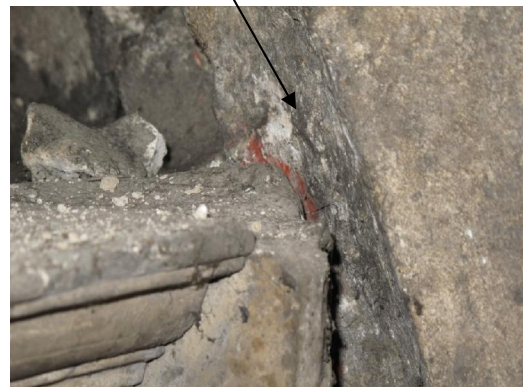
Of great interest here is the presence of red pigment remaining on the arch stone as indicated by the white arrow. There is further evidence of painted stone at the eastern end as shown in the photographs below.

Samples should be examined by a specialist to try and ascertain a date for this paint.

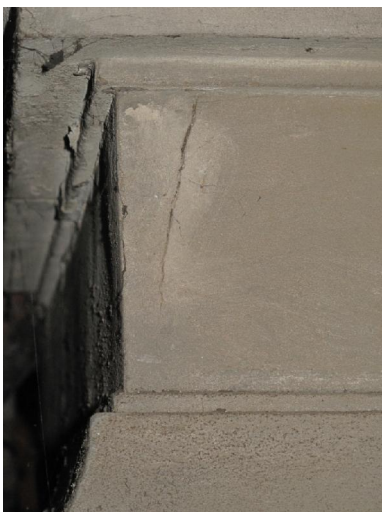
08/057

There is a stress fracture apparent in the stone as indicated. This is most likely but not definitely the consequence of an internal cramp corroding.

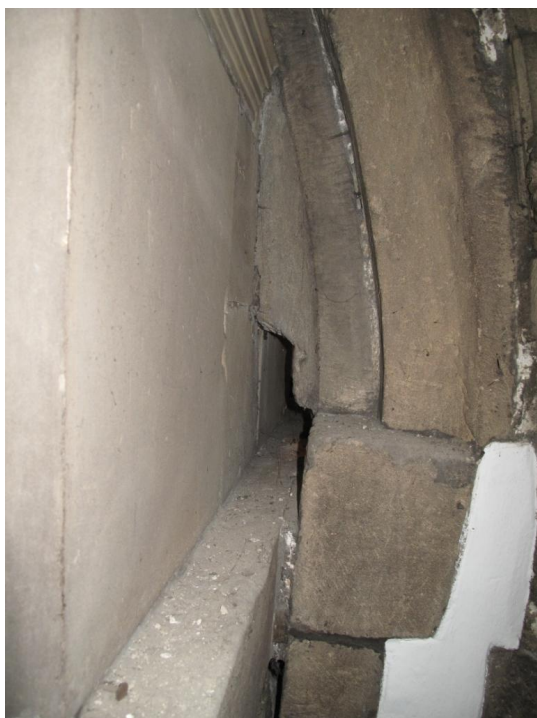
08/085

Detail of the recess between the eastern elevation of the tomb and the arch of the arcade at the location as indicated below.

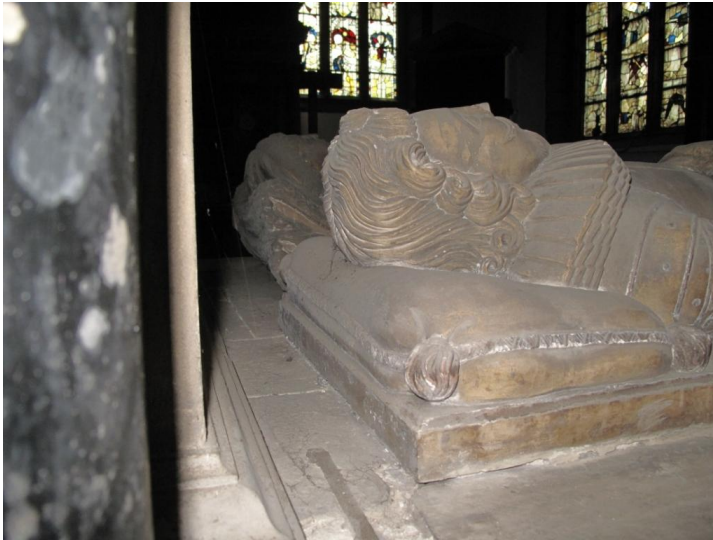
08/103

Detail of the head of Sir George.

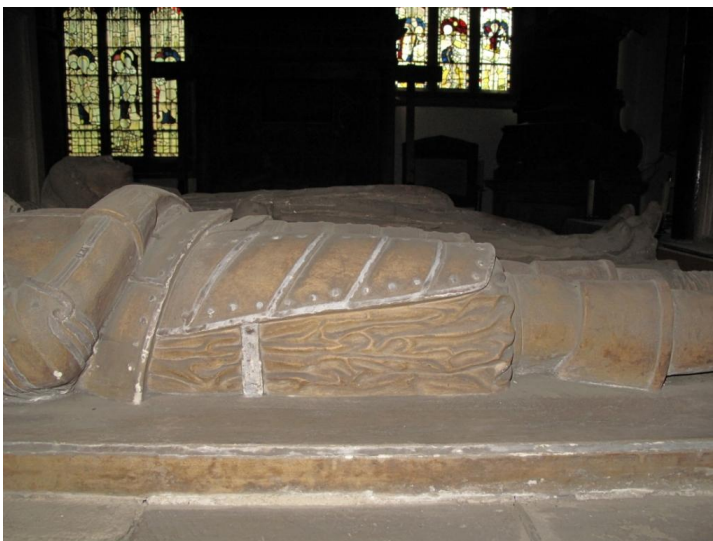
08/105

Detail of the central section of the effigy to Sir George.

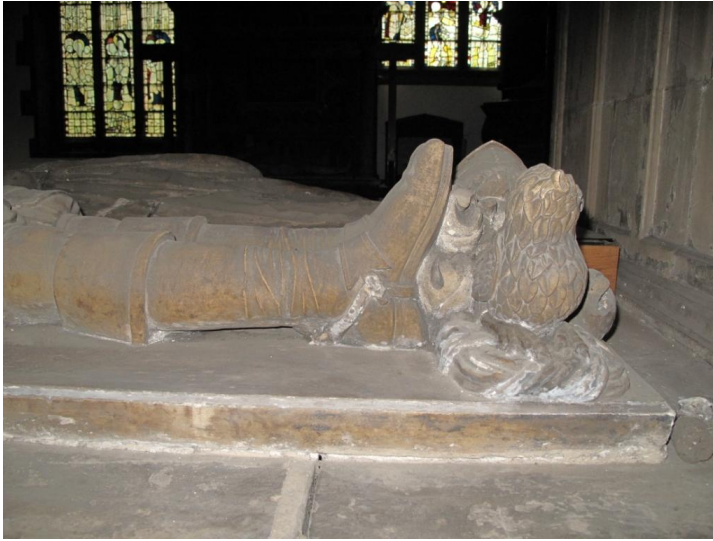
08/106

Detail of the feet of the effigy to Sir George.

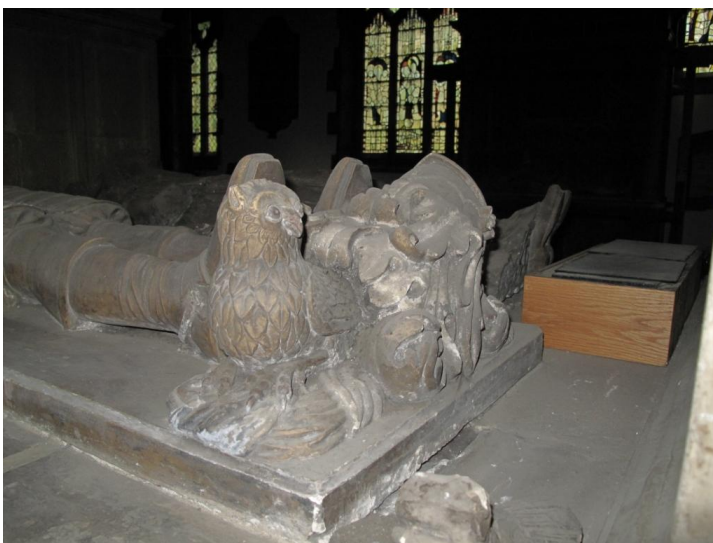
08/108

Detail of the emblems at the feet of Sir George including the owl.

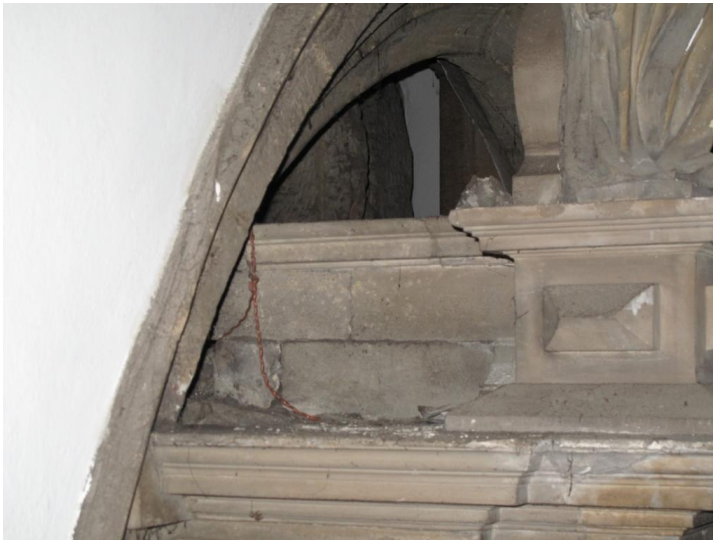
08/115

Detail of the western elevation of the entablature.

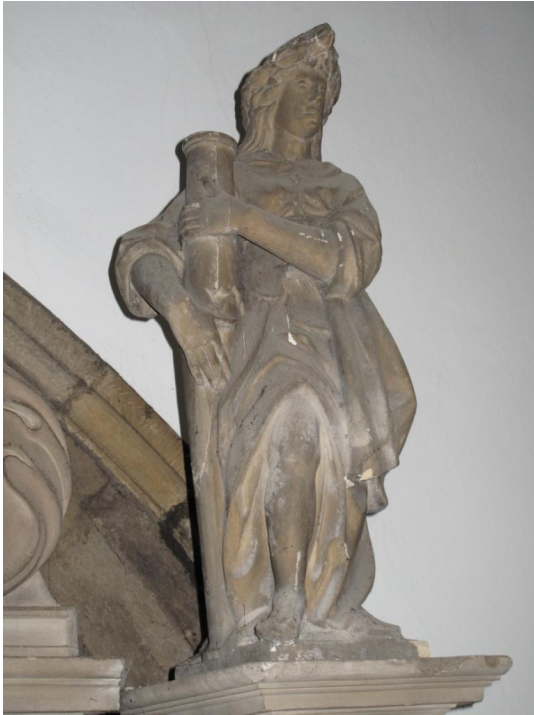
08/122

Detail of the eastern allegorical figure.

This figure also has a number of damages that appear to be from impacts.

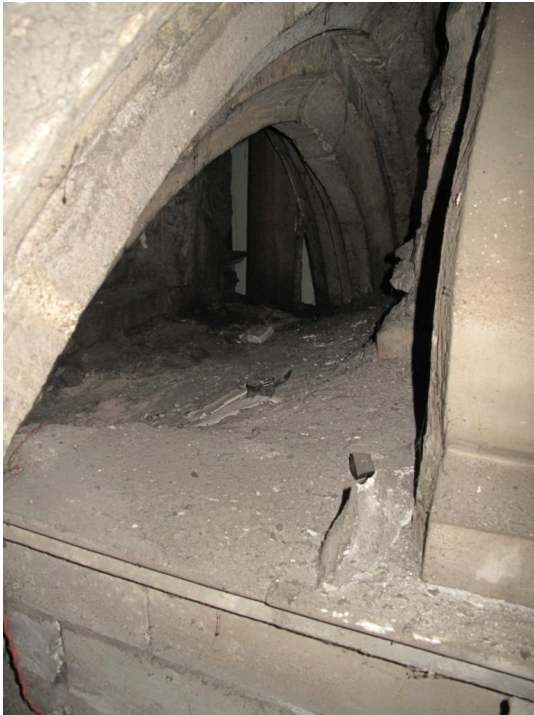
08/143

View of the top of the canopy between the two pediments – looking from the west elevation.

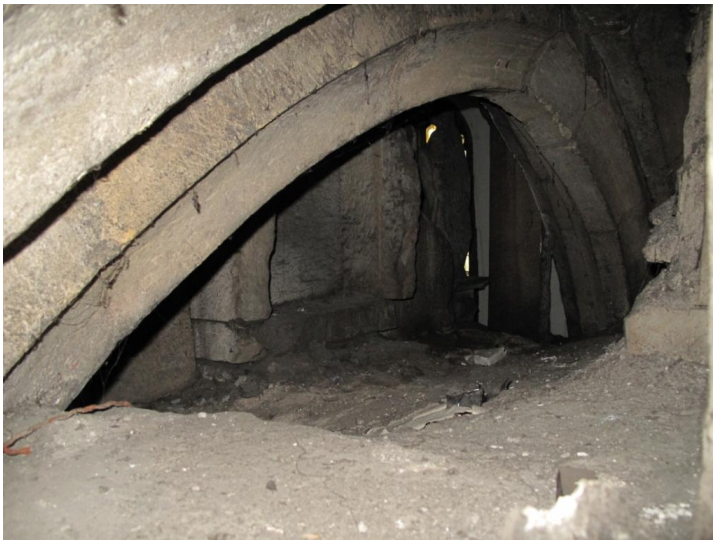
08/144

The area has been filled with rubble and a mortar capping.

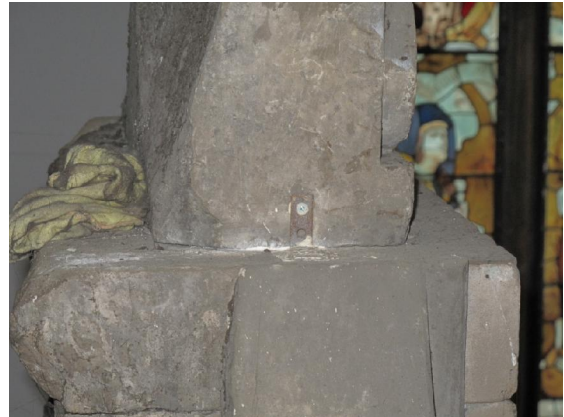
08/146

Below: The western elevation of the pediment top which supports the cherub showing the installation of a modern metal angle bracket.
